Federal Democratic Republic of Ethiopia
Ministry of Transport
Aircraft Accident Investigation Bureau

Aircraft Accident Investigation Final Report

Delta 2 Turbo Thrush (F-HLDD)

Report No. AI-01/21

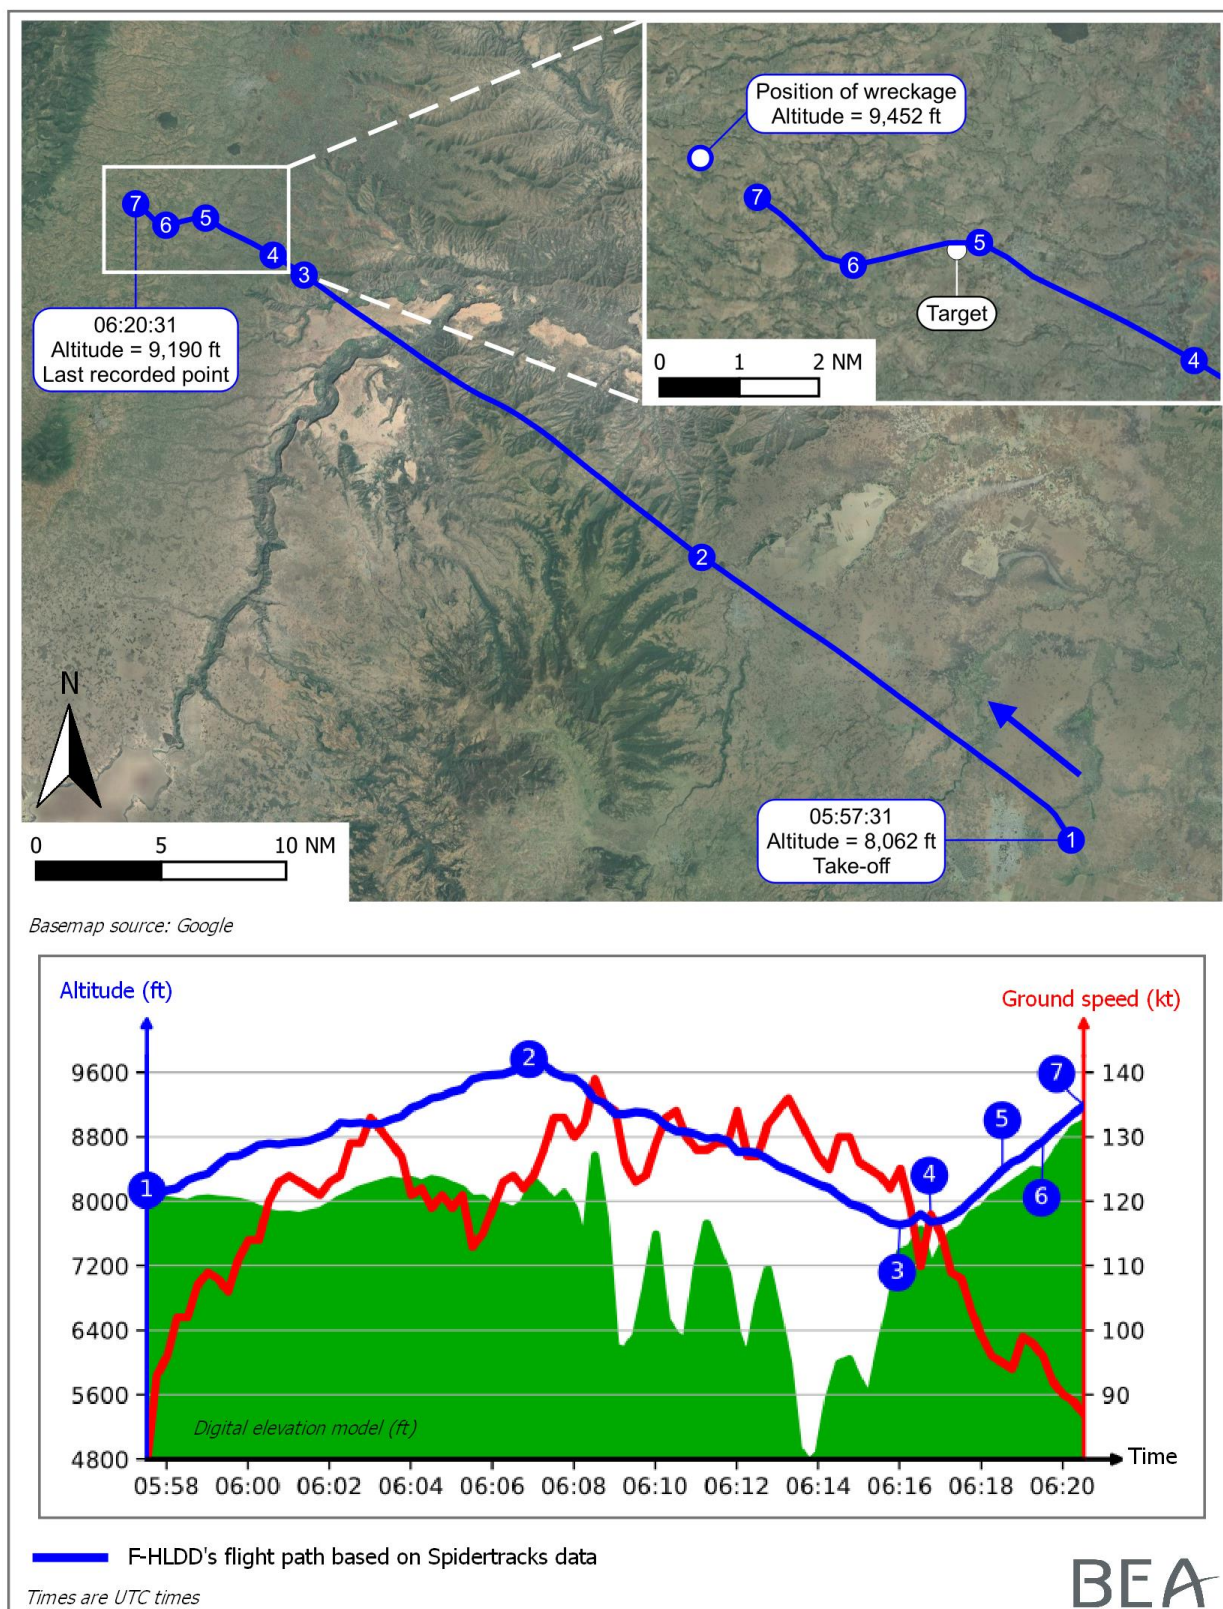
Figure 2 : flight path reconstructed by the BEA (France) on the basis of the airborne Spidertracks data system

After taking-off at 05 h57min (point 1) the pilot climbed to 9725 ft (2964m) above sea level to cross a mountain ridge that he overflew at 06h07 min (point 2).

After crossing the mountain ridge, the pilot began a slow descent, following the downward slope of the mountain until 06:16:01 UTC when he faced a second mountain slope. He was at that time at around 7700 ft (point 3).

Until that point, the pilot had been flying at an average height of 1000 ft, maintaining a heading of approximately 305° heading directly to the target.

From 06h 16 min 46 sec (point 4), the pilot began to climb. From that moment, he flew at around 200 ft above the ground. The ground speed started to decrease.

At 06h 17 min 31 sec, the rate of climb was around 430 ft/min. The ground speed decreased below 110 kt.

At 06:19:31 (point 6) the ground speed went below 95 kt. The aircraft was at that time passing 8 750 ft. The rate of climb was around 440 ft/min. The gap since the start of climb between the plane and the ground had remained until then between 200 and 300 ft.

At 06h 20min 31sec UTC (point 7), contact was lost at 9 190 ft.

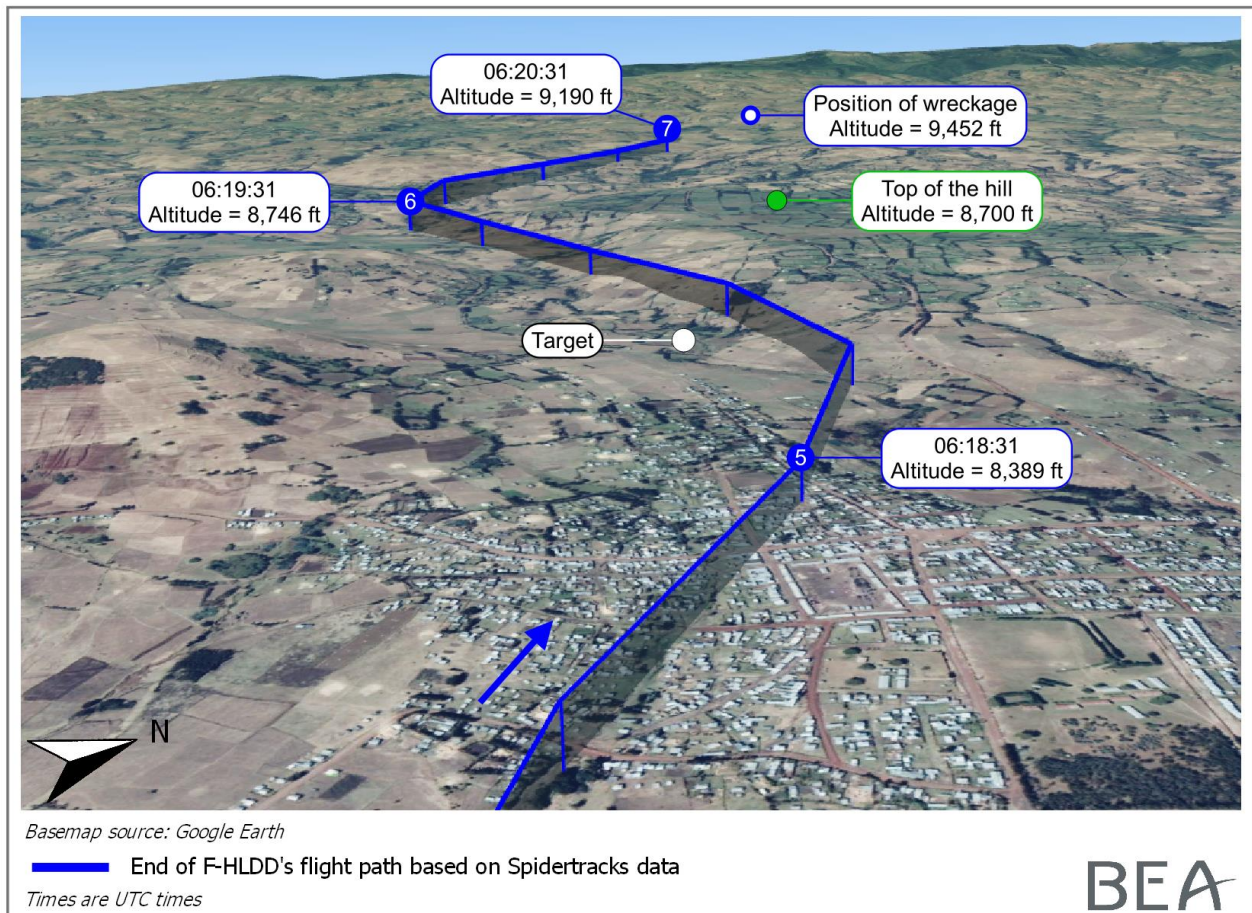
Figure 3 : Last portion of the flight path

At 06 h 18 min 31 sec (point 5), after passing over GADO town (see figure 3), the pilot performed a heading change to the left. He was at that time passing 8 390ft , climbing at a rate of about 430 ft/min. During this turn, he passed around 200 meters north of the target.

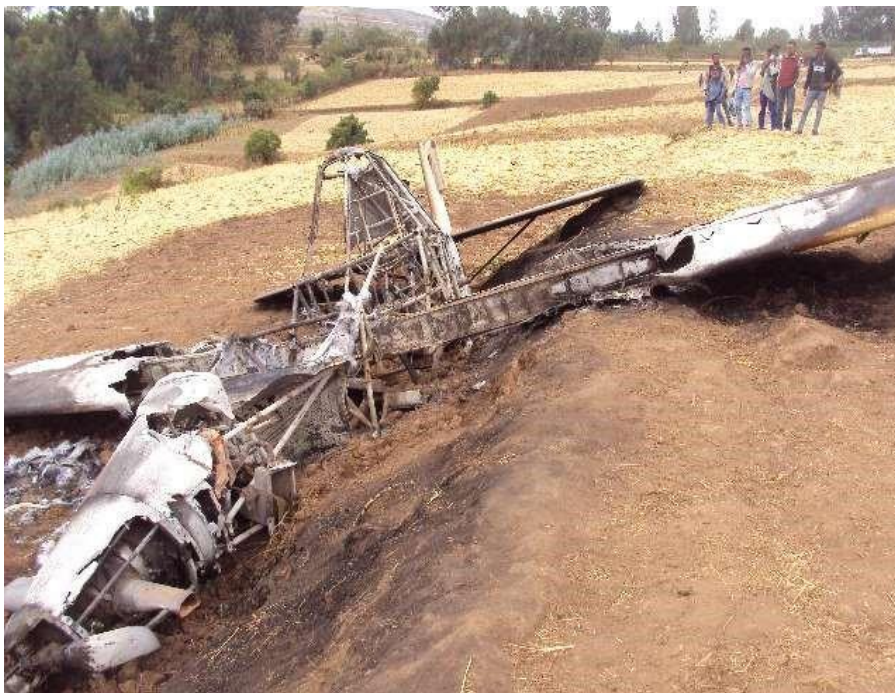
The aircraft was totally destroyed by impact forces and post impact fire as seen below

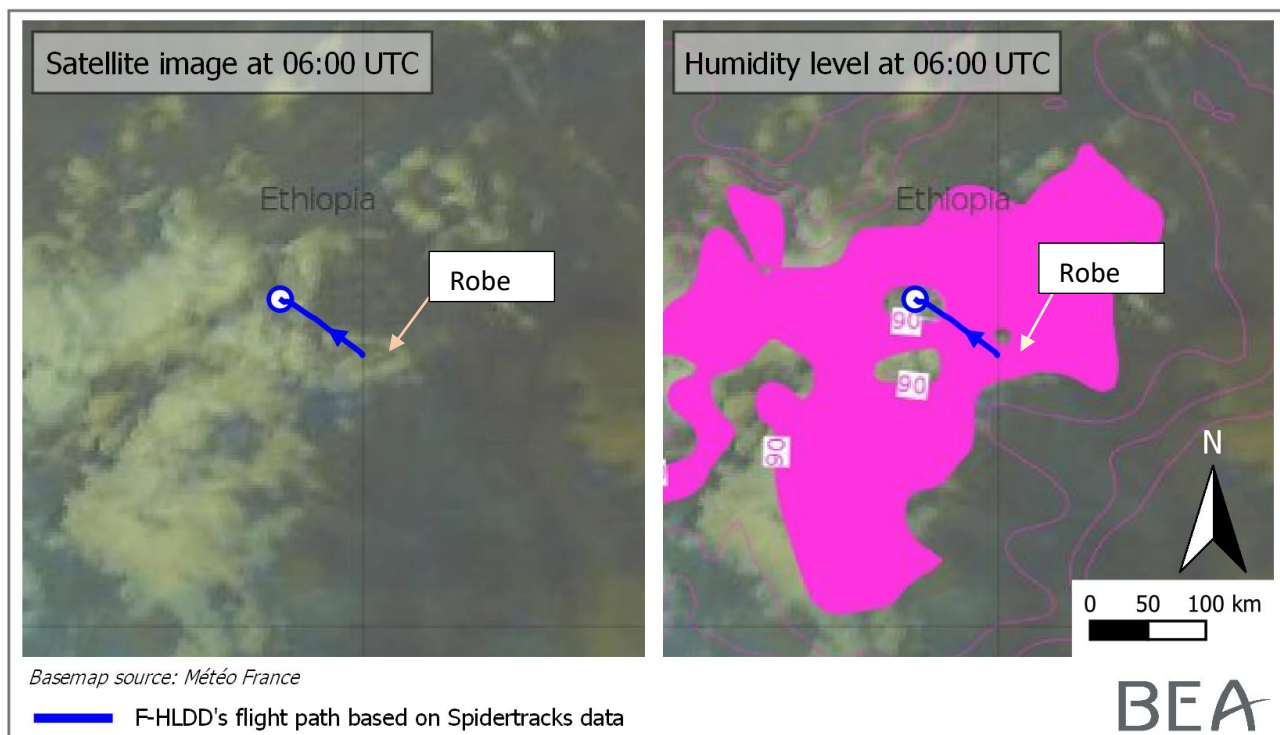
Figure 5: full horizontal flight path superposed on the satellite images

The BEA superposed the F-HLDD flight track on the satellite images. This tends to show that the sky was partly covered by clouds in the Robe area. In the middle portion of the flight the sky seemed to be clear. In the last portion of the flight the cloud layer seemed to be compact.

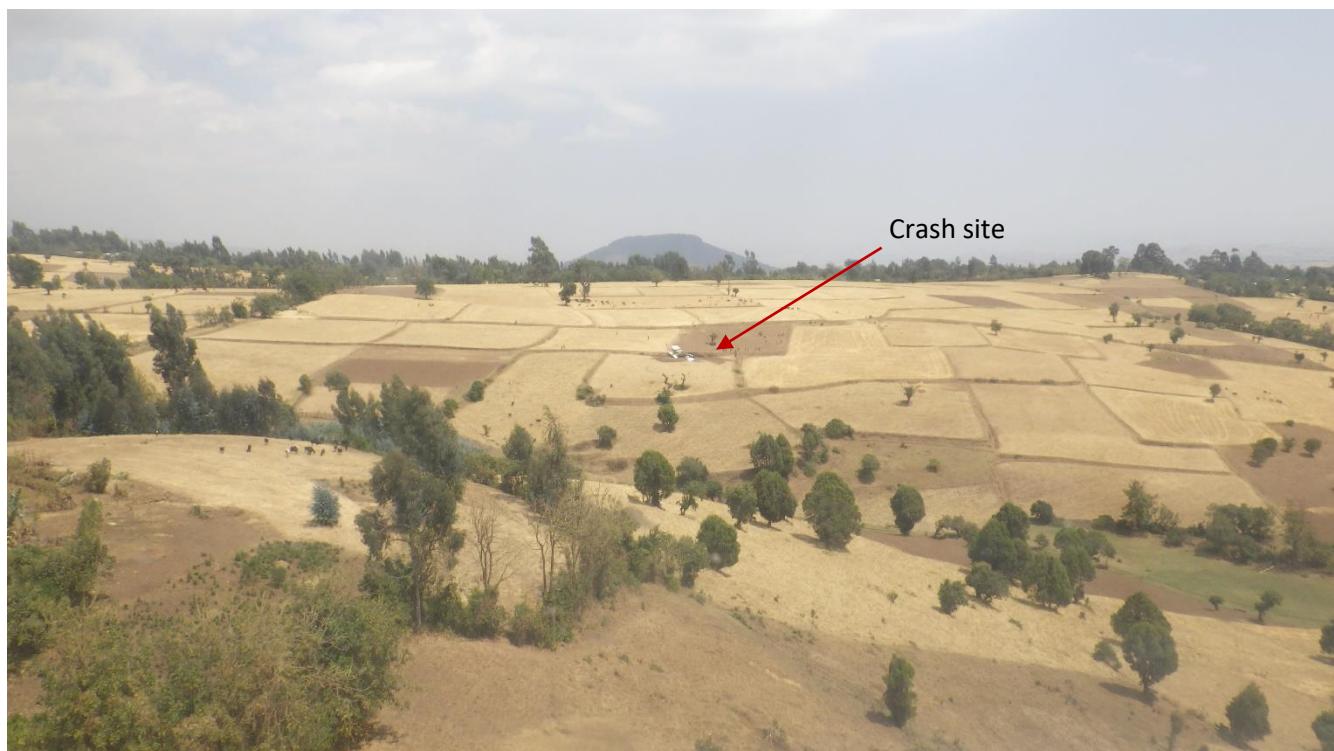
Figure 6: general view of the crash site

The aircraft crashed on the upward slope of a hill made up of fields, separated by ditches and mounds (see figure 6).

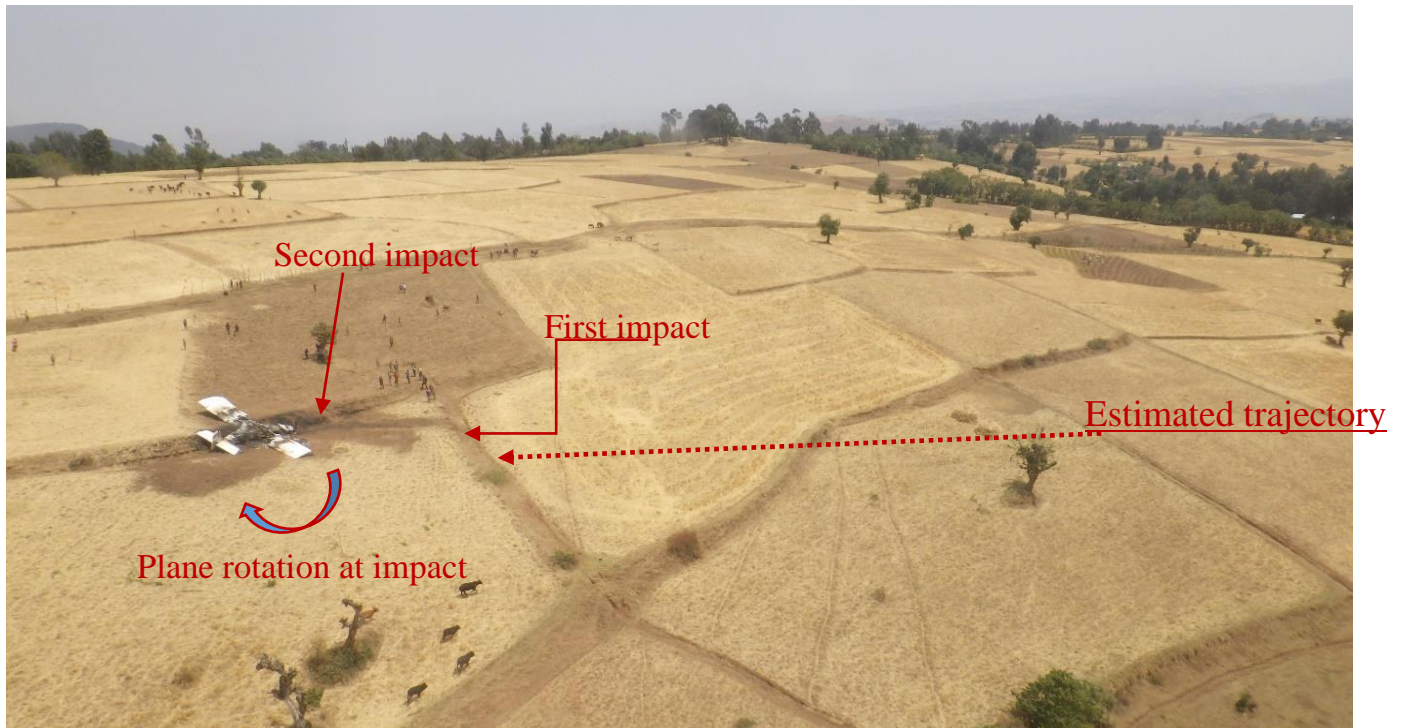
Figure 7: Impact zone

The main landing gear impacted a first mound. The aircraft then continued its course on about 10 meters until it hit another mound. At this second impact the aircraft turned about 150° degrees to the right on itself and caught fire (see figure 7).

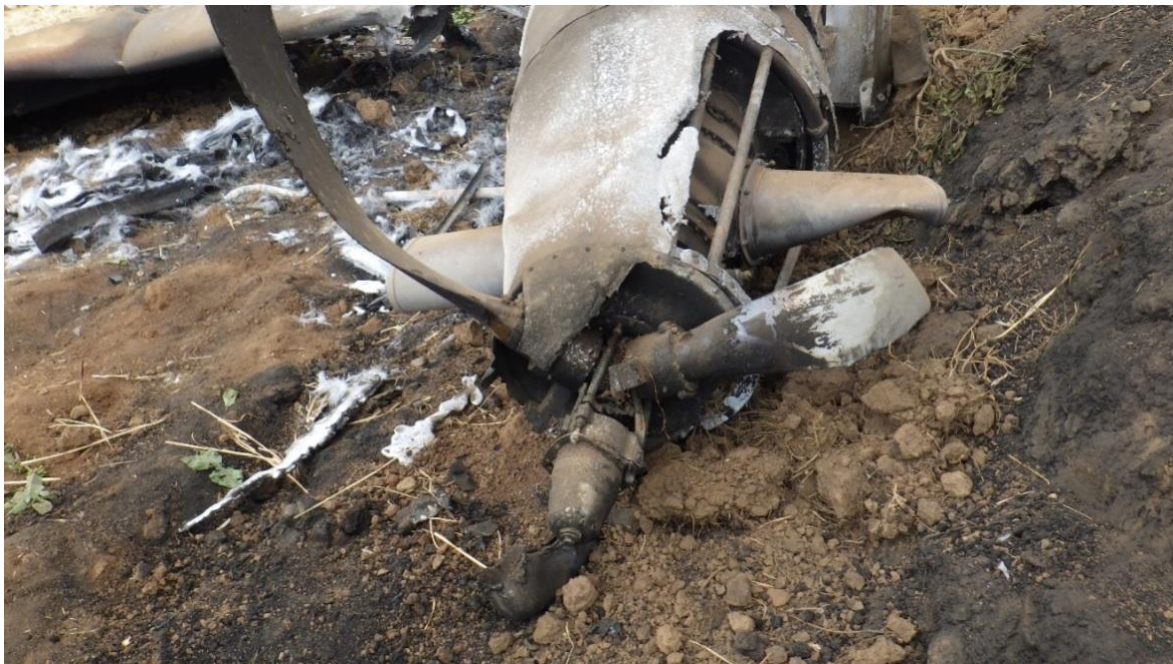
Figure 8: propeller

The examination of the wreckage, especially of the propeller aspect tends to show that the engine was delivering power (see figure 8). The amount of power could however not be determined.

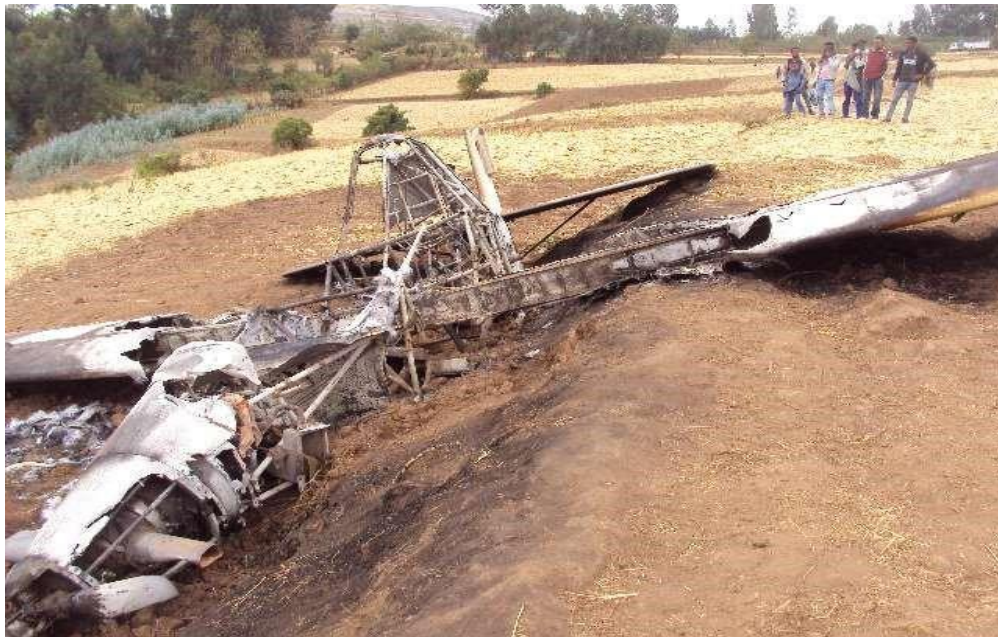
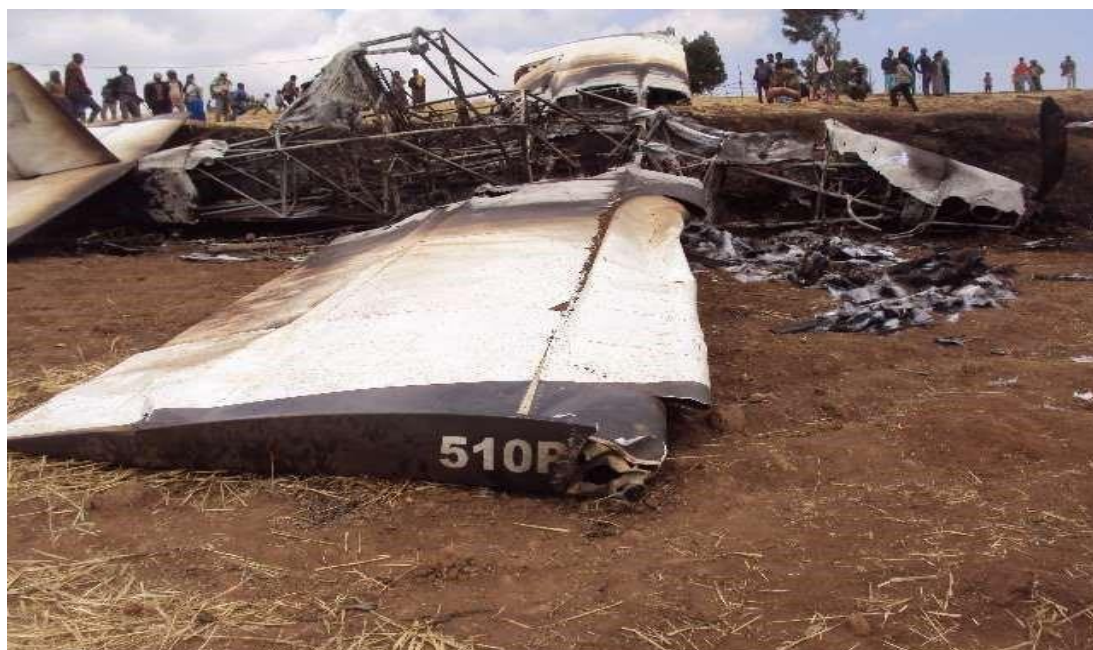
Figure 9: F-HLDD wreckage

The fire probably broke out in the middle part of the aircraft soon after the impact and destroyed major parts specially the engine, propeller and the fuselage structures. (see figure 9).

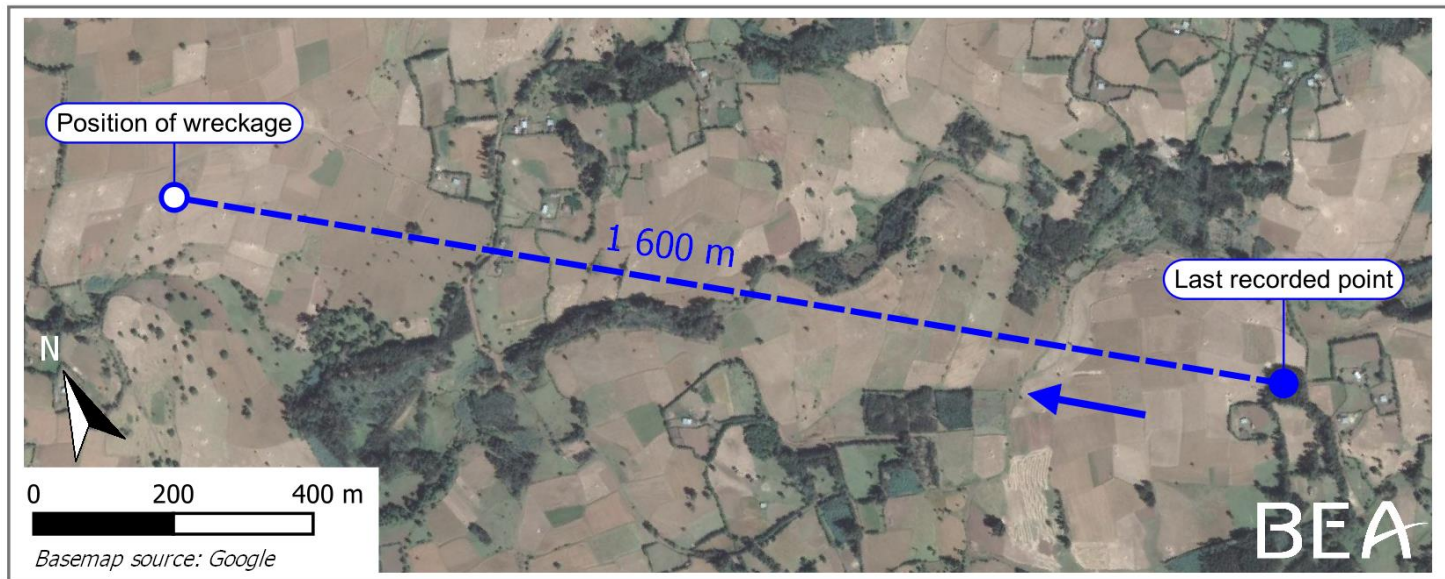
Figure 11: estimated flight path after the loss of contact.

The distance between the two points is 1.6 km which represents around thirty seconds of flight⁹.
