Accident to the PIPER - PA30
registered **N7977Y**
on 2 March 2021
at Courcelles-sur-Viosnes

Right engine shut-down in airport circuit, difficulty in holding level flight, forced landing in a field, in instruction

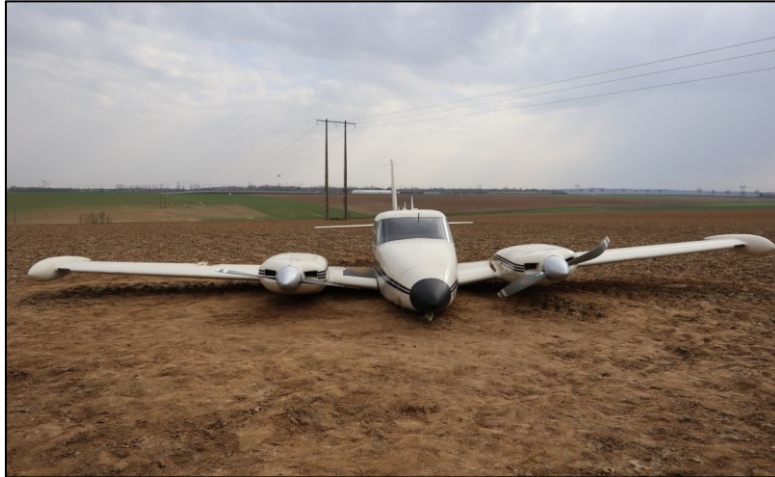
Figure 1: site of occurrence (source: BEA)

The aircraft came to a stop in a ploughed field, slightly to the left of the axis of runway 05 and approximately 1.7 NM from the threshold.

The aeroplane was lying on its belly with the flaps retracted. The lower section of the fuselage was damaged. Both blades of the left engine propeller were bent backwards. These distortions are compatible with a rotating propeller and little or no engine output when the aeroplane made contact with the ground.

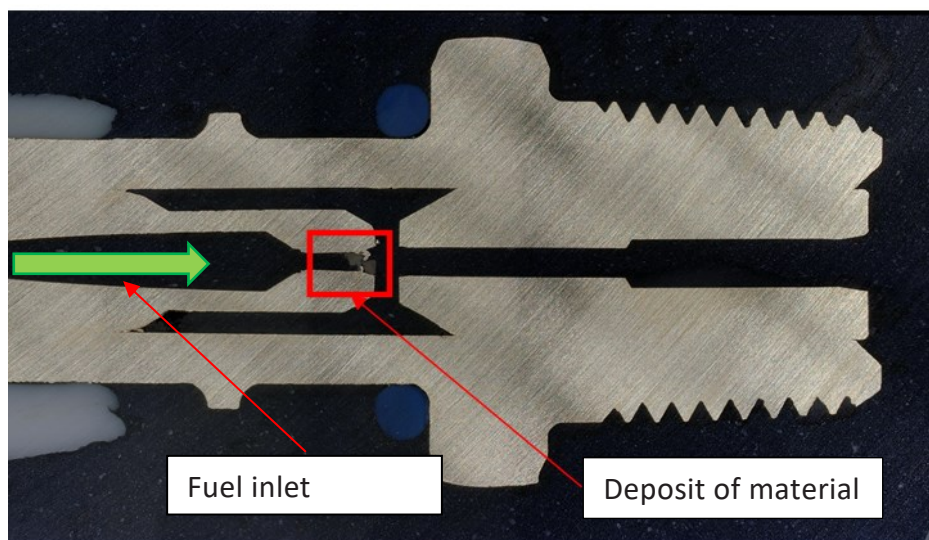
Figure 2: cross-sectional view of injector nozzle (source: BEA)

At the end of the test, the external temperature of cylinder No 3 was close to the ambient temperature, which is indicative of an abnormal operation. The injector nozzle of the cylinder was removed and found completely clogged.

An examination of the injector nozzle revealed a deposit of material blocking the fuel flow.

The right engine shut-down was due to the clogging of the injector nozzle of cylinder No 3 by the build-up of contamination in the damaged area of the injector line. This contamination was able to reach the injector nozzle because the strainer of the system regulating the fuel flow to the cylinders (FSI) was no longer fulfilling its function due to distortion. This distortion, which does not cause any particular difficulty in removing or reinstalling the strainer, was not detected during the last annual inspection. The investigation was unable to determine when the strainer was distorted. The damage to the injector line probably occurred when the injector nozzle was cleaned with unsuitable tools. A precise date for this damage, which occurred before the last annual inspection, could not be determined.

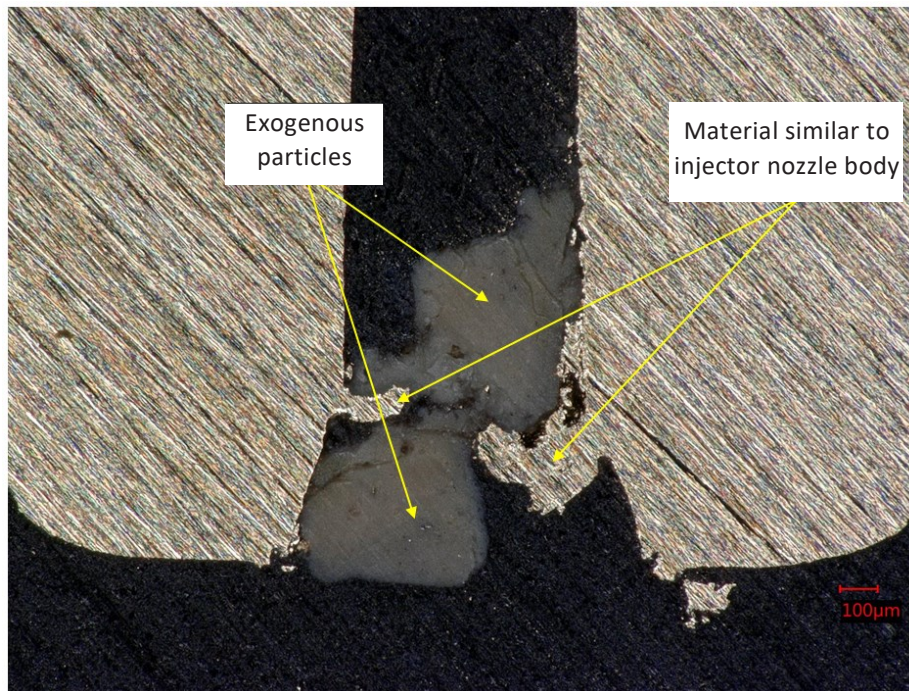
Figure 3: cross-sectional view of the clogged area (source: BEA)

Damage to the injector nozzle was also observed in the area of the obstruction. This type of damage may be the result of cleaning or unclogging the injector nozzle with an unsuitable tool such as a metal rod.

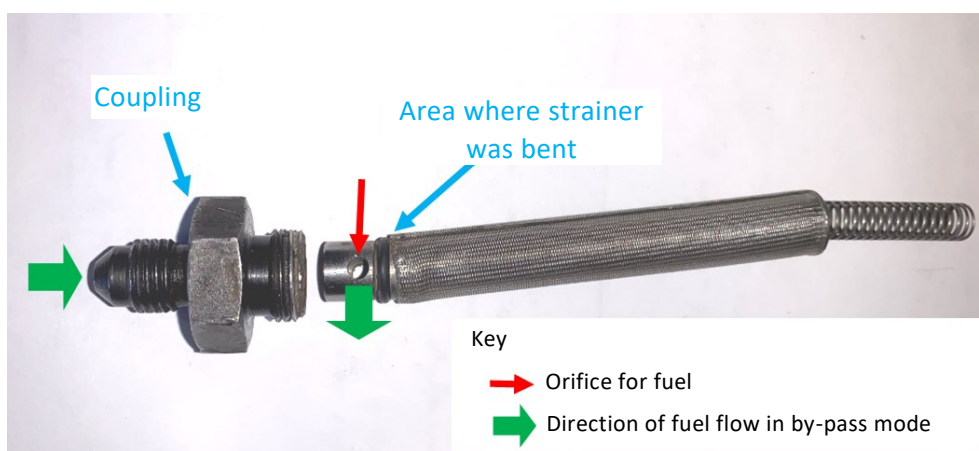
Figure 4: strainer of right FSI and its coupling (source: BEA)

The fuel strainer of the right FSI was found bent. This distortion implies that the strainer will take a "bypass" position when installed in the FSI. The fuel is then no longer filtered. It should be noted that the strainer could be installed in the FSI without any particular difficulty despite this distortion and that it was difficult to detect that it took a bypass position.
