INVESTIGATION REPORT

Incident to the ATR 72-212A operated by Caribbean Airlines registered 9Y-TTC on 4 May 2014 at top of descent to Piarco airport (Republic of Trinidad and Tobago)

Safety investigations

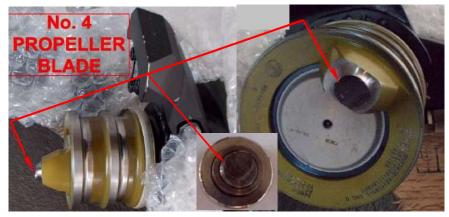
Figure 3: Root of blade 4 of right propeller

After the flight of 5 May and the tests carried out by the maintenance personnel, blades 3 and 4 of the right propeller were in a position corresponding to reverse whereas the four other blades were feathered. Blade 4 of the right propeller rotated freely around its axis. The disassembly of the right propeller blades revealed the rupture of the trunnion pin of blade 4 (Figure 3) and damage to the propeller blade actuator yoke plate (Figure 4).

Broken trunnion pin

The blade trunnion pin 4 was found broken. SEM examinations of the fracture surface revealed the presence of dimples on the entire surface, characteristic of a sudden ductile fracture by overload. The fracture was initiated on the side of the trunnion pin which corresponds to the position of the actuator forward yoke plate, and spread to the diametrically opposite edge. No apparent material or manufacturing anomaly was observed on the trunnion pin (the pin is an integral part of the blade tulip).

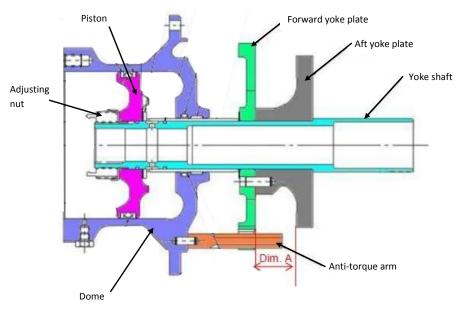
Figure 18: Measurement of distance Dim A between forward yoke plate (green) and aft yoke plate (grey)

The maximum measured deflection (Figure 18 and Table 1) of the yoke plate ear associated with blade 3 is 8.88 mm. The trunnion pin therefore passed behind the yoke plate while reverse was being used in ground engine tests (reminder: the minimum blade angle in reverse is -14°).

According to the maintenance manual (CMM 61-13-12), the maximum distance between the forward and aft yoke plates is 41.43 mm.

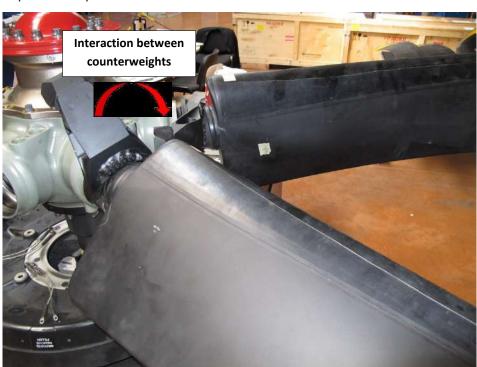
Figure 21: Interaction between the counterweight of blade 4 and the counterweight arm of blade 5

It could also be seen that when the trunnion pin of blade 4 was broken, the blade was able to rotate freely on its axis and interact with blade 5. The markings observed on the counterweight arm of blade 4 and the counterweight of blade $5^{(33)}$ were consistent with this sequence of operations.

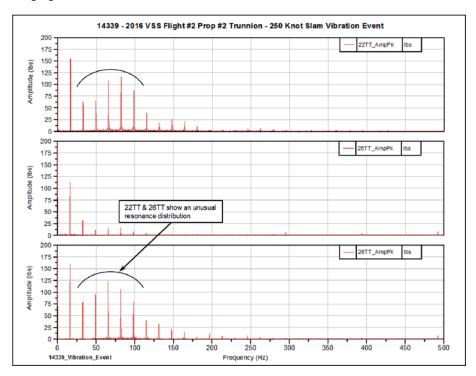
FFT plots for 22TT and 26TT show an unusual peak pattern. Typically 1P and 2P predominate. But in this case 1P is dominant while 2P through 6P are also major contributors to trunnion loading. A physical explanation for this 'ringing' phenomenon would be similar to a response observed after an impact load. The obvious candidate for such an impact would be the cyclic load of the trunnion loading and unloading the yoke plate. The 25TT FFT appears normal in that 1P dominates.

The 22TT and 26TT unusual resonance distribution compared to 2014 VSS (see chapter 5.5.4) could be an evidence that the machined gap between the plates exacerbates the vibration event.
