## Serious incident to the Robin DR400-120 registered F-GOVA

on 6 December 2014  
at Cambrai (Nord)

## Carbon monoxide poisoning on a night flight, U-turn and emergency landing, in instruction

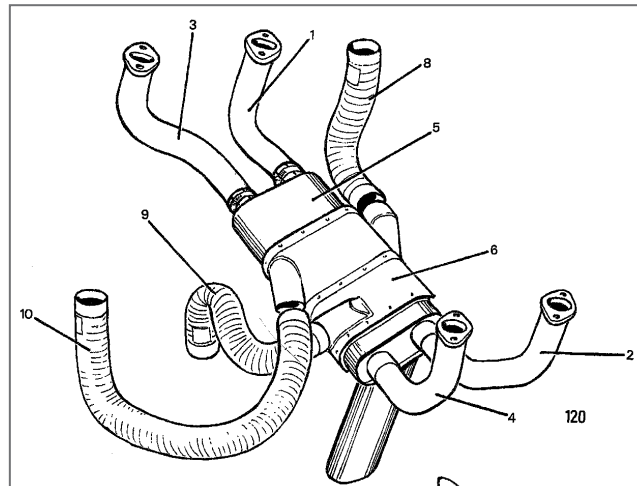
The 4-in-1 exhaust manifold is surrounded by a housing known as a "*heat exchanger housing*" (item 6), which is composed of two half-shells. It has two compartments completely sealed from the exhaust gas collection area: one for the carburettor heating unit and the other for the cockpit heating unit.

Three flexible hoses (numbered 8-9-10) are fitted to this housing. They have the following functions:

- ❑ To supply fresh air, taken from the front of the engine (item 8), to the compartment dedicated to the cockpit heating control unit via the flexible hose (item 10).
- ❑ To supply hot air to the carburettor heating unit (item 9). This flexible hose is connected to the "centre right" outlet of the exhaust manifold. The carburettor heating compartment is supplied with air taken from the engine compartment via a meshed surface in the lower half-shell of the heat exchanger.

Drawing of the exhaust manifold system of the O-235 engine on the DR400-120

- ❑ A leak at the ceramic seals of the exhaust pipe associated with wear of the gland packing of the exhaust manifolds of cylinders 2 and 4. The exhaust gases were thus able to permeate the engine compartment.
- ❑ Weld beads bearing witness to repairs made to numerous cracks in the manifold.
- ❑ Wear on the peripheral seal of the shut-off flap of the heating control box.
- ❑ The flexible hose connection supplying hot air from the heat exchanger housing to the heating control box had been switched with the connection supplying hot air to the carburettor air inlet.

- the switching over of two flexible hose connections fitted to the exhaust manifold;
- a progressive leakage due to a worn ceramic gasket/gland assembly on the exhaust manifolds of cylinders 2 and 4.
