INVESTIGATION REPORT

**Incident to the Boeing B737-800
registered EI-EMK
operated by Ryanair
on 29 January 2015
on approach to Bergerac-Roumanière
airport (Dordogne)**

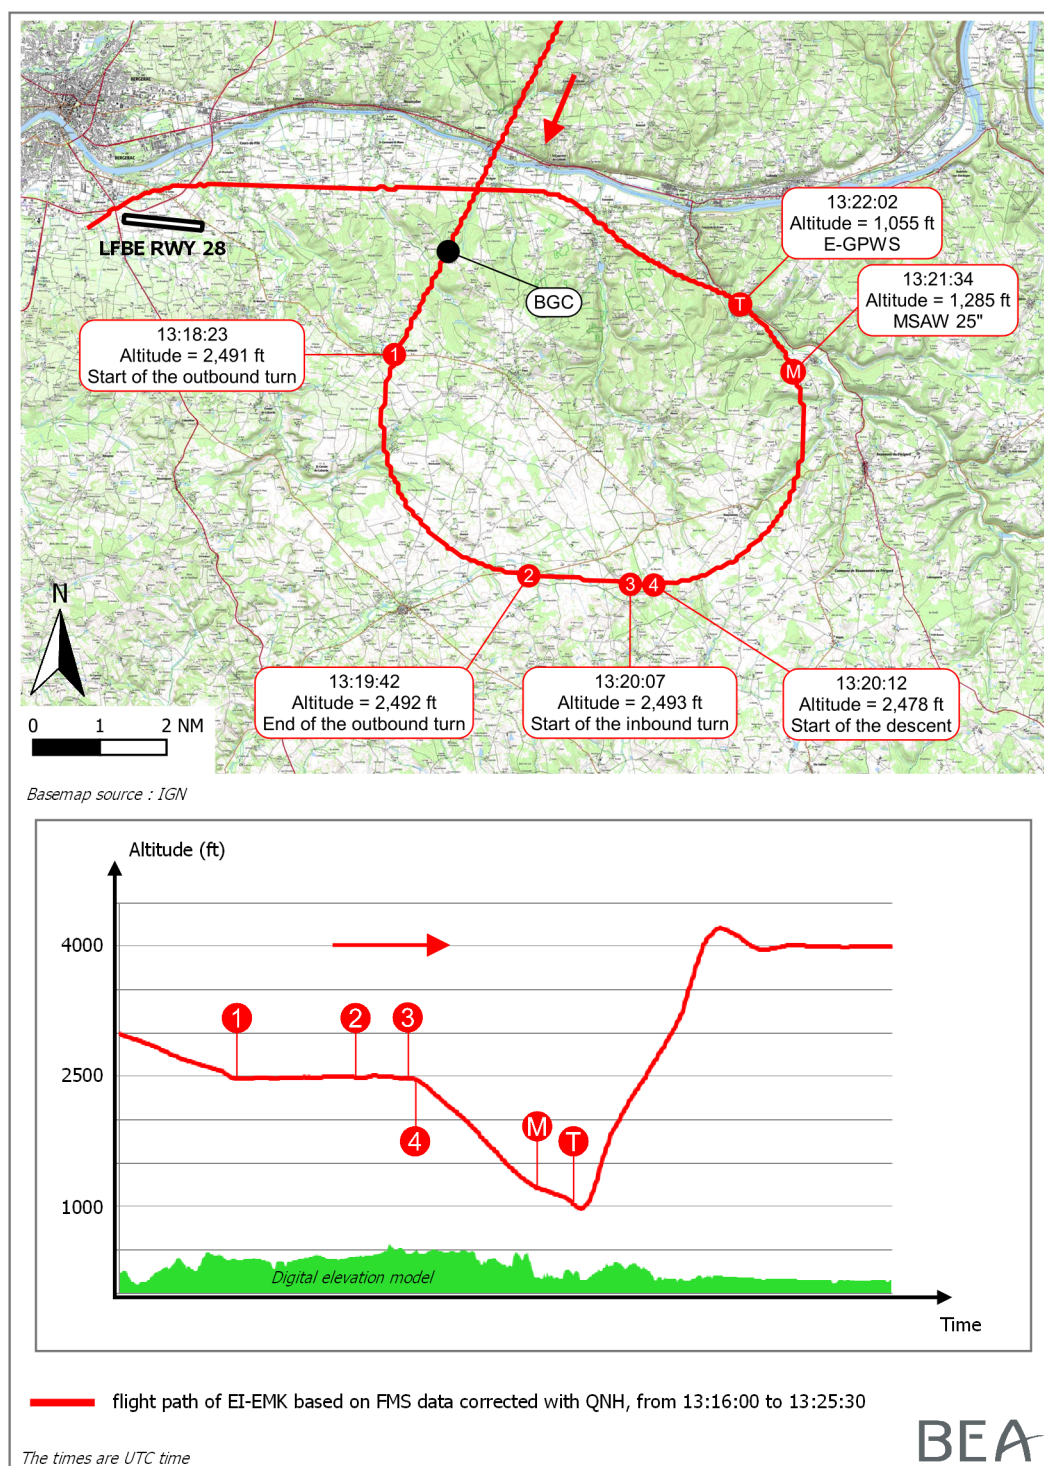
Figure 1: path

At 13:18:23, the crew selected flap position 1. The aeroplane, still in LNAV mode, started a left turn (see Figure 1, point ①).

At 13:19:42 (see Figure 1, point ②), the aeroplane came out of the turn on a heading of 097°. It was then in level flight at an altitude of 2,500 ft (in ALT HOLD mode) and its indicated airspeed was 185 kt. Three seconds later, the crew extended the flaps to position 5.

At 13:21:34, (see Figure 1, point M), when the crew had changed frequency, a MSAW was activated in the Aquitaine-Approach control room.

At 13:22:02 (see Figure 1, point T), the E-GPWS “TERRAIN” alert was activated and perceived by the crew. At this point, the aeroplane was more than 8 NM from the runway threshold, still turning, left of the runway axis, at an altitude of 1,054 ft, i.e. a radio altimeter height of 842 ft. The autopilot lateral and vertical modes engaged at this moment were LNAV and ALT ACQ respectively⁽⁵⁾. The rate of descent was 970 ft/min and the indicated airspeed 166 kt.

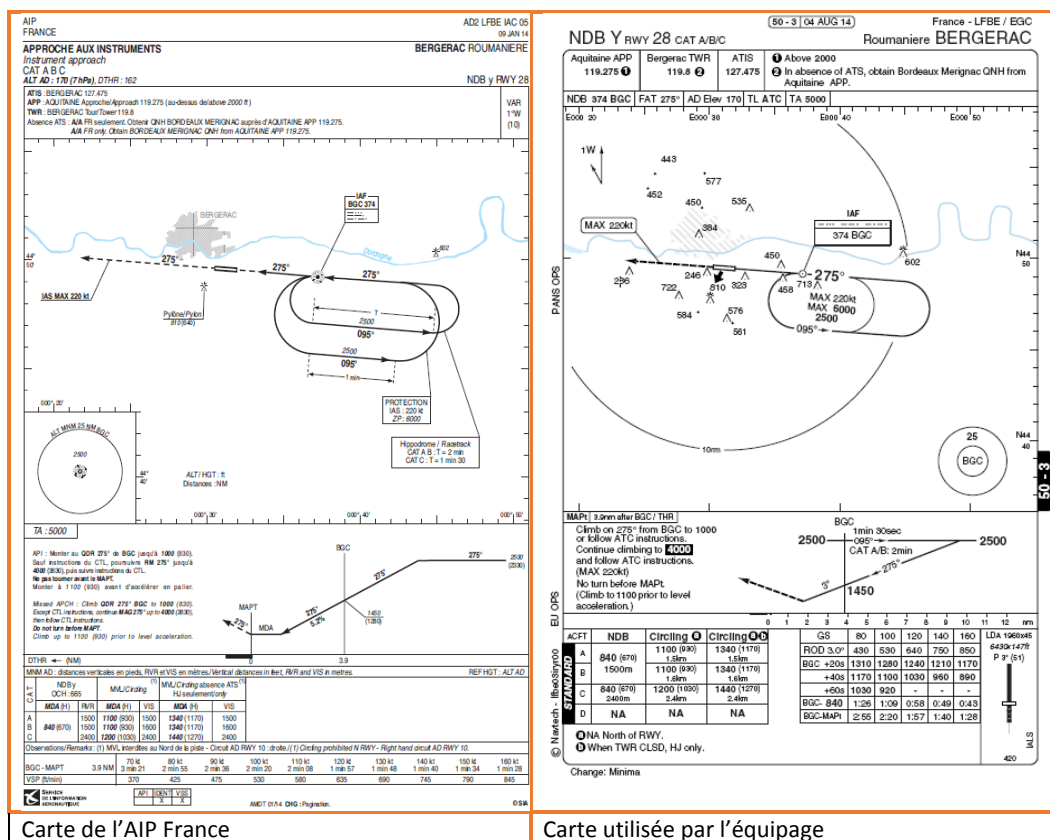
Figure 3: comparison between Bergerac-Roumanière airport NDB Y 28 approach charts

Paragraph 11.3.3 of ICAO Annex 4 regarding aeronautical charts⁽¹⁴⁾ deals with the chart scale. It specifies that “except where this is not practicable, a distance circle with a radius of 20 km (10 NM) centred on a DME located on or close to the airport, or on the airport reference point [...] shall be shown” on the chart. Furthermore, it is recommended that “a distance scale should be shown directly below the profile.”

More specifically, concerning the procedures without a means for obtaining distances, as for the Bergerac-Roumanière NDB Y 28, certain experts in charge of the design and publication of the approach charts in the AIP France consider that the representation of a 10 NM circle could cause confusion, as could the representation of a detailed distance scale under the vertical profile.

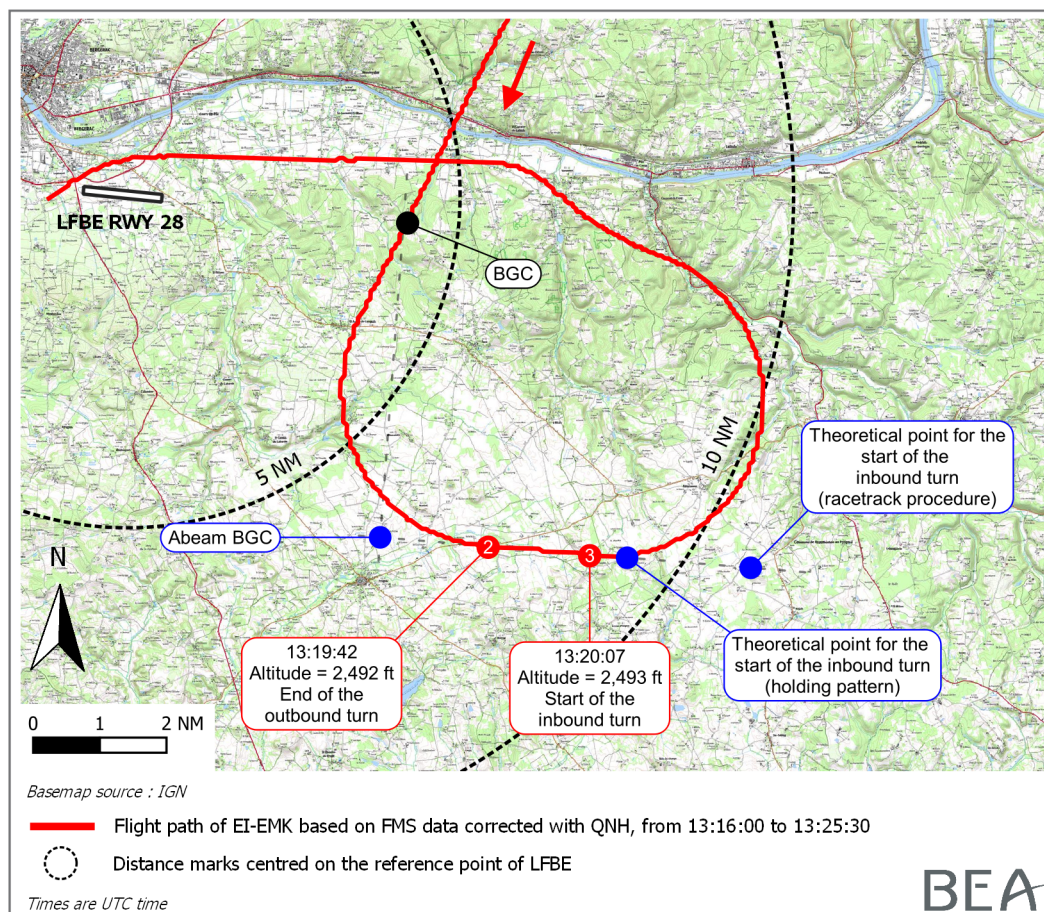
Figure 4: estimated theoretical positions of start of inbound turn in the holding pattern and in the racetrack procedure with respect to the aeroplane's actual path

The average ground speed recorded for the outbound leg was 227 kt. This value was used to position the theoretical points for the start of the inbound turn corresponding to the holding pattern and racetrack procedure (i.e. respectively 1 min and 1 min 30 sec outbound after passing abeam BGC beacon).

For information, during the incident flight, the aeroplane (in LNAV mode) started the inbound turn shortly before the theoretical start of turn point for a holding pattern, and before the theoretical start of turn point for a racetrack procedure (see Figure 4).
