Accident to the ELA 07 R100 gyroplane identified **62-AYF** and the Crossfire 2-109 parachute on 30 April 2015 at Lens - Bénifontaine aerodrome (Pas-de-Calais)

Collision between a parachute and a gyroplane in climb out, in training flight

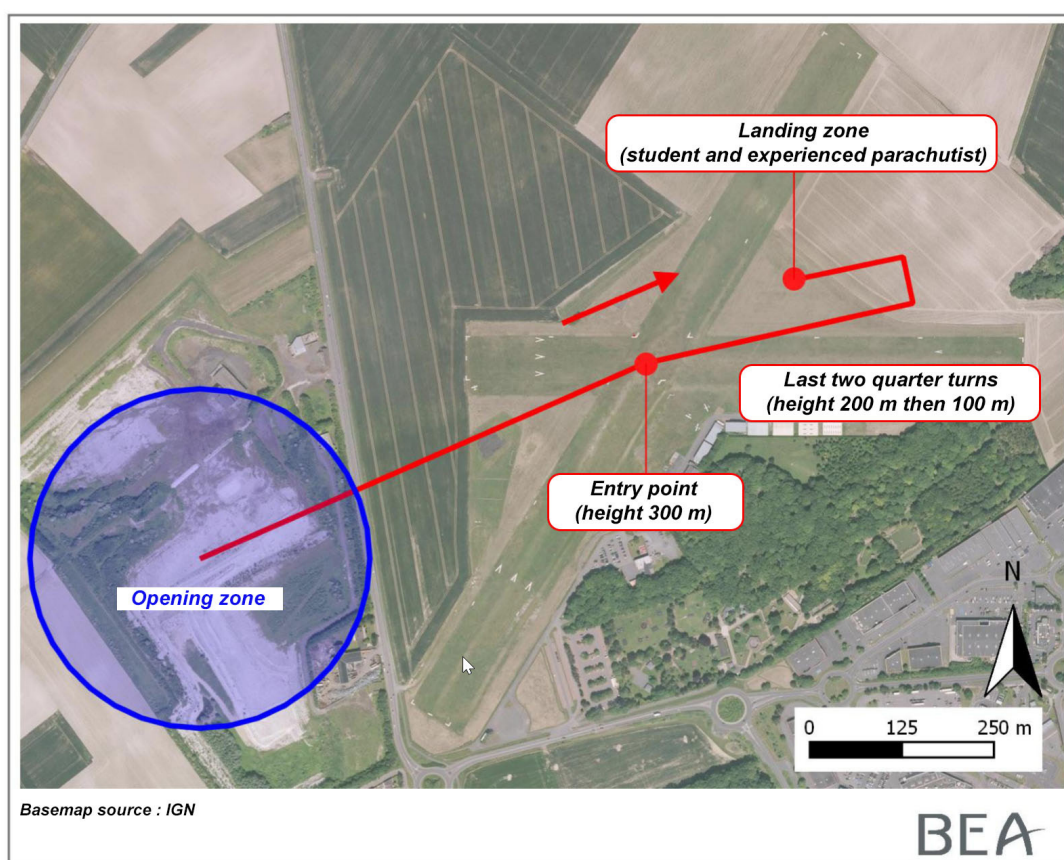
Figure 2: theoretical circuit to be followed by parachutists to land in the “*student and experienced parachutist landing zone*”

After the accident and based on the conditions of that day, the school produced the theoretical circuit to be followed to land in the “*student and experienced parachutist landing zone*”, shown below.

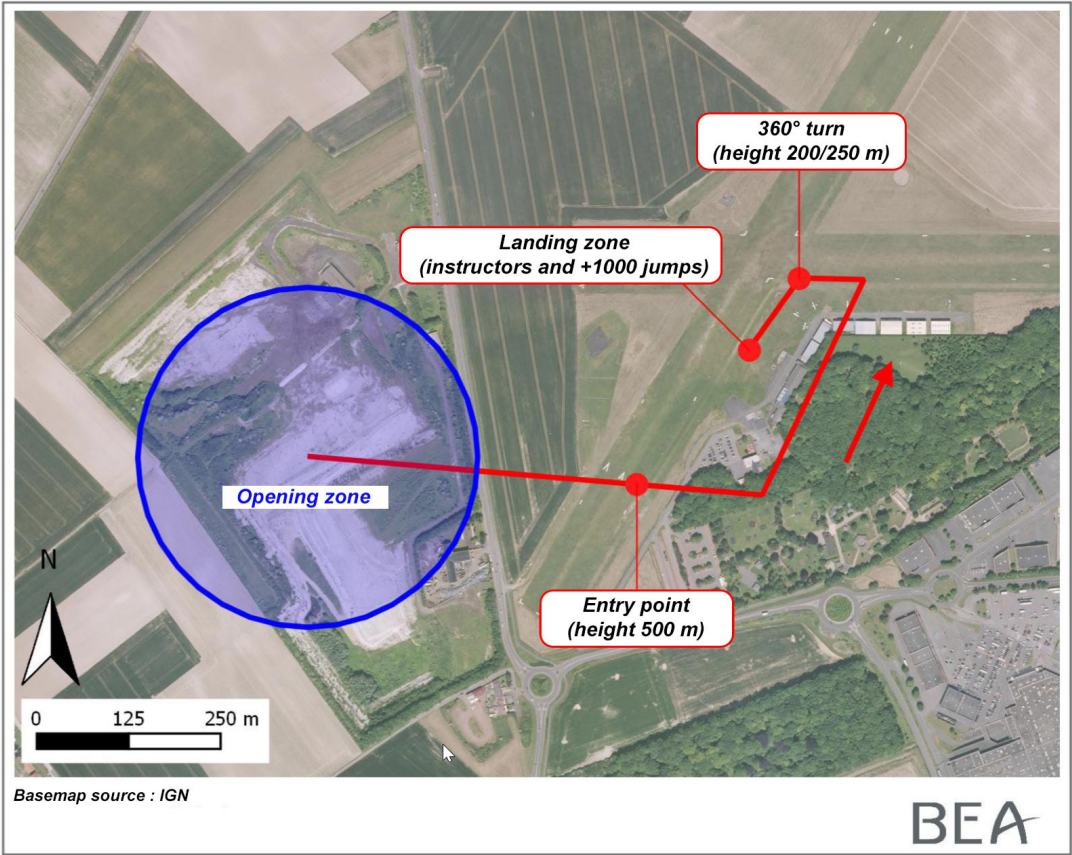
Figure 3: circuit followed by two instructors to join the “instructor and +1,000 jump landing zone”

The circuit followed by the two instructors who landed in the “instructor and +1,000 jump landing zone” the day of and a short time after the accident was the following:

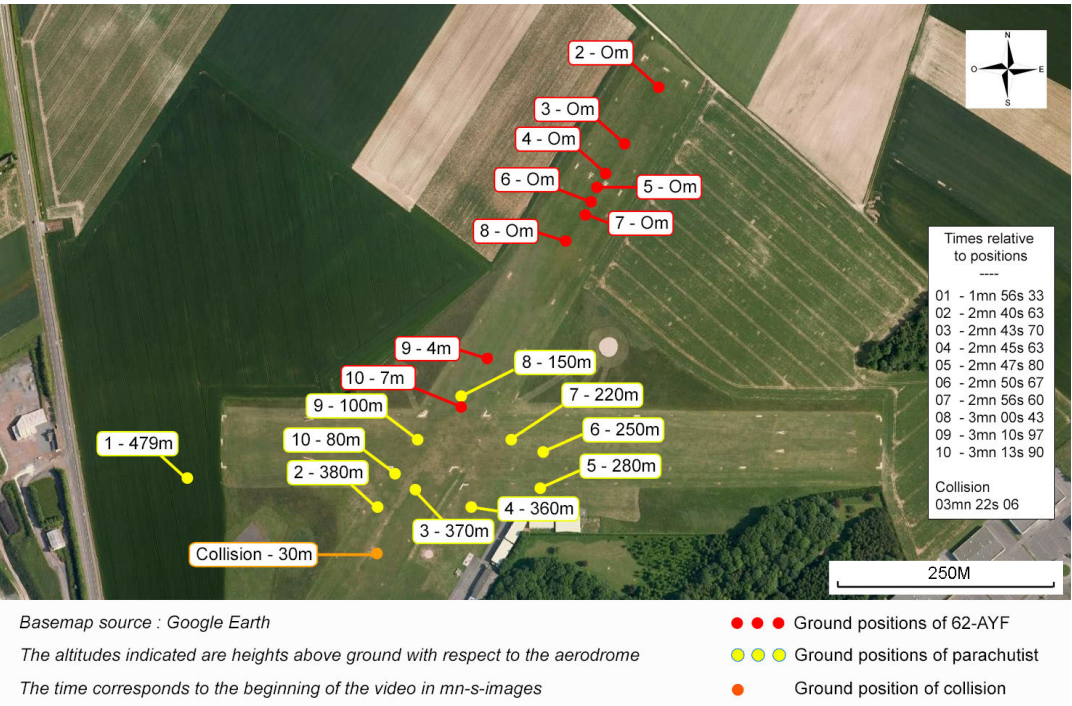
Figure 4: reconstituted flight paths of gyroplane and parachutist involved in the accident

The analysis of the video made it possible to determine the paths of the gyroplane and parachutist involved in the accident. These are shown below.

After the free fall and opening of the parachute which took place normally, the parachutist headed towards the intersection of the runways from the west. He passed over points "1", then "2" and "3" under his open canopy without any visible steering difficulty. He was at point "4" after cutting across the runway 03/21 centreline at a height of around 370 metres. It was then possible to observe a controlled, fast descending tightening turn and a loss of height of 80 metres in two seconds, normal for this type of manoeuvre. At point "5", the parachutist, while continuing a standard descent, returned to the runway 03/21 centreline and cut across it at around 3 min 00 s at a height of between 150 metres and 200 metres. Up to point "8", the path followed allowed him to have visual contact with the gyroplane. Then the parachutist turned left to fly a heading of 210° over the runway and to the right of the runway centreline. The following of this path shows that the parachutist was not trying to land on the *"student and experienced parachutist landing zone"*. From point "8" up to the collision, the gyroplane was behind the parachutist and the latter could not see it. Just before the collision, the parachutist had started a left turn.

The collision between the parachutist and the gyroplane was due to the parachutist following an unusual and conflicting path with the standard path of the gyroplane.

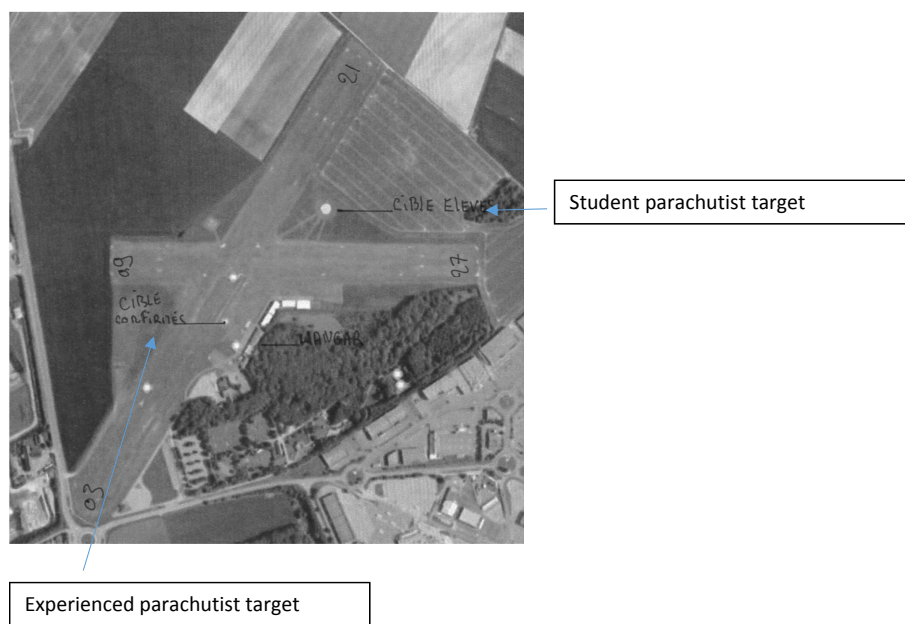
Figure 7: photo of “targets” present in the Manual of Specific Activities of 30 June 2008

Two “targets” for parachutists can be seen in an aerial photo:

- ❑ the “STUDENT PARACHUTIST TARGET” which corresponds to the “parachute jumping target” shown on the VAC chart;
- ❑ the “EXPERIENCED PARACHUTIST TARGET” which is situated close to the south-east runway intersection.

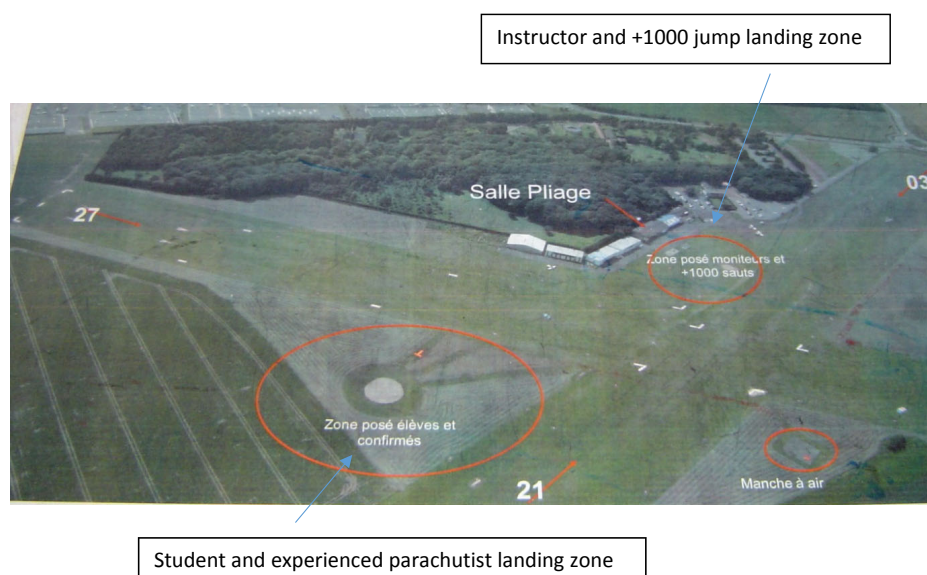
Figure 9: view used by the CERPL in briefing rooms

No theoretical circuit or entry point to be followed by the parachutists, under the canopy, according to the various possible winds and runways in use are shown on these charts.

The difference in the names given in the Manual of Specific Activities and on the photo and the absence of any written instructions may create a certain amount of confusion in the parachutist’s mind about the landing zone that s/he can use.
