Accident to the Tecnam P2002-JF
registered **F-HFCM**
on 26 July 2015
at Compiègne aerodrome (Oise)

Fatigue failure of left main landing gear while taxiing during a training flight

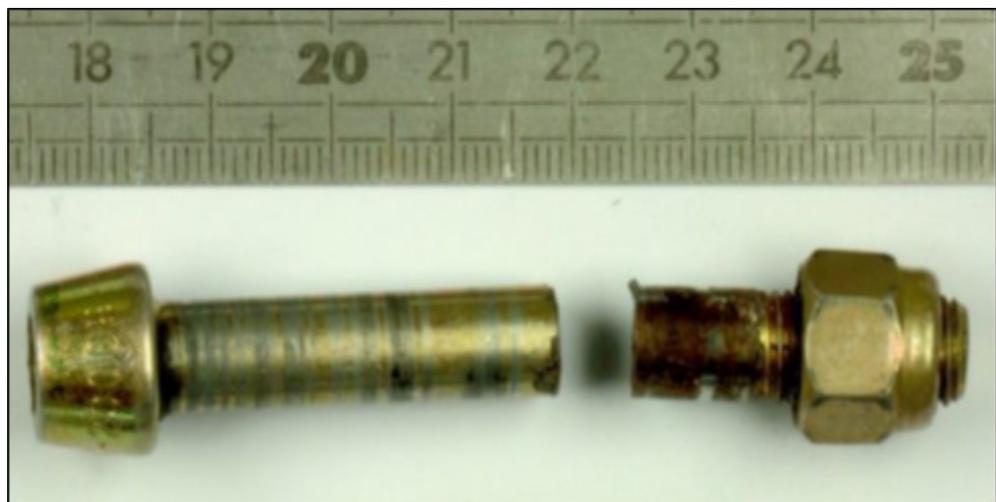
The shank of the central attachment bolt had fractured approximately 33 mm below the bolt head (see below). The fracture zone showed no sign of deformation.

Circumferential markings were observed on the side of the bolt, and the bottom part showed traces of corrosion.

Figure 2: Broken left central attachment bolt

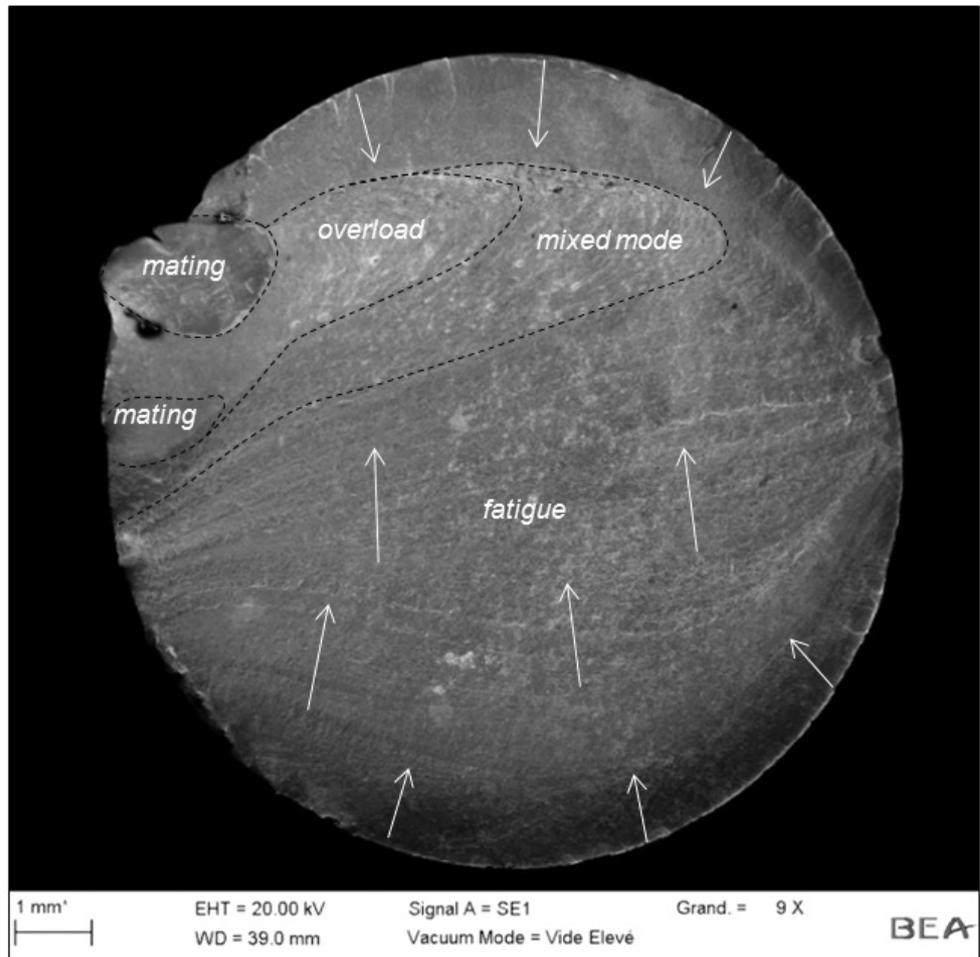
A SEM⁽²⁾ examination of the central bolt found fatigue cracking in approximately 70% of the surface, which had propagated from diametrically opposed, multiple initiation sites around the bolt circumference. Such damage is characteristic of alternate bending loading.

Figure 3: examination of the bolt failure, thread side

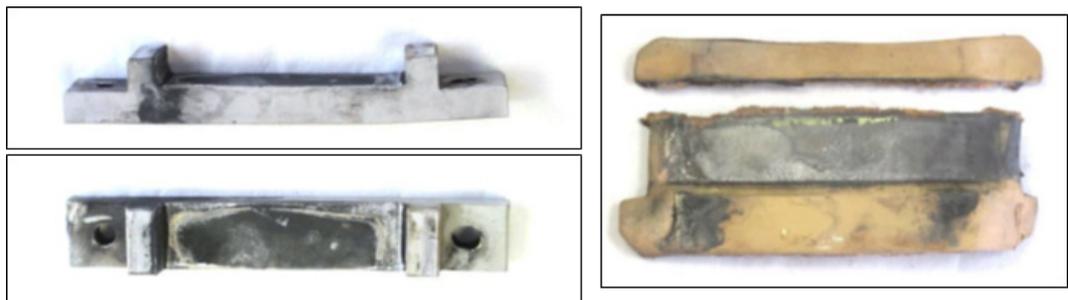
The two bolts holding the flange were bent following the failure of the attachment bolt and the collapse of the gear spring.

The left main landing gear flange was distorted. The flange bore on the bent side had become oval in shape. The leather spacer had split and had a flattened area on the surface in contact with the aeroplane frame.

Figure 4: left main landing gear flange and leather spacer

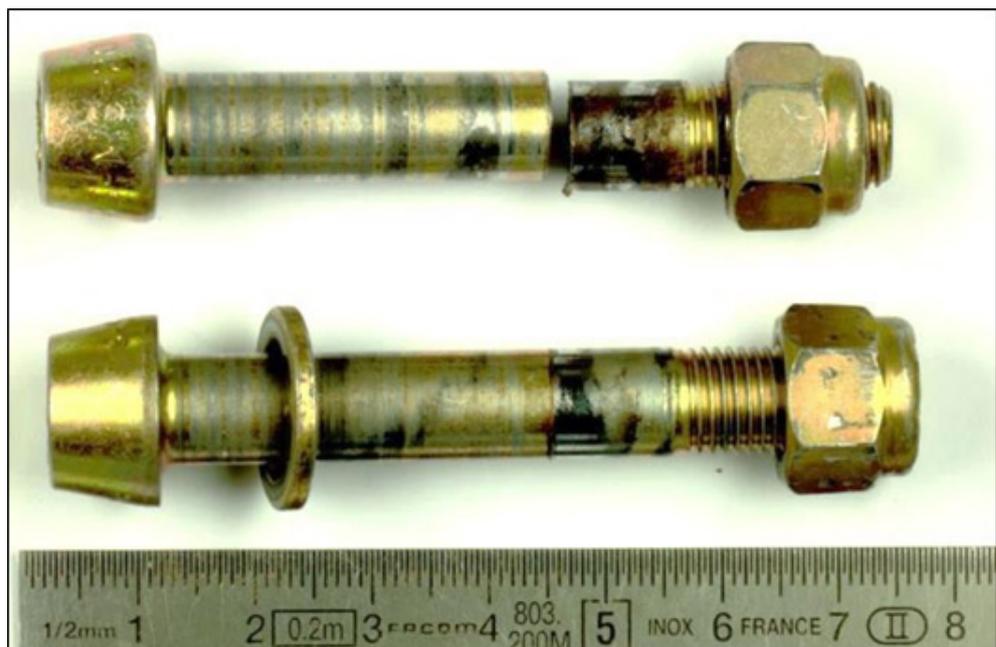
The right main landing gear central attachment bolt was taken for examination. It had circumferential markings on its shank, approximately 33 mm below the head, in the same location where the left bolt had fractured. Between this marking and the head, numerous circumferential wear marks could be observed, as for the left landing gear bolt. A SEM examination showed a circumferential crack in the same location as the left bolt fracture.

Figure 6: central attachment bolt, left bolt above, right bolt below

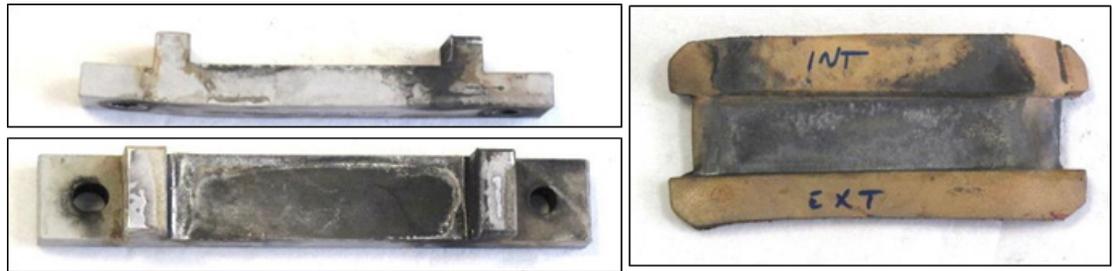
The right main landing gear flange was deformed, in a similar way to the one on the left landing gear. In addition, the leather spacer had a flattened area on the surface in contact with the aeroplane frame.

Figure 7: right main landing gear flange and leather spacer
