Engine shut down on initial climb, emergency landing

Aircraft	Dyn-Aéro MCR "Sportster" registered HB-YKY
Date and time	4 May 2016 about 16h30 ⁽¹⁾
Operator	Private
Place	Dommartin (25)
Type of flight	General aviation
Persons on board	Pilot
Consequences and damage	Pilot slightly injured, aeroplane seriously damaged

This is a courtesy translation by the BEA of the Final Report on the Safety Investigation. As accurate as the translation may be, the original text in French is the work of reference.

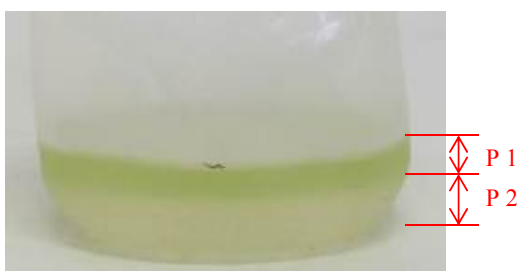
No anomaly was observed in the engine operations. However, a significant amount of water was noted in the fuel tank, in both carburettors and the electric pump.

Fuel and water recovered from the left carburettor bowl

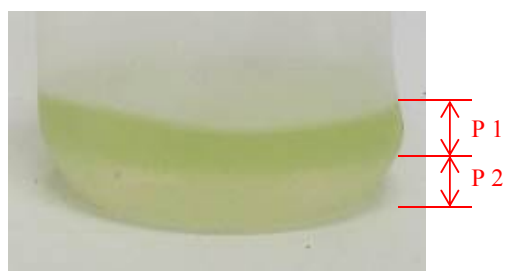
Fuel and water recovered from the right carburettor bowl

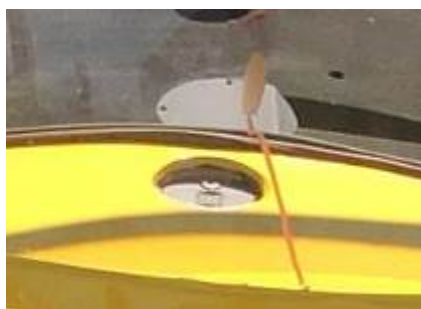
In relation to the engine casing, the HB-YKY tank cap is about three centimetres lower than the manufacturer's standard assembly.

Position of HB-YKY tank cap

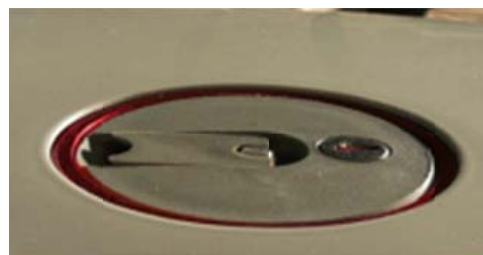
Position of the cap as envisaged by the manufacturer

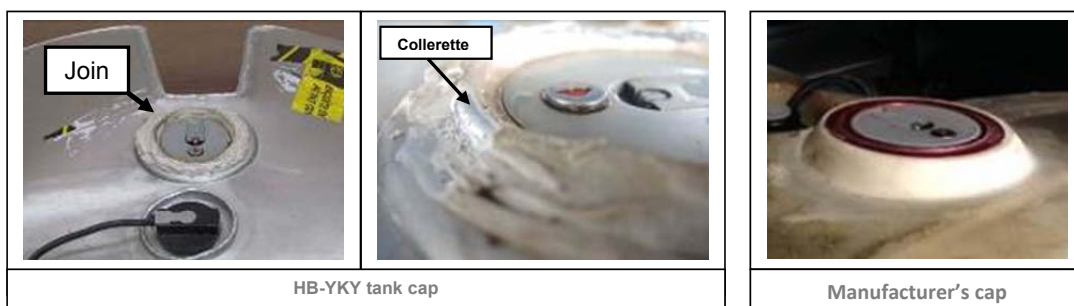
This discrepancy, associated with a collar and a sealing ring, created a sealed bowl between the tank and the casing, around the cap.

Tests carried out after the accident showed that this bowl made it possible for a quantity of about 25 ml of water to be retained, and that this water could penetrate the tank around the cap seating lock at a flow rate of about 15 ml per minute.

The distinctive feature of the tank and its assembly, with an area of retention around the cap, made it possible for the rainwater that had fallen in the days preceding the flight to accumulate and enter the fuel tank. This considerable presence of water in the fuel circuit led to the engine shut down.

The Swiss and German investigation authorities were informed that this metal tank made water infiltration possible via the tank cap. They were requested to inform the owners of aeroplanes equipped with this tank.
