Accident to the Airbus A320 registered **F-HBNK** on 11 September 2016 at Bastia Poretta (2B)

Injury to ramp agent when connecting GPU to parked aircraft

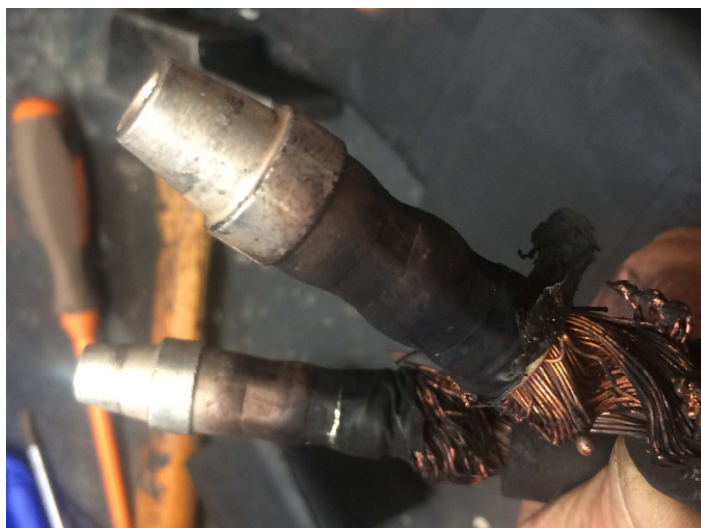
The examination of the ground power connector revealed a short circuit located inside the connector itself, between the three phases. This short circuit caused the fusion of the copper on the three phases. There was no defect nor fusion on the neutral. This examination also showed the absence of insulating sheath on the end of the four cables (the three phases and the neutral) at the metal pins.

Connector pins removed from unit

The absence of insulating sheath on the end of the cables of the ground power connector was probably due to damage to the connector:

- ☐ following repeated pulling on the cables and not on the connector body to remove the connector or
- ☐ following the incident of 22 June 2016.

The absence of sheath led to a short circuit at the three phases of the connector when the latter was plugged into the aircraft receptacle and supplied with power by the simultaneous actuation of selector switch S10.

Following the accident, Air France recommends modifying the design of the connector (no gap at the connector and fitting of a heat-shrink sheath at the junction between the connector and the cable) and informing the agents at the Bastia station that the GPU must only be energized once the connector has been connected.

Air Corsica has modified the design of the connector and updated the ground procedure for using the GPU by specifying that the GPU must be operated by a single operator and that it is forbidden to handle the power supply cable when it is energized.
