Accident to the Piper PA34-200T "Seneca III" registered **HB-LSD** on 7 December 2016 at Basel–Mulhouse airport (68)

Time	At 17:40 ⁽¹⁾
Operator	Private
Type of flight	Non commercial operation, pleasure, cross country
Persons on board	Pilot
Consequences and damage	Pilot fatally injured, aircraft destroyed
<i>This is a courtesy translation by the BEA of the Final Report on the Safety Investigation. As accurate as the translation may be, the original text in French is the work of reference.</i>

Non-stabilized approach in LVP conditions, go-around, loss of control, collision with ground, fire

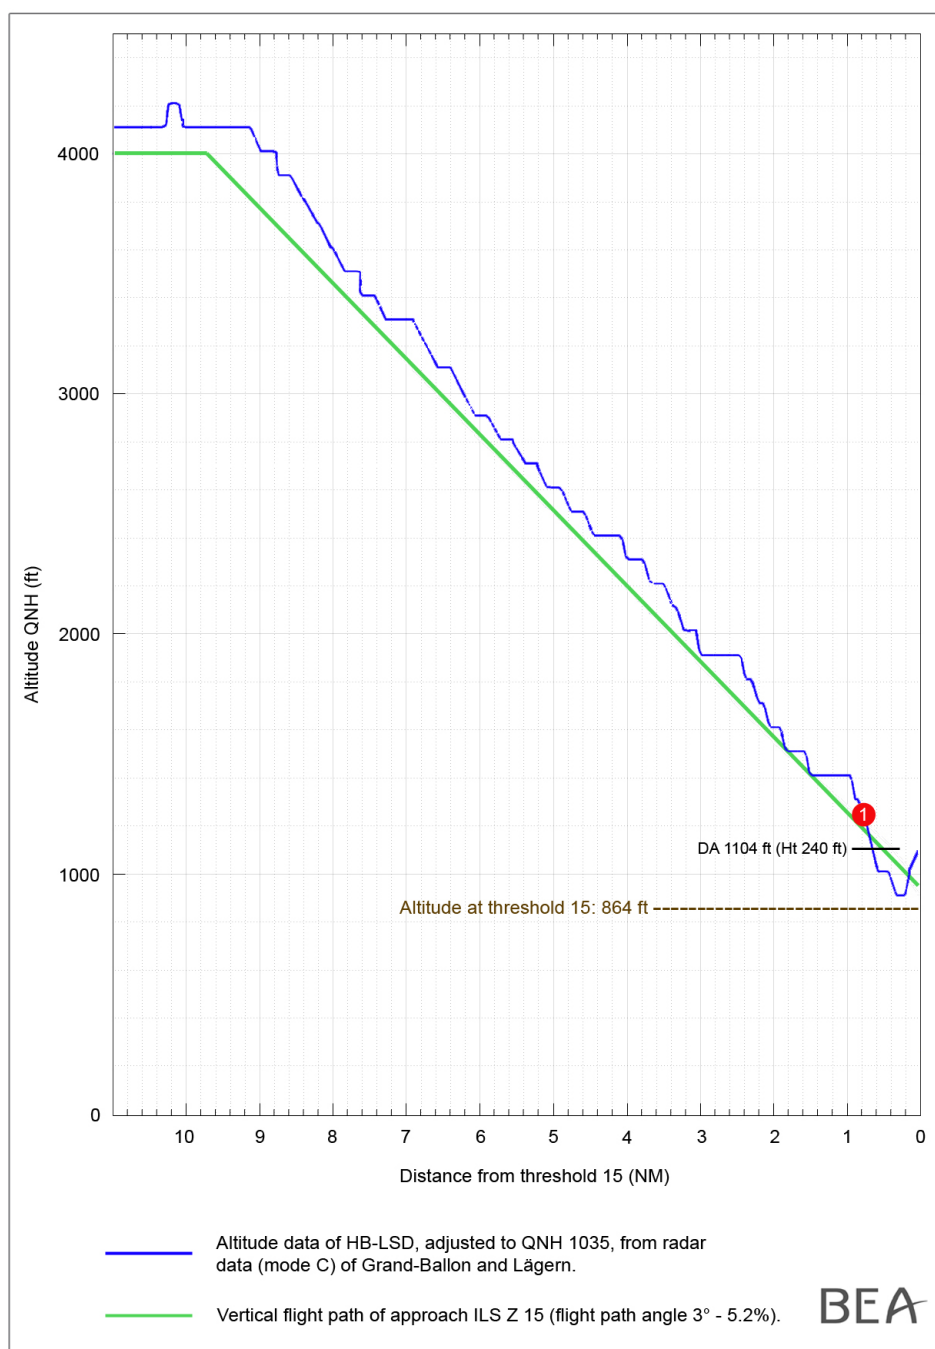
Figure 2: Comparison of vertical profile of HB-LSD with theoretical 3° approach slope

At 17:34, the pilot was transferred to the control tower frequency. The controller informed him that he was number 1 for landing on runway 15 and gave him new information about visibility: RVR 750 m at touchdown, 650 m at mid-point, 800 m at stop end. The pilot read back this information and announced that he was continuing his approach. The approach performed by the pilot followed the standard path and slope (Figures 1 and 2).

At 17:39:20, when the aeroplane was around 1,300 m from the runway threshold, its flight path started to deviate to the left of the runway centreline (point ❶ of flight path), up to the motorway running along the side of the Basel-Mulhouse airport. The lateral deviation reached with respect to the runway centreline was around 260 m⁽⁷⁾ (point ❸).

At 17:39:54, while the aeroplane was still on the left side of the approach path a few metres from the runway threshold, the pilot advised that he was going to conduct a missed approach (point ❹). The controller advised him to follow the standard go-around procedure along the runway centreline and then to climb to 5,500 ft QNH 1035. The pilot read back this missed approach procedure although the radar data showed that the aeroplane seemed to be in a continuous turn (point ❷).
