## Accident to the Cessna - 172 – R registered F-ONDU

on 1 May 2018

at Terre-De-Haut, Îles des Saintes (Guadeloupe)

## Off-centre final approach below the approach slope, collision with a tree

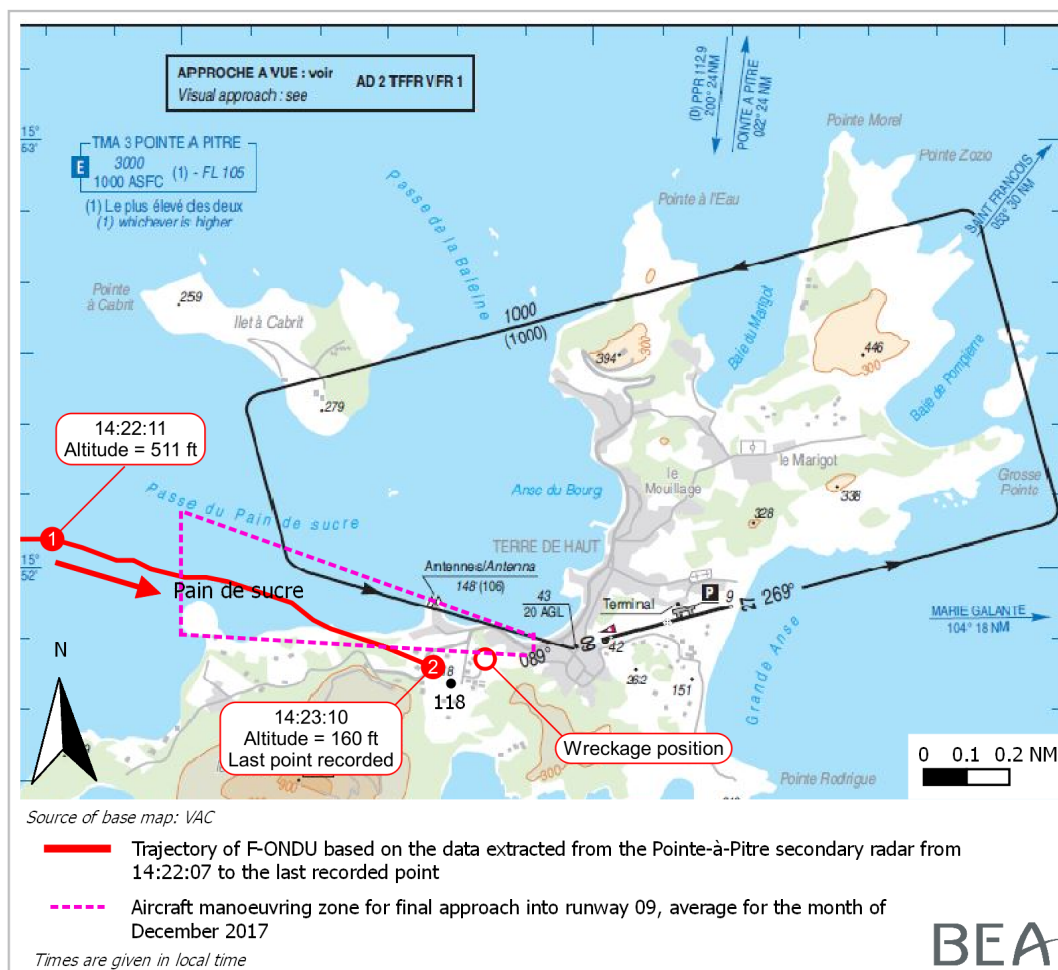
Figure 1: final trajectory of F-ONDU

The pilot flew overhead the aerodrome. During the approach to runway 09, the radar data showed that the aircraft was following a trajectory parallel to the approach path shown on the VAC and offset to the south by about 250 m (see Figure 1). Five hundred and twenty metres upstream from the runway threshold, the aircraft's left wing hit the top of a tree. The pilot lost control of the aircraft, which came to rest 60 m further on after being stopped by a tree trunk.

The radar recordings, the tree impact marks and the geographical position of the wreckage indicated that the pilot's trajectory was 250 m south of the recommended trajectory. The last recorded point (point ② in [Figure 1](#)) was located in an area likely to be subject to downdrafts or significant turbulence due to the surrounding terrain.

An analysis of the radar trajectories followed by aircraft in December 2017 served to determine the manoeuvring area of aircraft on final into runway 09 at Les Saintes (see [Figure 1](#)). A more general analysis for the year 2017 confirms that a significant number of approaches were performed with a trajectory offset to the south of the published approach path in areas subject to potential severe turbulence and characterized by the presence of obstacles that interfere with a conventional 3° approach path.

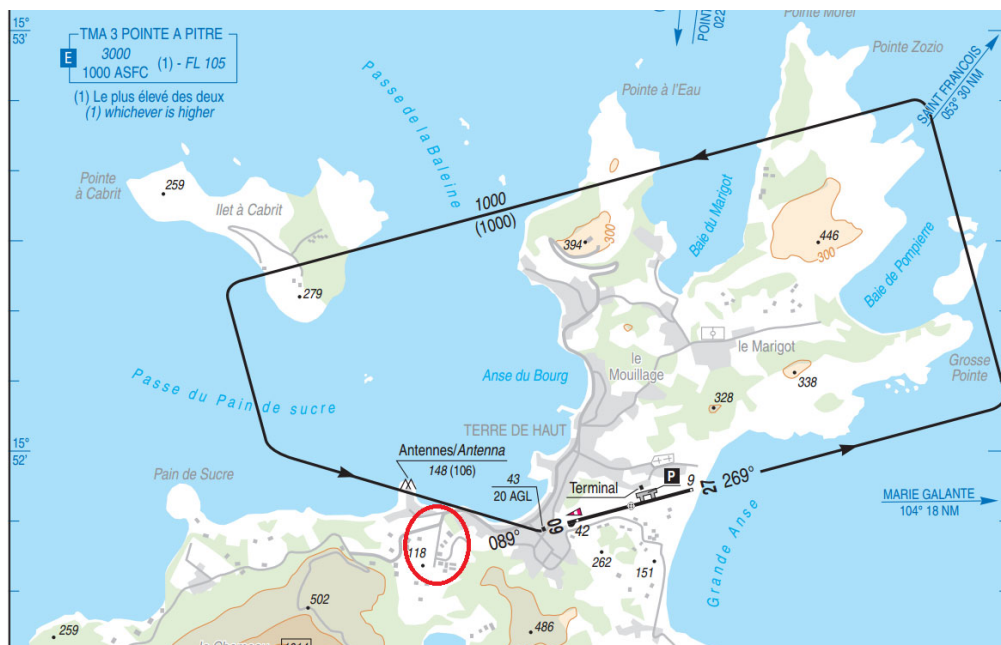
Figure 2: document used to inform the members of the aero club

The committee also drew the pilots' attention to the presence of a hill (see area circled in red in [Figure 2](#)) and the need to adapt their trajectory accordingly.

- ☐ Perform the pre-landing checklist before passing the Antenna (see [figure 2](#)) so that the pilot can keep his full attention on his final trajectory into Les Saintes.
- ☐ Pass the Antenna at a minimum altitude of 300 ft.
