Accident to the Van's Aircraft RV7 registered **D-EIOI** on 29 August 2018 at Bourg-Saint-Maurice (Savoie)

Continuation of mountain flight in stormy weather conditions, icing of carburetion system, loss of control, collision with terrain

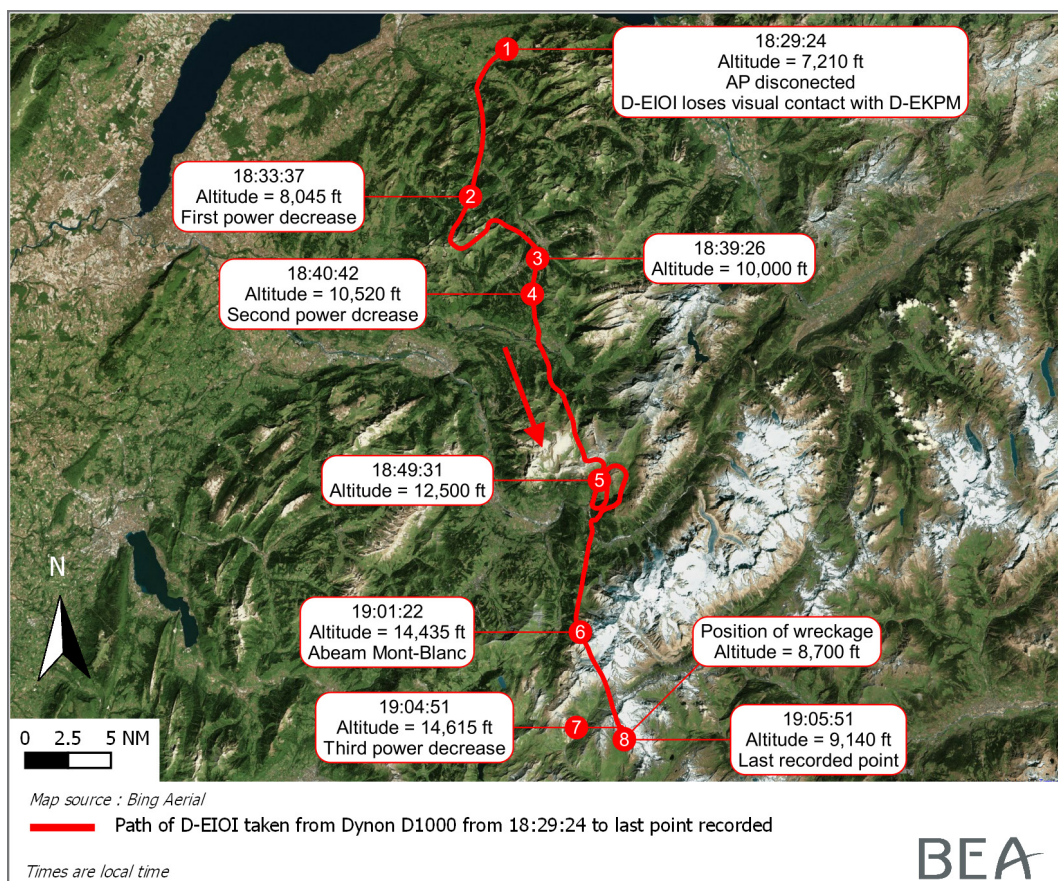
Figure 1: path of D-EIOI

At 18:29, he lost sight of D-EKPM and disconnected the autopilot (AP) (point 1 of Figure 1) before tracking south and starting to climb.

At 18:33, when the aeroplane was at an altitude of 8,045 ft, the EFIS data indicates the first icing phenomenon affecting the carburettor characterized by a decrease in the manifold pressure of the engine. This data also shows that a pilot input on the carburettor air intake heat control restored the engine power a few instants later (point 2 of Figure 1).

From 18:39, the D-EIOI pilot continued climbing and started manoeuvring above 10,000 ft (point 3 of Figure 1). A minute later, the EFIS data again shows an icing phenomenon affecting the carburettor managed by the pilot (point 4 of Figure 1).

At 18:49, he flew 360° to continue climbing and manoeuvred above 12,500 ft (point 5 of Figure 1).

At 18:56, the D-EIOI pilot said that he was "in clouds" and then "out of clouds" and that he was heading towards Megève altiport. Five minutes later, the aeroplane was abeam Mont Blanc (point 6 of Figure 1) at an altitude of 14,435 ft.

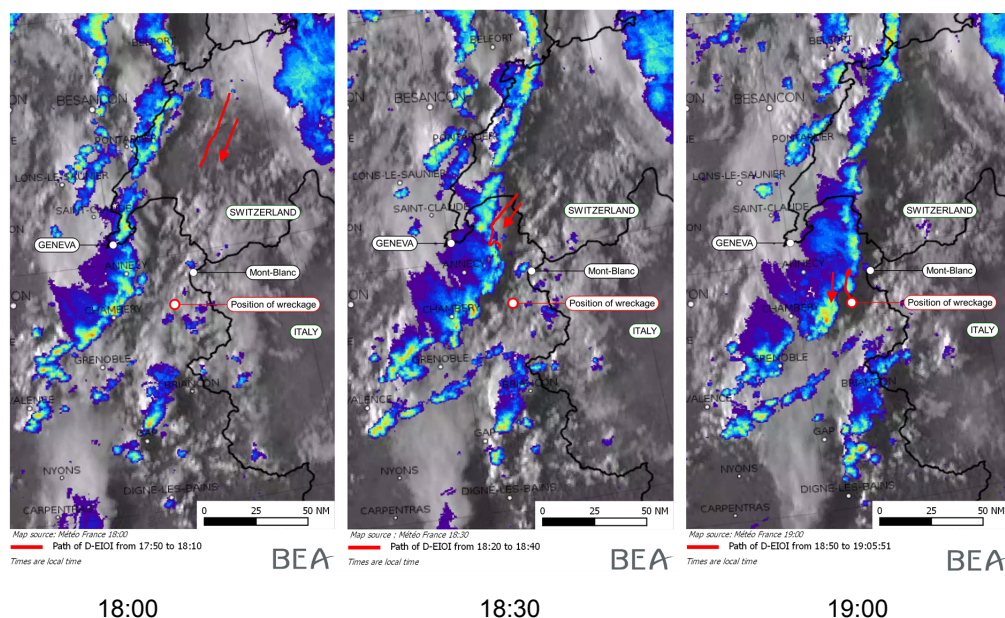
Figure 2: Météo France radar maps

The three radar maps (Figure 2) show the quick travel of the front whose most active part was at the latitude of the accident site. The overlaid red marks represent portions of the aeroplane's flight path during the few minutes around the time at which each weather map was issued.

A yellow, orange or red patch represents a precipitating cumulonimbus, red indicating probability of hail in most cases.

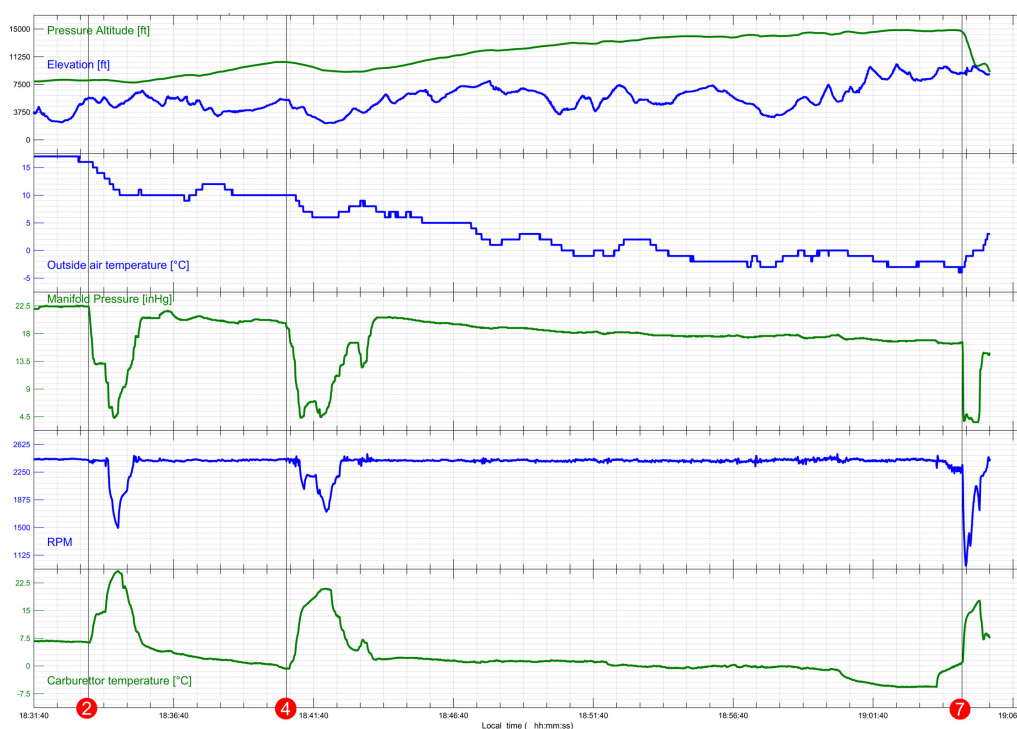
Figure 3: Readout of parameters recorded during flight

Based on this information, the readout of the parameters recorded during the flight show three icing phases of the carburetion system. For each phase, the parameter curves show that the hot air source was indeed selected to remedy this. The third and last phase shows that the pilot selected the hot air source a few seconds before the manifold pressure dropped (Figure 3) and that a more sudden onset of the phenomenon occurred doubtlessly due to the more severe icing conditions. The return of engine power was identified around one minute 50 s after this action, i.e. less than 30 s before the impact with the ground.

The parameters seem to show that the pilot was monitoring the occurrence of the icing phenomenon using the aircraft instruments by acting in a quick and suitable way to recover the manifold pressure.
