Accident to the Centrair Pégase C101 A registered F-CGSH

on 30 May 2019

at Castillon-en-Couserans (Ariège)

Collision with vegetation during a slope soaring flight

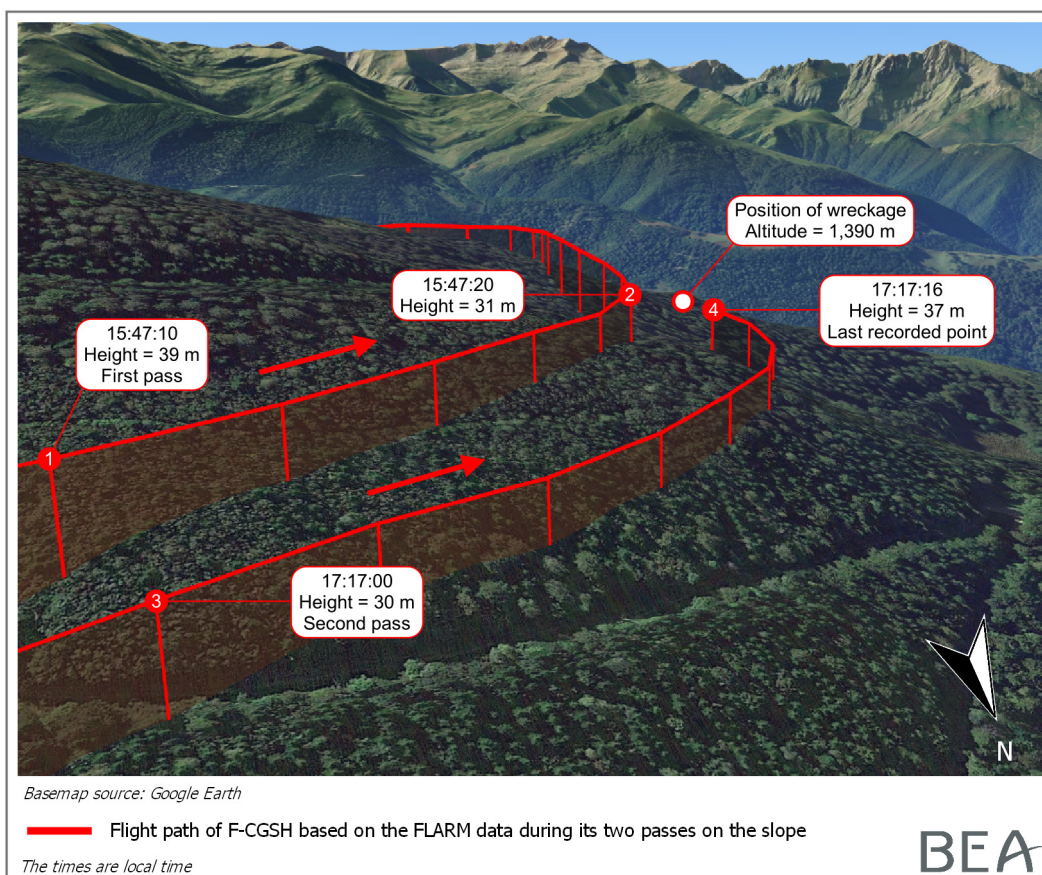
The glider was equipped with a FLARM computer. The flight path was reconstructed from the data taken from the computer read-out. It shows that the pilot made two nearly identical passes on the accident slope: the first at about 15:45 and the second around 17:15. The two passes were made at comparable heights, between 30 and 40 m. During the second pass, the ground speed was about 100 km/h, 10 km/h lower than for the first pass.
