Accident to the SCHLEICHER - ASK21 registered F-CLIN

on 31 May 2019

at Bonneville (Haute-Savoie)

Off-field landing, ground loop, solo instruction

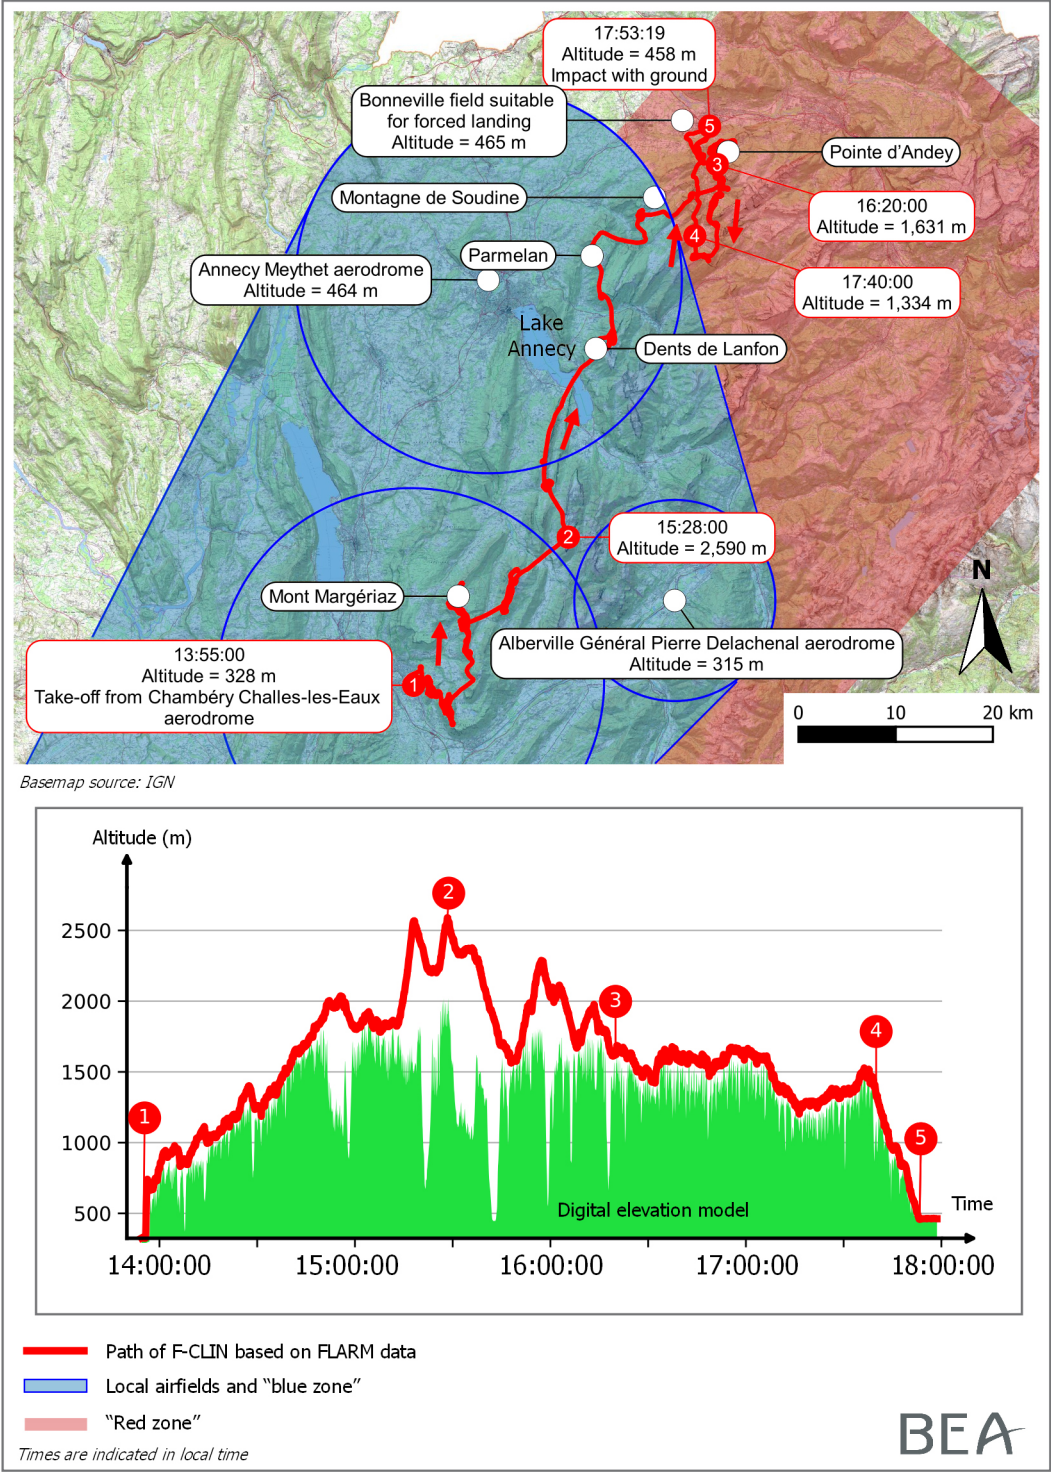
As part of his cross-country flight training, the pilot, who was alone onboard the glider, made a winch take-off at 13:55 ❶ from Challes-les-Eaux aerodrome (Haute-Savoie) for a north-eastbound flight to Pointe d'Andey.

After the winch release at an altitude of 700 m, the glider gradually gained altitude and reached 2,600 m after Mount Margeriaz at 15:28 ❷. The pilot then travelled towards Lake Annecy, flew over it and then made use of the uplift at the Dents de Lanfon, where the glider reached an altitude of 2,150 m, and then flew along the west side of the Massif du Parmelan.

At 16:20 ❸, he reached Pointe d'Andey at an altitude of 1,631 metres. There, the pilot performed manoeuvres for about an hour without managing to gain altitude. He then tried to make use of the uplift further south.

At 17:40 ❹, while the glider was at an altitude of 1,334 m, it flew up the valley to the north. The pilot tried once again to make use of the uplift along the north west slope of Pointe d'Andey, and then exited the valley at an altitude of about 600 m, i.e. at a height of less than 100 m.

The glider headed east, started a very low left turn to head into the wind and landed in a field of tall grass ❺. On touchdown, the right wing hit the ground and the glider entered a ground loop.
