Accident to the SCHEMPP HIRTH - JANUS C registered F-CFAL

on 25 June 2019

at Laval Entrammes aerodrome (Mayenne)

Spurious air brake extension during winch launch, hard landing

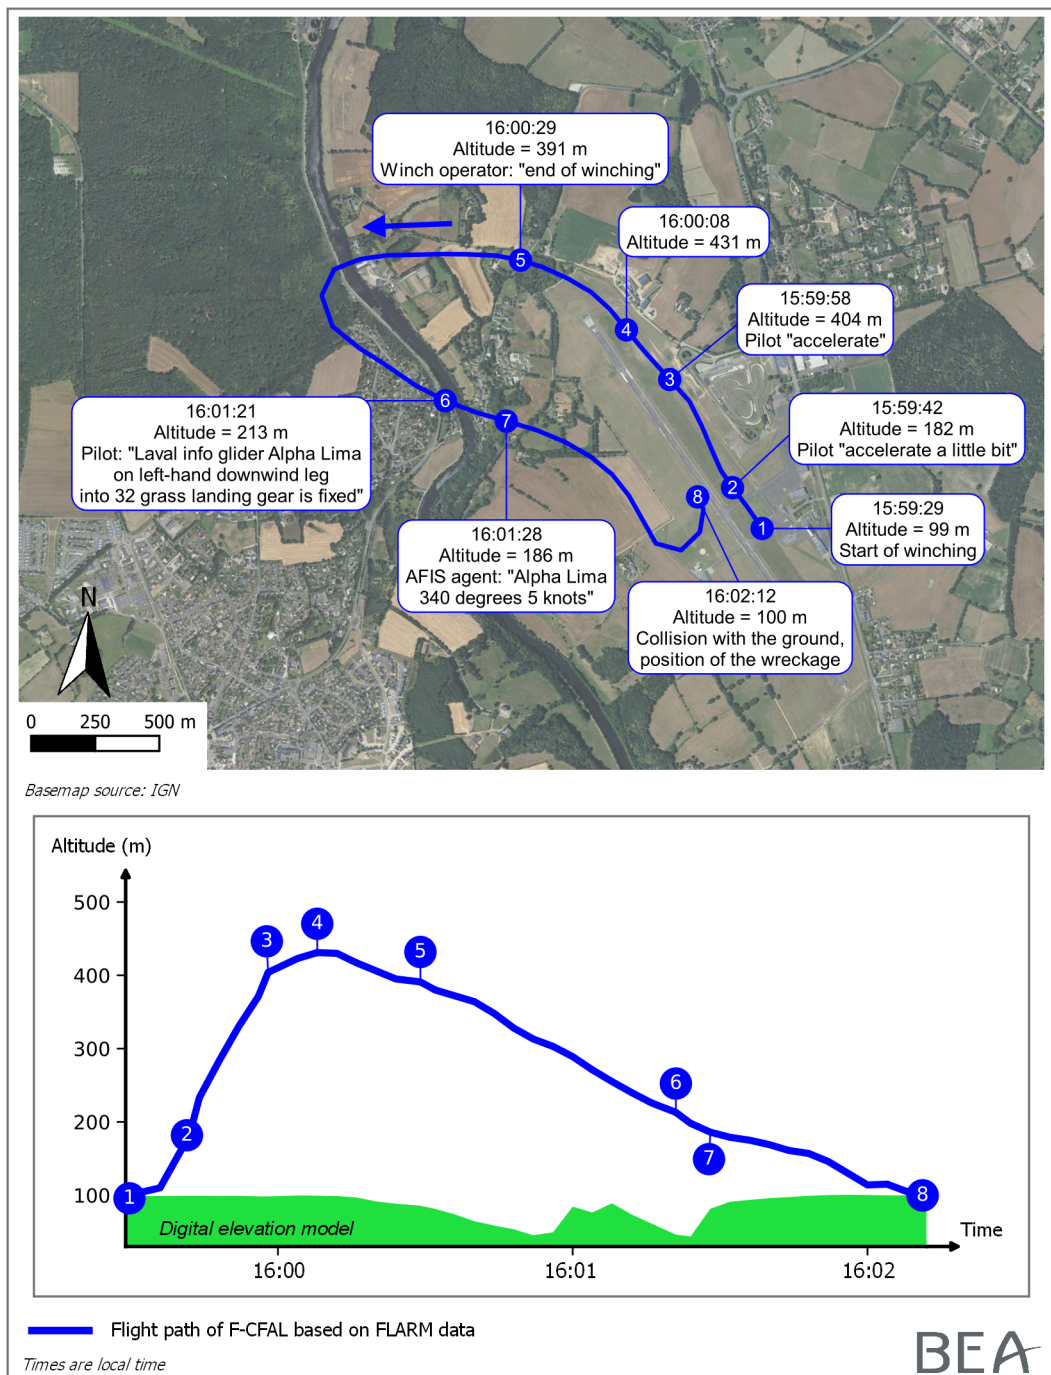
Figure 1: path

The pilot, who was seated in the front seat, took off in winch tow at 15:59 from unpaved runway 32 accompanied by one passenger, who was also a glider pilot (point ❶ on the path below). During the initial climb, he asked the winch operator to accelerate on two occasions. After being released at an altitude of approximately 430 m (point ❷), the glider lost altitude. The pilot in the rear seat suggested to the pilot in the front seat to head towards a cumulus cloud to make use of any uplift. At an altitude of 300 m, they decided to turn back to land on unpaved runway 32 and the pilot in the rear seat took control with the agreement of the pilot in the front seat. At 16:01, he announced over the radio that he was on the left-hand downwind leg to unpaved runway 32 (point ❸). The AFIS agent communicated to him a wind from 340°, at 5 kt (point ❹).

At a height of about 30 m, while still on the downwind leg, the pilot in the rear seat realised that he was too low and that he would not be able to reach the threshold of unpaved runway 32. He turned left and converged toward the mid-point of runway 32. During this turn, the glider made contact with the ground before the paved runway in the obstacle free zone at an angle of 30° in respect of the runway centreline (point ❺). It came to rest 65 m further along on the left-hand edge of the paved runway.
