## Accident to the class-6 Helisport CH 77 Ranabot registered 54AXP

on 15 July 2019

at Grand Couronné microlight base (Meurthe-et-Moselle)

## Loss of control on landing, collision with ground

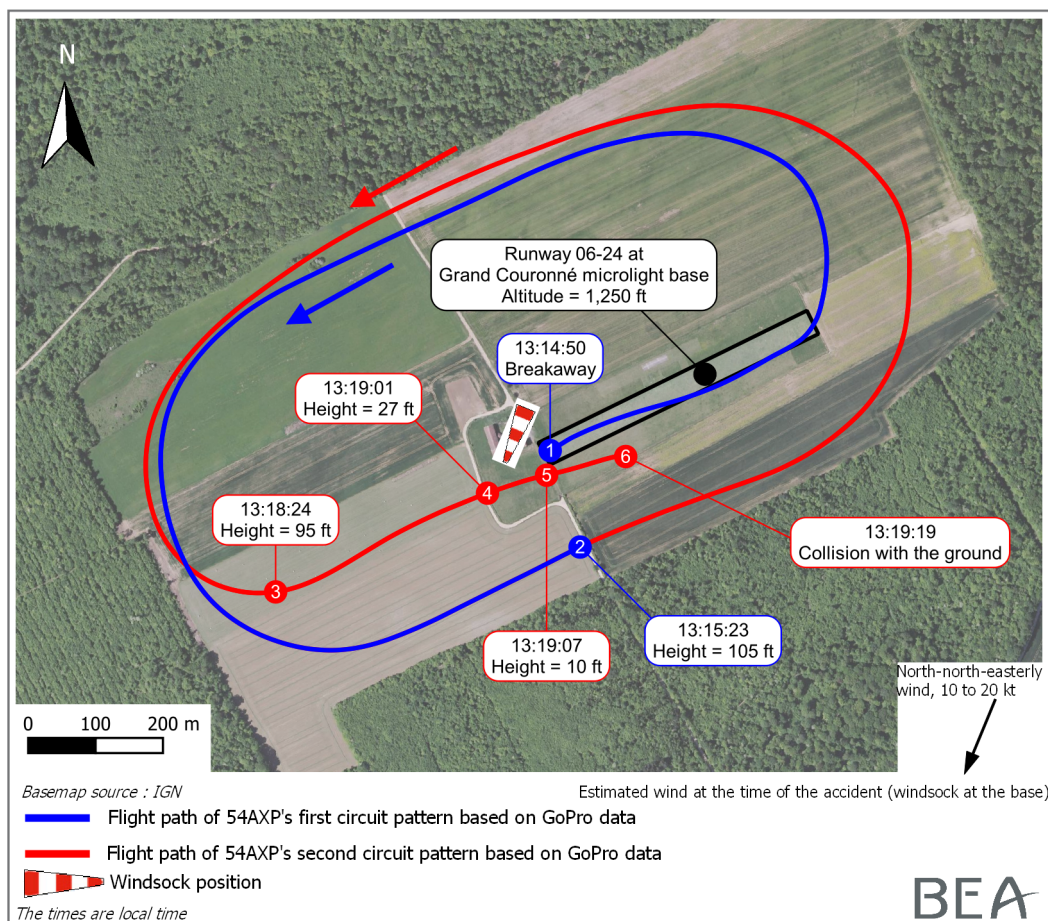
Figure 1: Path of 54AXP

After a first left-hand low-level circuit pattern (about 100 ft), offset to the right of the runway (see Figure 1), the pilot went around and completed a second low-level circuit pattern (maximum 250 ft).

On short final <sup>(4)</sup>, the microlight veered to the right. The pilot continued in order to enter hover over a prepared strip adjacent to the runway <sup>(5)</sup>. While it was a few metres above the ground <sup>(6)</sup>, the microlight turned right 180° and then left and hit a bank with its left skid. The microlight tipped over and came to rest on its right side.

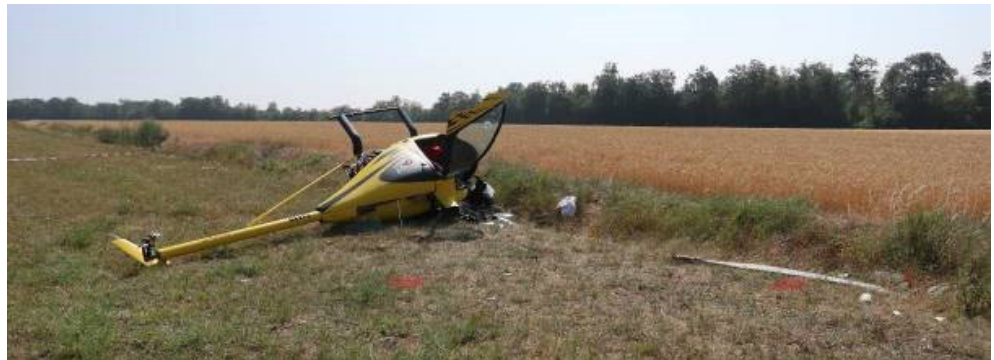
Figure 2: Wreckage of 54AXP

An examination of the wreckage did not reveal any defects that could have contributed to the accident. The damage observed was caused by the accident.

The following points were observed:

- ☐ The pilot was strapped in with his 4-point harness.
- ☐ A 15-kg bag of wood pellets was on the floor on the passenger side. This bag is provided by the importer when the microlight is delivered to simulate the effect of a passenger weighing approximately 65 kg on the centre of gravity and so that a pilot alone on board is not hampered by the lack of stability of the microlight.
- ☐ A 35-kg sandbag was strapped to the passenger seat. This bag was installed by the pilot probably to approach the maximum weight and simulate the weight of a passenger.
- ☐ The tanks contained 28 litres of fuel (total capacity of 66 l).
