Accident to the Cessna - 206 (SOLOY) registered F-HSTL

on 28 September 2019
at Albi (Tarn)

Collision with ground after a parachute drop, at night, fire

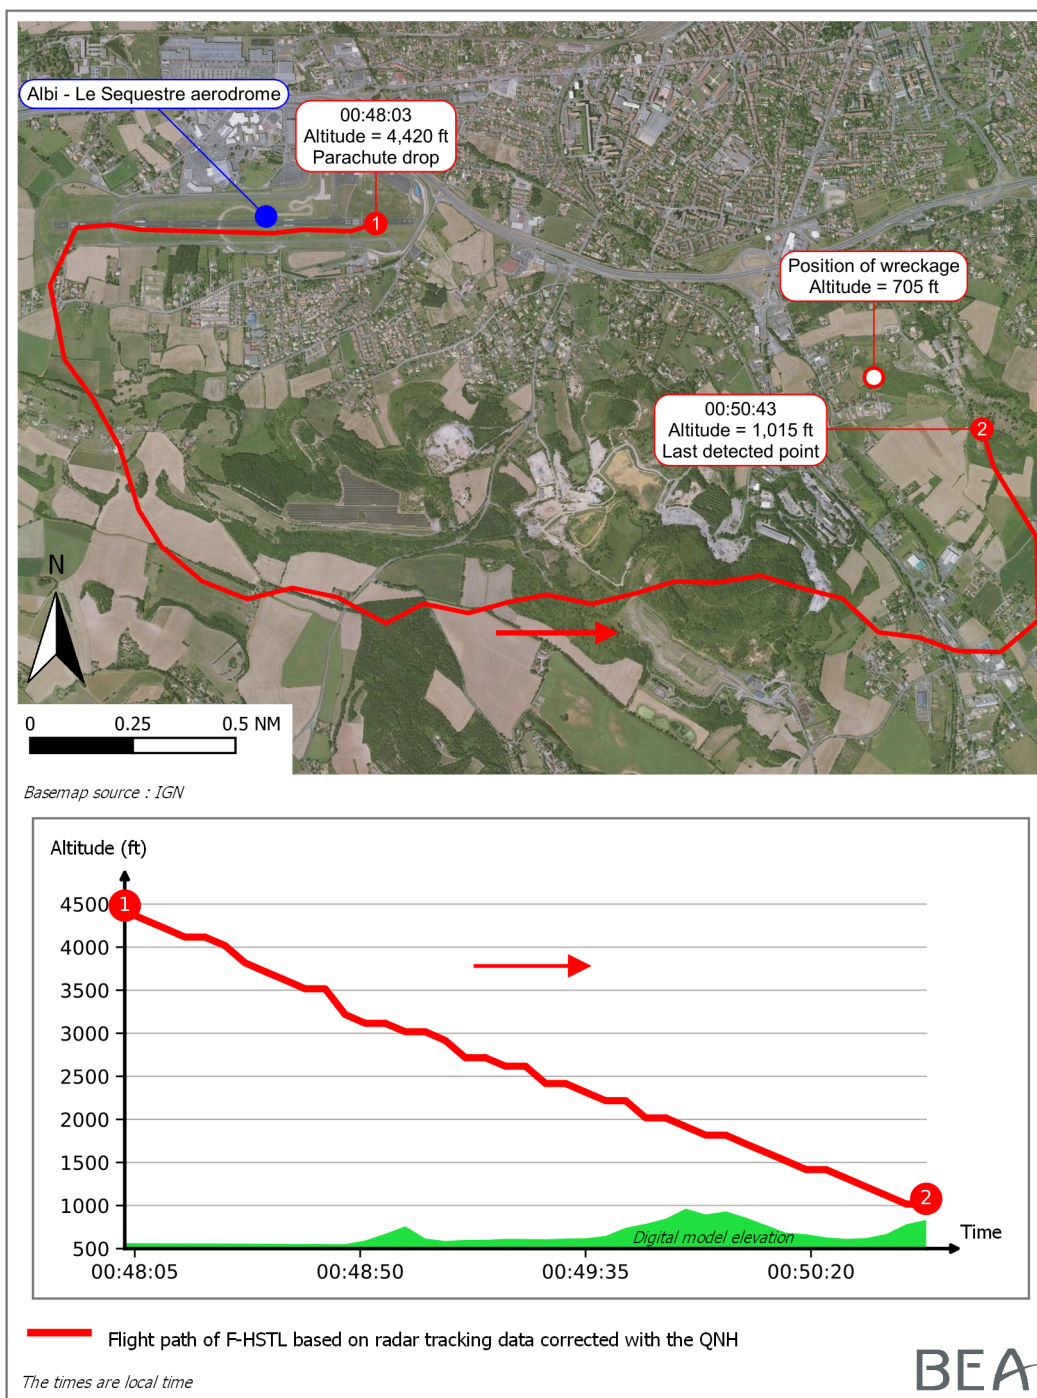
2.4 Trajectory

The examination of the flight path found that the average rate of vertical descent was constant during the last minute of the flight and was approximately 1,100 ft/min. The glide path did not show any dip that would be consistent with a loss of engine power. The glide path was constant up to the radar detection limit near the accident site. At that point, its height was approximately 200 ft.
