Air Accident Investigation Unit Ireland

FACTUAL REPORT

**Coopavia, PIEL CP301A, G-ASLX
Mullinahone Airfield, Co. Tipperary**

5 July 2017

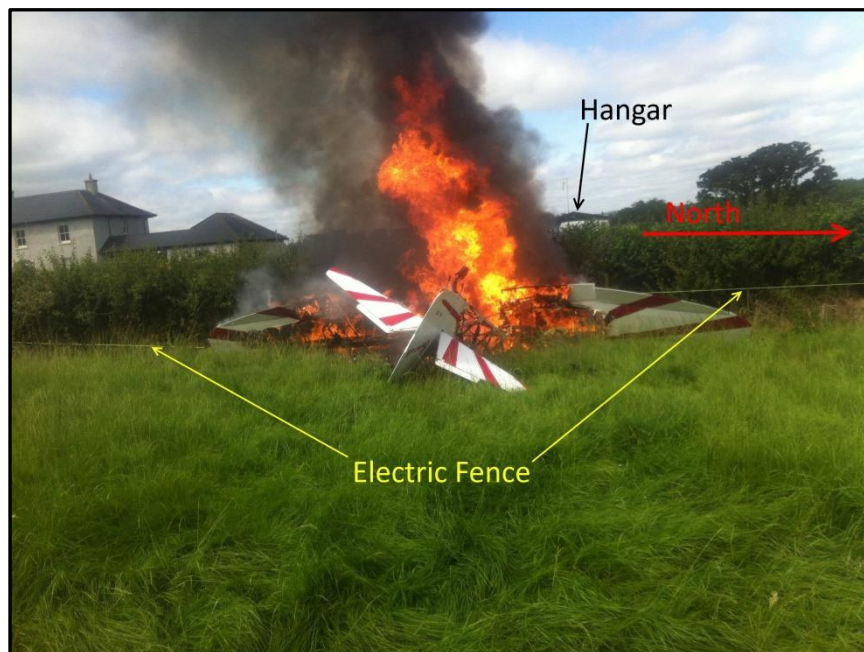
The Pilot had intended flying the aircraft from his private airfield at Mullinahone, Co. Tipperary, to Sligo airport (EISG). At approximately 10.15 hrs the Pilot took the aircraft out of the hangar, set the ignition switch to the '*ON*' position, advanced the throttle, and commenced an engine start by hand-swinging the propeller. There was no one aboard the aircraft and the brakes were not set. The main wheels were not chocked. When the engine started the aircraft began to move forward. The aircraft travelled approximately 70 metres east across the airfield and impacted a ditch and hedge. On impact with the ditch, the aircraft overturned and came to rest inverted on an electric fence on the other side of the hedge. The propeller impacted the ground and the engine stopped. The Pilot stated that fuel began leaking from the aircraft, and that the electric fence may have acted as a source of ignition for the fuel spillage. The fuel ignited and the aircraft was destroyed, see **Photo No. 1**. The Pilot, who had pursued the aircraft on foot, remained at a safe distance, and was not injured.

Photo No. 1: G-ASLX in its final resting position (Courtesy of Pilot/Owner)

The Pilot submitted a detailed description of the event, including a photographic survey of the site. He also provided his assessment of the cause of the accident. He stated that on the day of the accident he was in somewhat of a hurry to get airborne; he had not chocked the aircraft and set the throttle *'a little too high'*, all of which he stated, contributed to the accident.
