FINAL REPORT

of civil aviation safety investigation

Ixess/arv TANARG 912

YR-5132

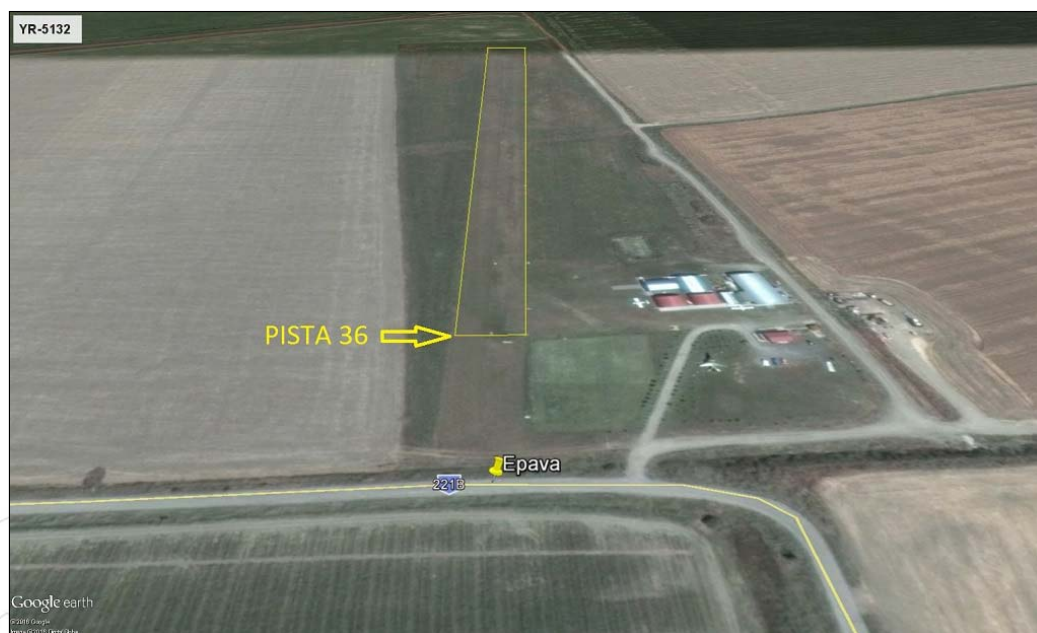
Fig. 1 Accident site

Due to the height at which the aircraft was, the pilot had no more time to recover the motorized hang glider, which frontally hit the embankment of DJ 221 B County road, at a distance of almost 100 m from the landing field threshold. The aircraft rolled over on the road surface, leading to the aircraft damage and serious injury of the pilot.

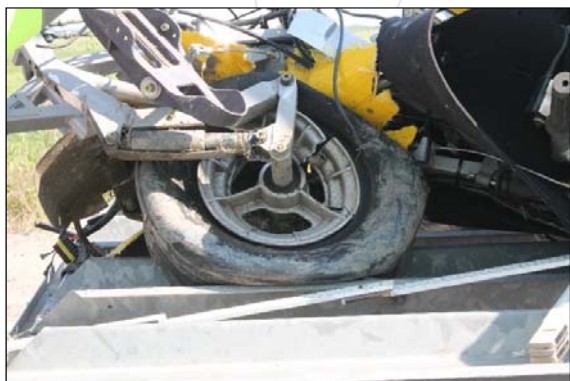
After the impact, the aircraft suffered substantial damage to: the tricycle landing gear, cockpit, braking system, instrument panel and propeller hub.

Fig. 2 Landing gear front wheel

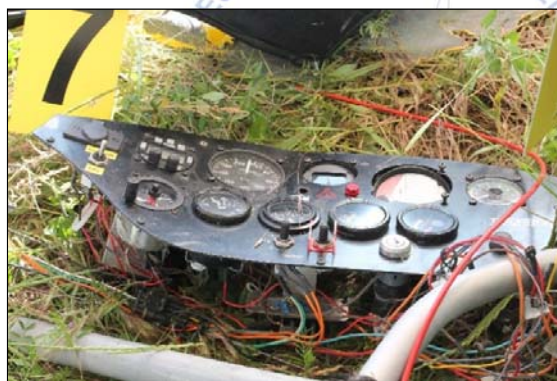
Fig. 3 Instrument panel

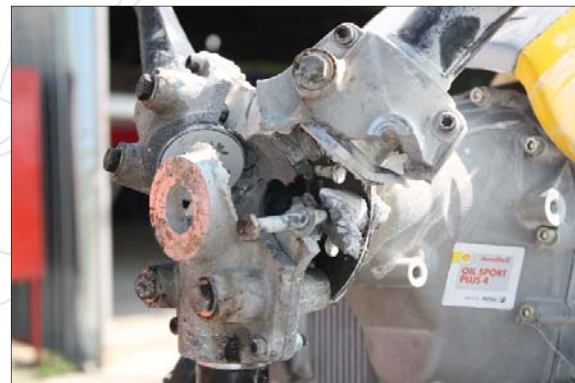
Fig. 6 Broken propeller hub

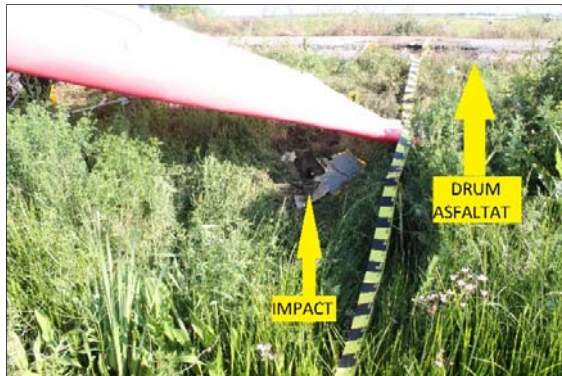
The aircraft impact occurred in the embankment of DJ 221 B at a distance of almost 100 m from the landing runway threshold of "Aerial Club", on direction 360°. After the impact the aircraft rolled-over on the road surface.

Fig. 11 Site of first impact

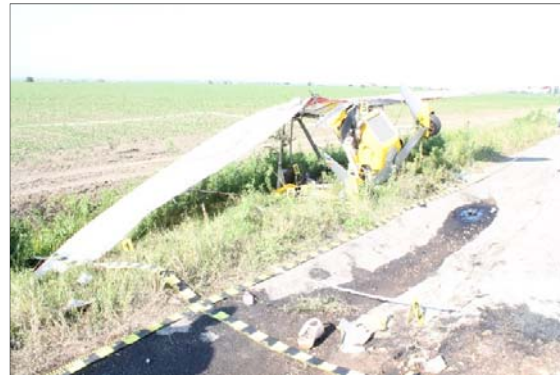
Fig. 12 Final position on DJ 221 B roadway

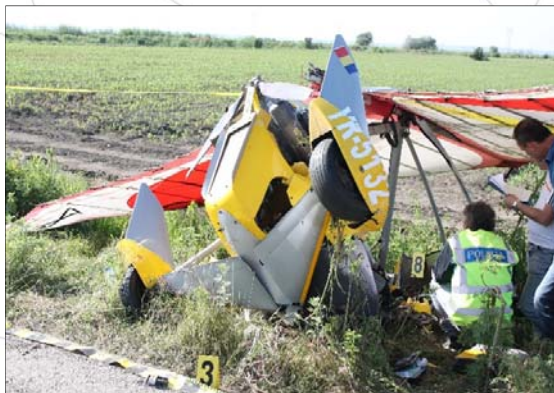
Subsequently the aircraft's position was changed to remove the victim from the cockpit (see fig. 13). During the aircraft changing position, due to tensions in the aircraft structure, the ballistic parachute was accidentally launched (fig 14). After examining the wreckage, the investigation commission found that the operating handle of ballistic parachute was secured (see figure 15).

Fig. 13 Aircraft position after victim removal
