Low oil pressure on one engine in cruise, diversion, dual hydraulic failure during landing roll

Aircraft	Airbus A320 registered CS-TKP
Date and time	25 April 2014 at 07 h 45 ⁽¹⁾
Operator	Thomas Cook
Place	Toulouse Blagnac Airport (31, France)
Type of flight	Public transport
Persons on board	Captain (PF), co-pilot (PM), 5 cabin crew members, 179 passengers
Consequences and damage	None

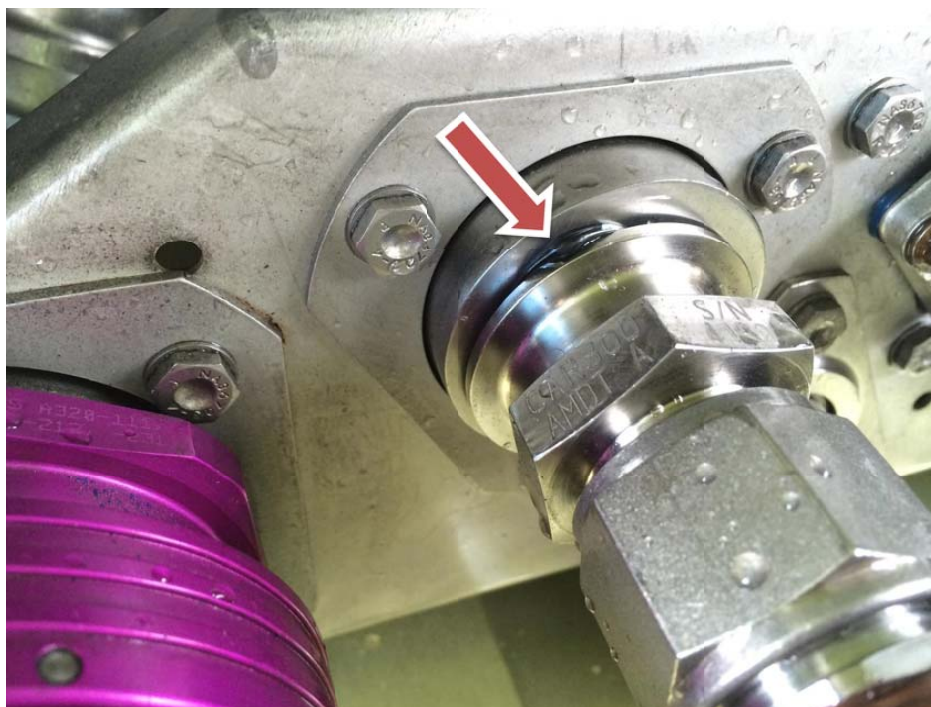
Figure 2: engine no.2 yellow system

Hydraulic fluid was found at the level of the hydraulic connection at the junction between the pylon and engine no.2. The sealing ring for this connector was found to be outside its housing. It corresponded to specifications and had no signs of damage. Only an error in tightening could cause the seal to come out of its housing with no damage, and consequently explain the leak.

The investigation was unable to determine whether there was a common link between maintenance operations on the no.1 engine and the yellow hydraulic system. The failure of the yellow hydraulic system was caused by an incorrectly performed maintenance operation. The oil leak on engine no.1 can be attributed either to a maintenance operation or to a deterioration of the magnetic seal.
