# INVESTIGATION REPORT

**Accident** to the Pitts S2-B  
registered **F-GEAL**  
on 8 December 2013  
at Meaux Esbly (Seine-et-Marne)

Bureau d'Enquêtes et d'Analyses  
pour la sécurité de l'aviation civile

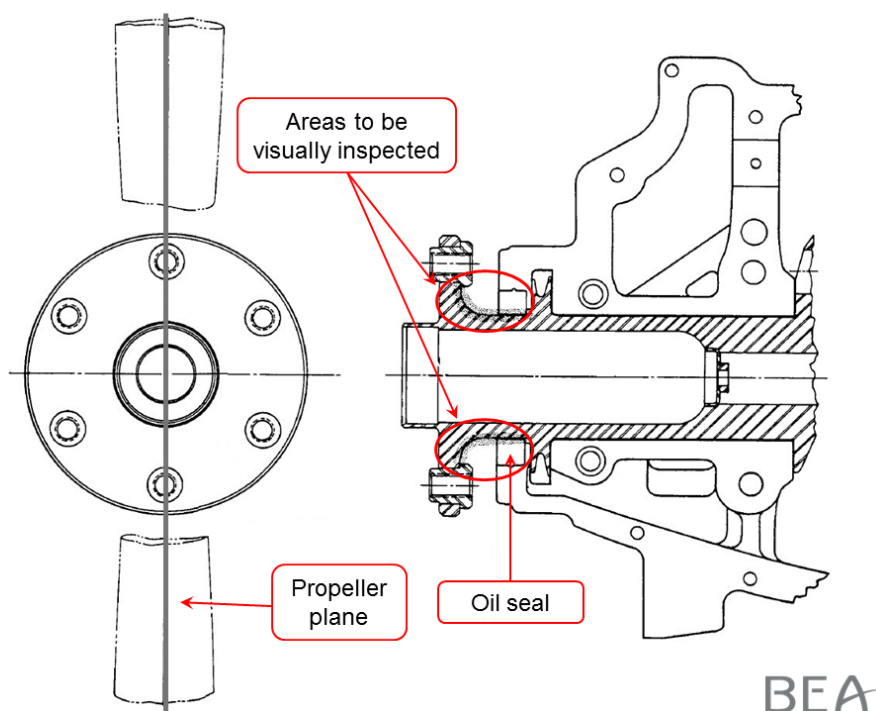
Figure 1: diagram taken from SB No 482

On 3 June 1988, Lycoming issued SB No 482 marked "mandatory" in red<sup>(10)</sup>. It was issued subsequent to "Reports from the field indicat[ing] that a few [...] engines have encountered cracking in the crankshaft area during unlimited category aerobatic maneuvers"<sup>(11)</sup> and concerns AEIO-540-D and IO-540 engines converted for aerobatic flight as well as all 540 engines equipped with a 2-3/8 in dia. oil seal "used in unlimited category aerobatic maneuvers" (Lomcovak, inverted flat spins or multiple snap rolls).

The bulletin states that these manoeuvres "produce severe bending loads on the propeller flange area. Exceeding the engine maximum rated speed and/or using the aircraft in maneuvers which produce rapid angular propeller centerline acceleration may result in crankshaft failure."

The SB requests, every ten hours of aerobatic flight involving "unlimited" category manoeuvres, that all of the crankshaft area situated between the oil seal and propeller flange are visually inspected after cleaning. The SB says to pay special attention to the crankshaft area to the rear of the propeller plane. To do this, the propeller, starter ring gear and oil seal have to be removed. Lastly, if the crankshaft is determined to be serviceable, it requires that the oil seal is replaced before installing the starter ring gear and propeller.

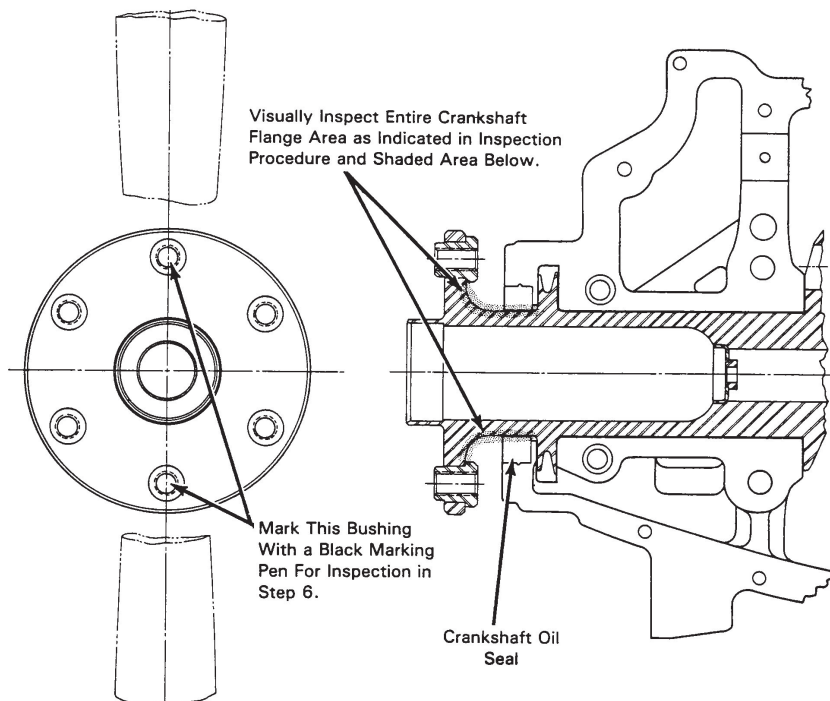
Figure 1. Visual Inspection of Crankshaft Flange Area

Unlimited category maneuvers such as multiple snap rolls, inverted flat spins, lomcevak, etc. produce severe bending loads on the propeller flange area. Exceeding the engine maximum rated speed and/or using the aircraft in maneuvers which produce rapid angular propeller centerline acceleration may result in crankshaft failure. Any engine which has been subjected to unlimited category aerobatic maneuvers must be inspected for cracks in the crankshaft flange area within the next 10 hours. See Figure 1.

After each additional 10 hours of aerobatic flight involving unlimited category maneuvers, close visual inspection for cracks in the crankshaft flange area back to the oil slinger is required. The proper

7. If the crankshaft is found to be cracked, it must be replaced. If crankshaft is determined serviceable,

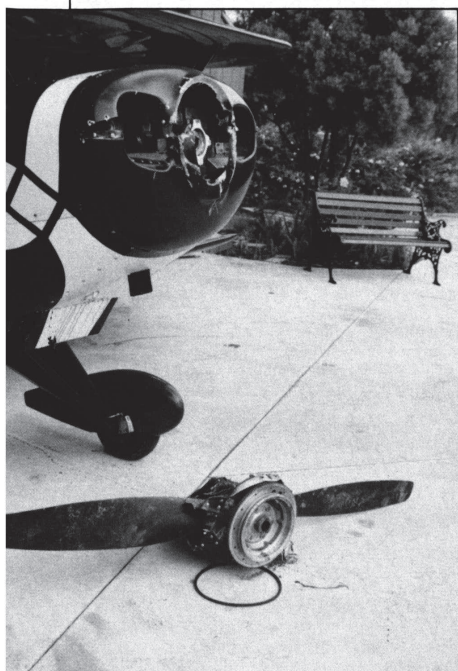
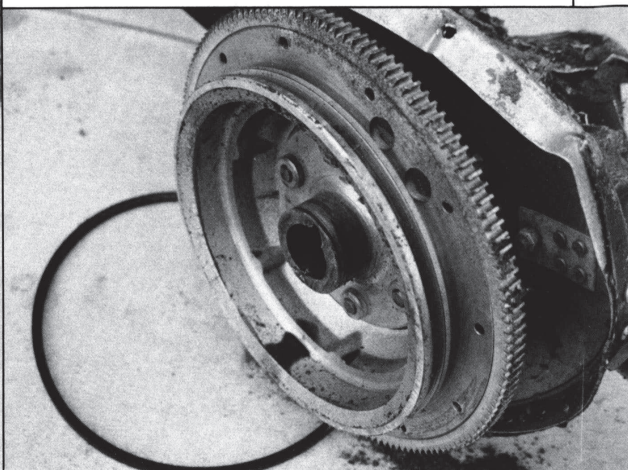
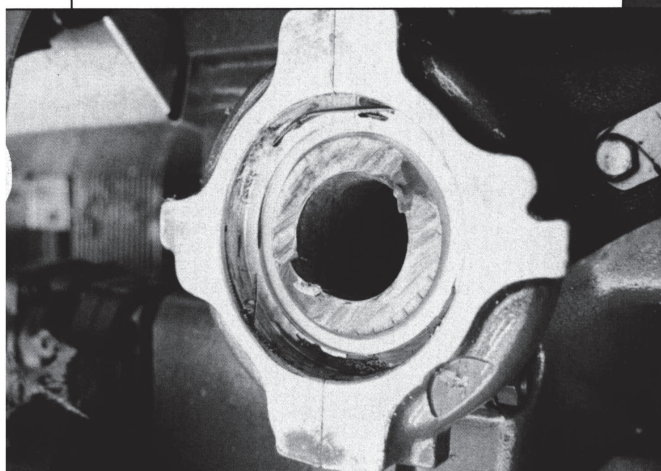
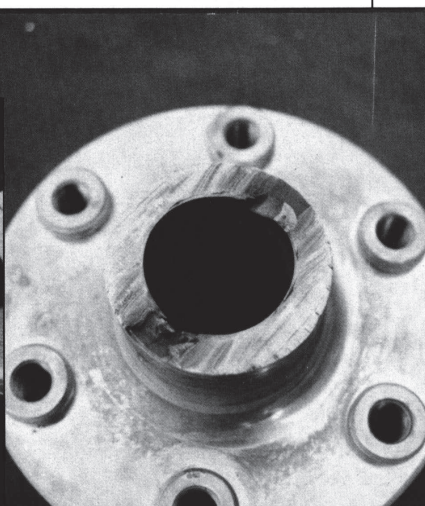
— Failure occurred BETWEEN the front oil seal and the front main bearing.

Also, after studying the photographs of the O-540 crank it appears that the crank failed due to reverse bending. A close examination reveals several ratchet marks at the outer edges of the crank cross section indicating the failure was initiated at multiple points. This would seem to indicate severe overloading.

Note how closely the failed crankshaft in this article resembles the failed crankshaft shown in the November 1985 issue of SPORT AEROBATICS. Both crankshafts had solid (holeless) flanges and both crankshafts failed aft of the prop mounting flange in what appears to be bending/fatigue failures.
