## Accident to the MOONEY - M20J registered F-GNGG

on 8 November 2013

at Cholet le Pontreau aerodrome (Maine-et-Loire)

## Nose gear collapse on landing during instruction flight

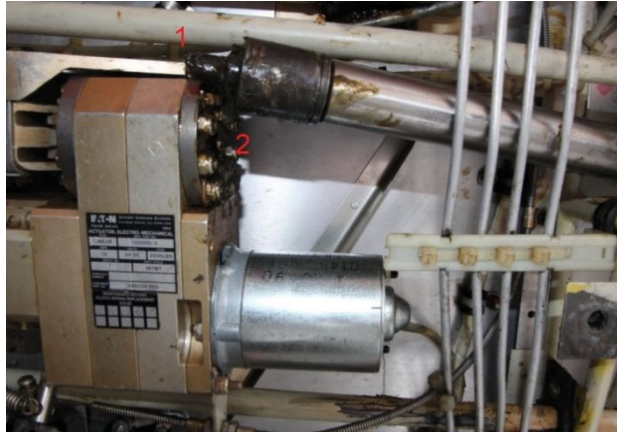
The threaded part of the rod of the nose gear actuator, which controls the extension or retraction of the nose gear, was fractured inside the gearbox (Figure 1).

Figure 1: Photo of the actuator with the threaded part of the rod (1) separated from the gearbox (2)

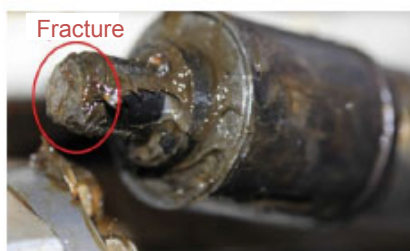
The round nut on the actuator rod could be rotated freely (Fig. 2).

Figure 2: Fractured actuator rod and round nut

During maintenance, disassembly operations to uncouple the round nut and the rod barrel tube may have led to damage to the lock screws on the round nut. As this nut was no longer held in place, it was free to rotate and move freely, thus distorting the adjustment of the mechanical down stops. When the landing gear was retracted, the abnormal tensile and torsional forces were transferred to the actuator rod, causing it to fracture due to overload.

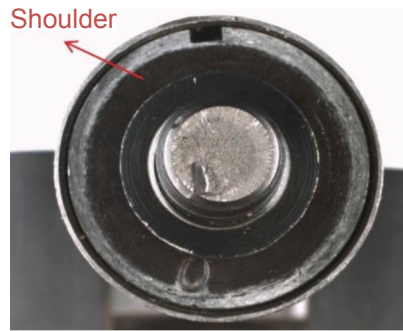
Circular marks (figure 3) could be seen on the mechanical down stop shims at the gearbox input. According to the maintenance manual, the mechanical down stops are adjusted with the landing gear extended subject to the tolerances in respect of the shoulder of the round nut (Figure 4).

Figure 4: Fractured rod and shoulder of round nut

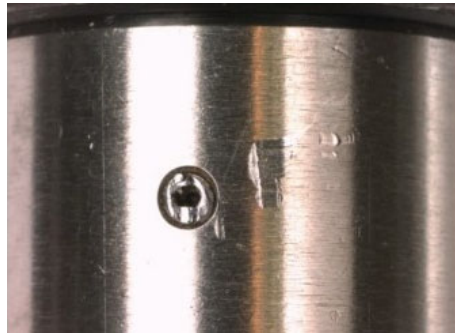
The actuator barrel and the round nut displayed marks (Figures 5 and 6) that resembled tool marks (possibly of the nose plier type).

Figure 5: Marks on the tube and worm screw

Two lock screws on the round nut are used to stop the round nut from rotating around the actuator rod. One of them was loose and was no longer performing its locking function on the round nut. The other one was marked and deformed, which prevented the use of the specific loosening tool.

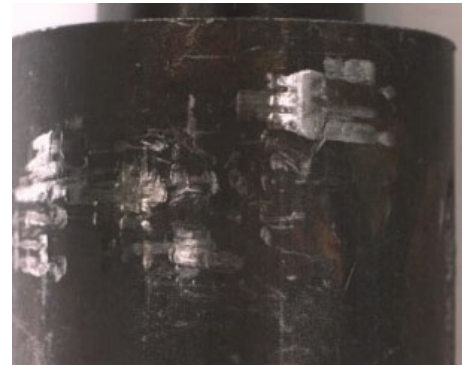
Figure 6: Marks on the round nut

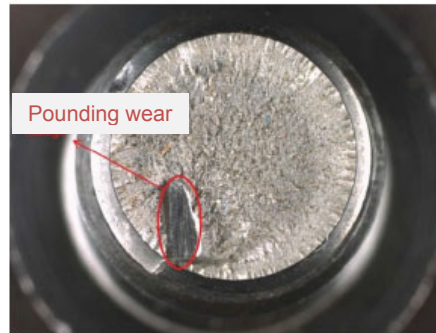
However, scanning electron microscopy examinations revealed the presence of dimples over the entire surface of the fracture face (Figures 7 and 8). These dimples are characteristic of a ductile fracture<sup>(2)</sup>. The outer edges of the faces on the opposite side to the fracture displayed ridge lines and small dimples around their entire circumference, which were consistent with torsional stress. The cores of the fracture faces displayed non-oriented dimples, which were consistent with tensile stress.

Figure 7: Photo of the fractured face (nut side)

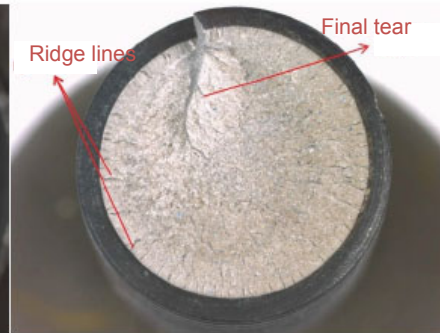
Figure 8: Photo of the fractured face (gear side)
