**Accident** to a Schroeder G42/24  
registered **F-GXTD**  
on 25 August 2013  
at La Meilleraie-Tillay (Vendée)

## Hard landing, collision between two passengers

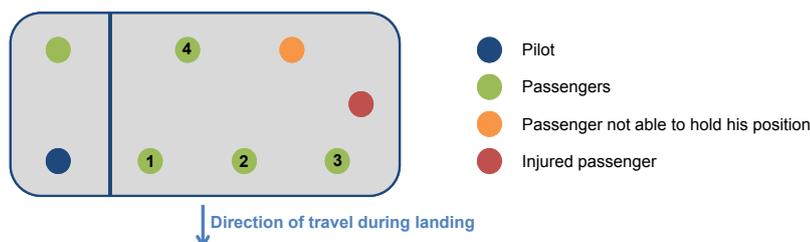
The positions of the pilot and the passengers in the basket during the landing were the following:

There were handholds in front of the passengers. Passengers 1, 2 and 3 were facing the balloon's direction of travel, unlike passenger 4 and the passenger who was not able to hold his position. The passenger who was injured, 57 kg, was facing the lateral wall of the basket, for space reasons according to the pilot. The passenger who collided with this passenger, aged 80, weighing approximately 90 kg and with a knee prosthesis, was unable to hold his position during the landing due to, according to him, the loads experienced and despite holding the internal handles.
