# INVESTIGATION REPORT

**Serious incident** to the AIRBUS A340-313E  
registered **F-GLZU**  
and operated by **AIR FRANCE**  
on 11 March 2017  
at Bogotá (Colombia)

BEA

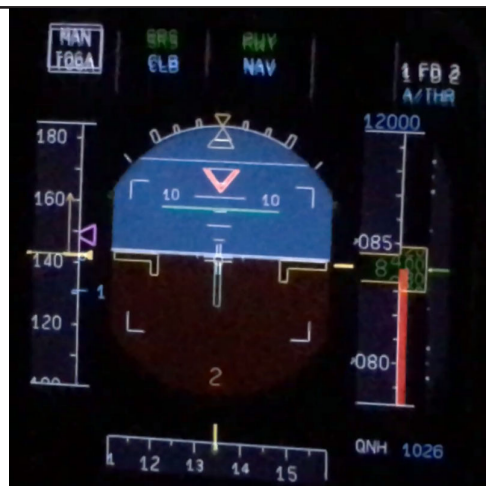
The aeroplane reaches VR and the PF calls out "ROTATE" at T0.

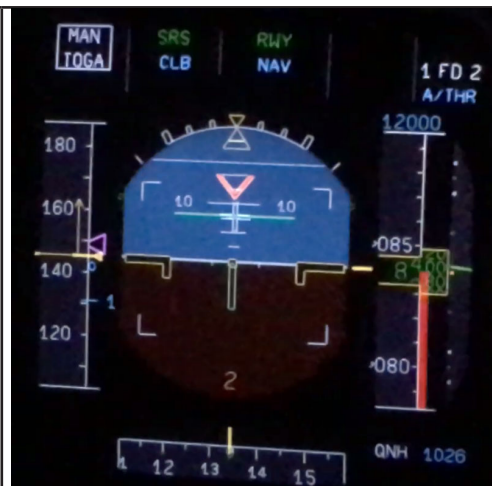
The PF initiates the rotation with a nose-up input of more than 2/3 of the deflection in less than one second, T0+1s.

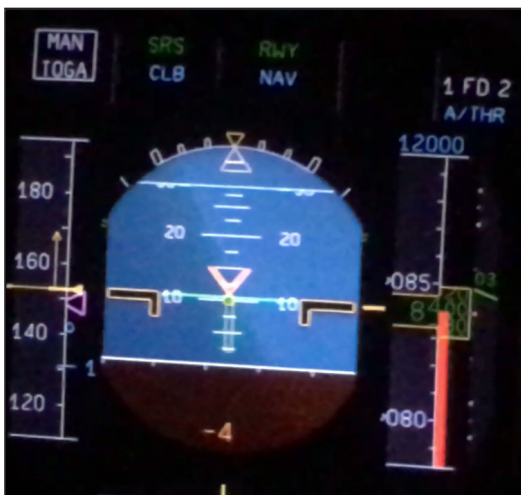
The pitch indicator quickly moves vertically towards the TAILSTRIKE PITCH LIMIT chevron, at T0 + 5 s and touches the chevron.

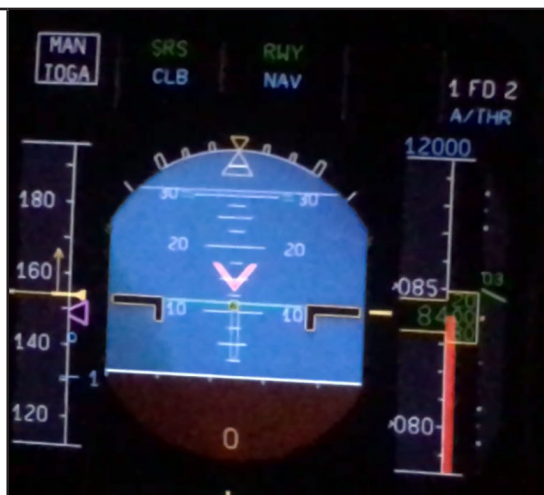
The chevron then moves away from the pitch indicator which is the sign of the start of lift-off (decompression of landing gears) at T0 + 6 s and then disappears.

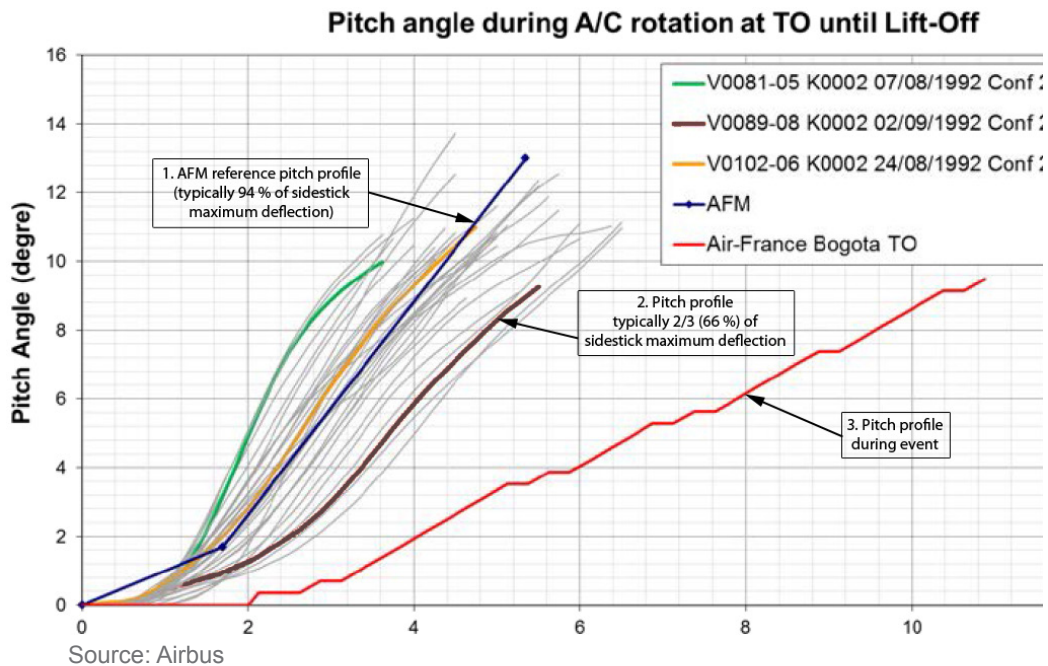
Figure 10: Pitch profiles

The brown curve (curve 2 below) corresponds, in the test conditions, to an initial stick input of  $11^\circ$  (which corresponds to the 2/3 typical initial stick deflection indicated in the FCTM) applied in around 0.5 s and then held at around this value. This test corresponds to the lower pitch profiles and to a rotation rate below that of the AFM used to calculate the take-off performance.

The green curve corresponds, in the test conditions, to an initial full backstick input ( $-16^\circ$ ) applied in 0.5 s then held for around 0.7 s before being moved to between  $9$  and  $12^\circ$ . This test corresponds to the upper pitch profiles and to a rotation rate above that of the AFM used to calculate the take-off performance.

1. Curve 1 (orange): pitch profile close to AFM model. In the test conditions, it corresponds to a flight for which the initial sidestick input was around 94 % of the maximum stick deflection. Blue curve: pitch profile model retained in the AFM performance model, i.e. an established rotation rate of  $3^\circ/\text{s}$ .

2. Curve 2 (brown): pitch profile corresponding, in the test conditions, to an initial stick input close to the typical initial stick input described in the FCTM (around 2/3 - 66 % - of the sidestick's maximum deflection) and held at 2/3 of the deflection.

3. Curve 3 (red): pitch profile reached in serious incident of 11 March.

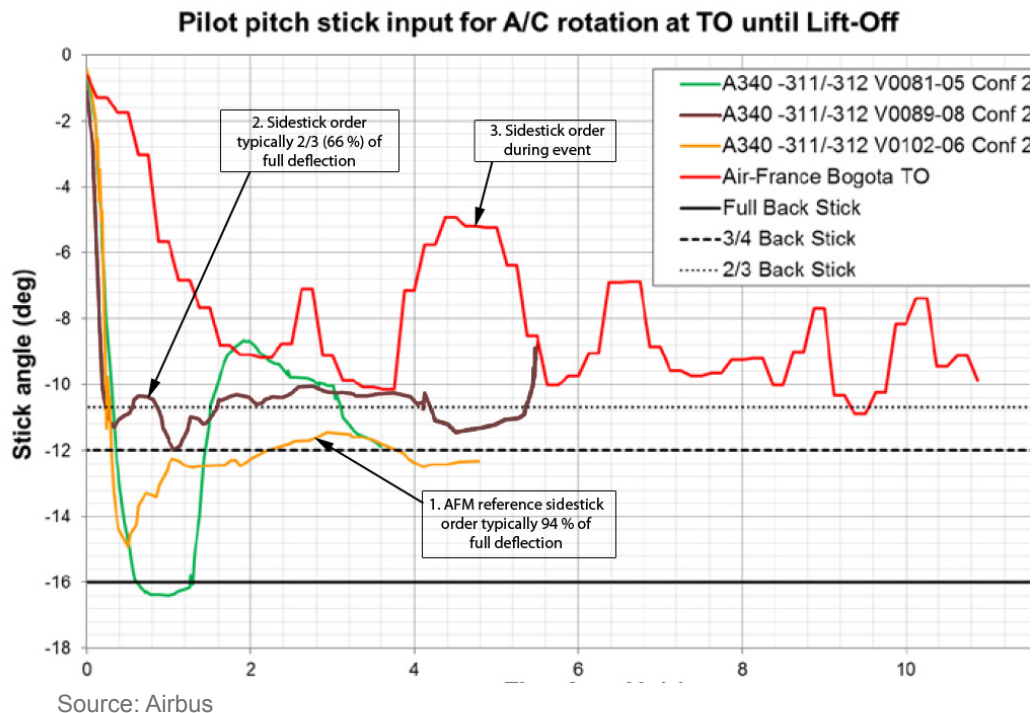
Figure 11: Sidestick inputs

1. Orange curve: sidestick input during test flight closest to the profile retained for the AFM.
2. Brown curve: sidestick input close to that described in the FCTM (around 2/3 (66 %) of the sidestick's maximum deflection).
3. Red curve: sidestick input applied in serious incident of 11 March 2017.

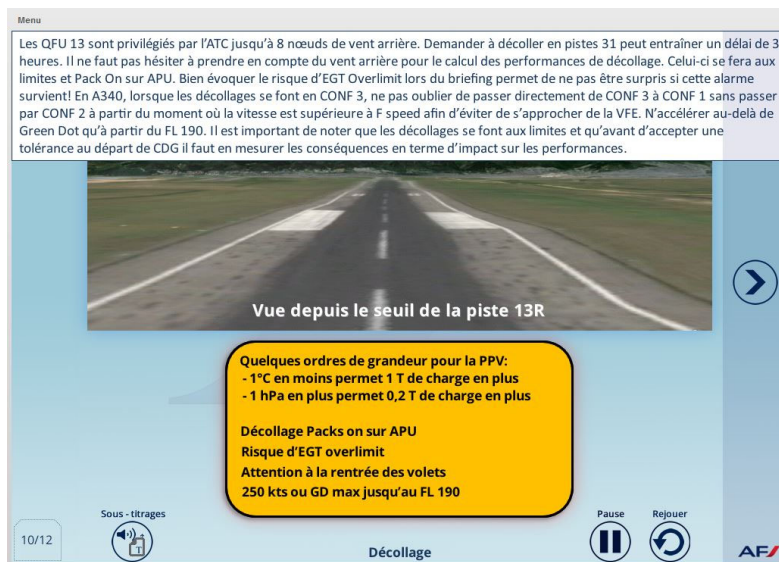
For the take-off, the e-learning notably advises that it is performed “with limits”, of the possibility of a tailwind, the risk of EGT Overlimit, the possible impact of tolerances accepted on departure from Roissy-CDG, on the performance at take-off from Bogotá and the difficulty of obtaining the QFU 31 (three hour wait).

No mention is made of the influence of the rotation rate on take-off performance nor of the difficulties in arbitrating between the rotation rate and the risk of tailstrike.

Figure 23: Excerpt from Air France e-learning page about take-offs

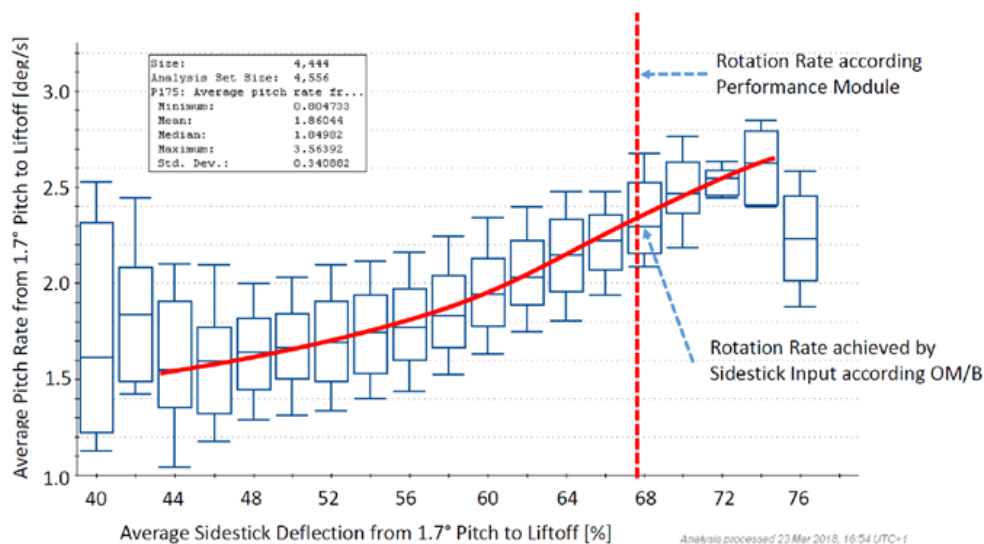
Figure 27: Summary of rotation rates obtained according to sidestick inputs when pitch reached 1.7°

The flight analysis department also studied the average rotation rate obtained according to the amplitude of the average nose-up input applied by the pilots.

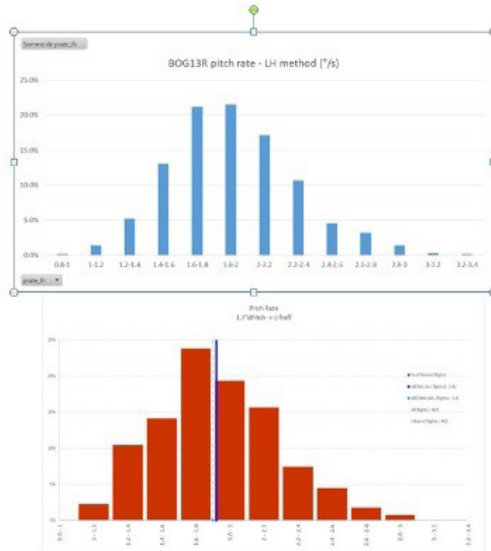
#### Pitch Rate

Measurement: Mean Pitch Rate 1.7 deg -> Liftoff

- ~ 1.900 flights BOG 13R
- Mean : 1.84 °/s
- Median: 1.81 °/s
- $\sigma$  : 0.36 °/s
- Liftoff: L/H MLG = AIR (4Hz)
