## Accident to a paraglider involving the Airbus - EC135 - T2 PLUS registered F-HTIN

on 11 May 2019  
at Le Conquet (Finistère)

## Fall of a paraglider pilot during slope soaring flight on crossing a helicopter on final, collision with ground

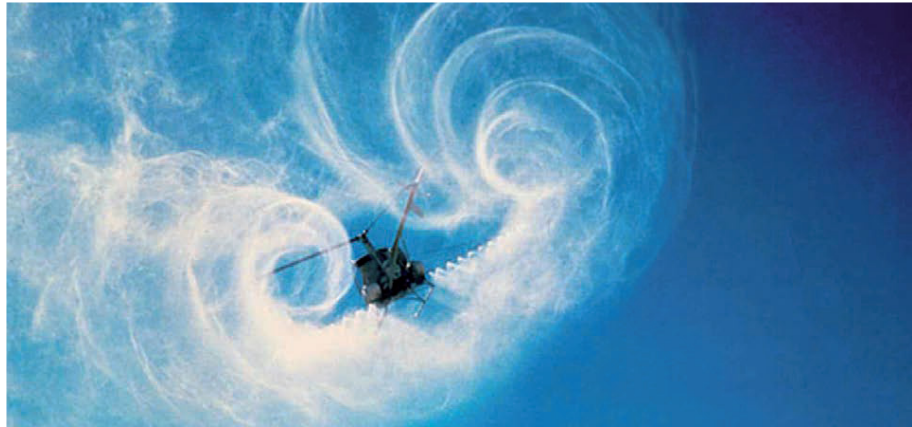
A distinction is generally made between the aerological modifications made by a helicopter in hover, called downwash (in this case a descending air flow is generated by the main rotor) and the aerological modifications made by a helicopter in forward flight called wake vortex (in this case the modified air flow behind the helicopter is similar to the wake vortex of an aeroplane with two main vortices).

Figure 5: helicopter wake vortex

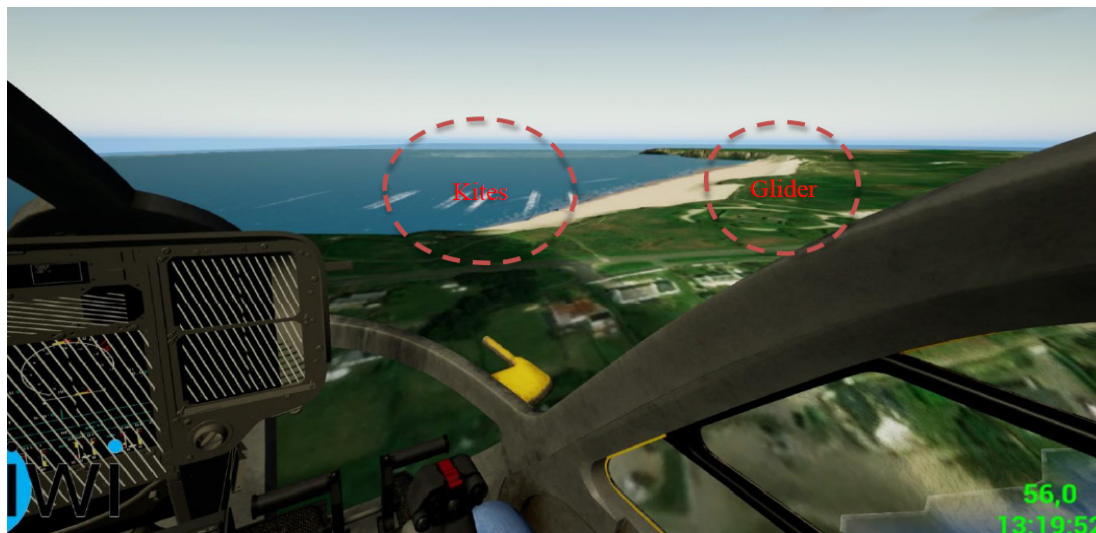
A supplementary photogrammetric analysis of the two photos taken by a witness on the beach (see [Figure 2](#) photographer witness) was used to more accurately determine the paraglider's path and to synchronize it with the helicopter's path. This was only possible during the last 13 s (time between the two photos), based on the supposition that the last position of the paraglider in flight was overhead the point where he fell. These photos were also used to estimate the orientation of the paraglider with respect to the helicopter.

Figure 7: illustration in Iwiation of point of view of helicopter pilot
