**Deviation below manoeuvring airspeed on final, go-around,
triggering of Alpha Floor protection**

Aircraft	Airbus A320-214 registered F-HEPE
Date and time	3 April 2012 at 12 h 56 ⁽¹⁾
Operator	Air France
Place	Tel Aviv Ben Gurion Airport (Israel)
Type of flight	Scheduled public passenger transport
Persons on board	captain (PNF), copilot (PF), 4 cabin crew and 149 passengers
Consequences and damage	None

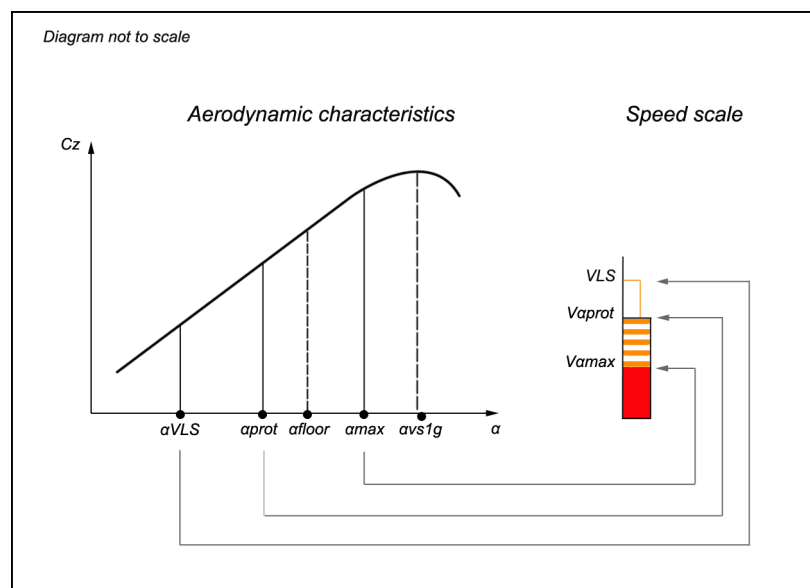
2.2.4 High angle of attack protection

When the aeroplane angle of attack increases and becomes greater than the α_{prot} angle of attack threshold, the pitch control system changes to protection mode. The automatic pitch-up compensation stops and the angle of attack varies in proportion to sidestick deflection.

If the angle of attack increases and reaches an α_{floor} threshold value, the A/THR changes to ALPHA FLOOR mode and automatically commands the maximum TOGA thrust and then maintains it whatever the position of the thrust levers. The locking of this maximum thrust is called TOGA LOCK. Pilot inputs on the thrust levers no longer control thrust. This mode can only be disengaged by manual disconnection of the A/THR.

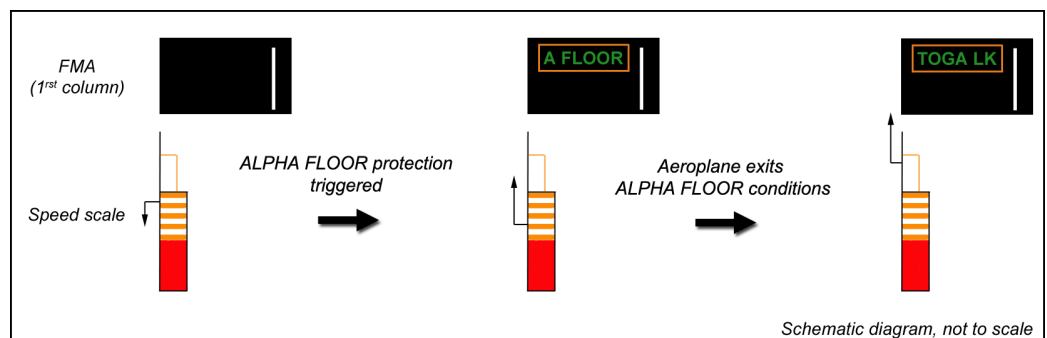
- On the FCU, the A/THR push-button lights up, if the A/THR was not already engaged;
- On the FMA:
 - A FLOOR appears in green, surrounded by an amber flashing rectangle, as long as the ALPHA FLOOR conditions are present;

- Maximum TOGA thrust is locked;
- A/THR is displayed in white;

- On the E/WD, A.FLOOR is displayed in amber and the word TOGA appears in blue with the percentage value.

No aural warning is associated with triggering of the ALPHA FLOOR mode.
