*Accident  
on 25 July 2000  
at "La Patte d'Oie"  
in Gonesse (95)  
to the Concorde  
registered F-BTSC  
operated by Air France*

**Interim report (10/07/2001)**  
**f-sc000725ae2**

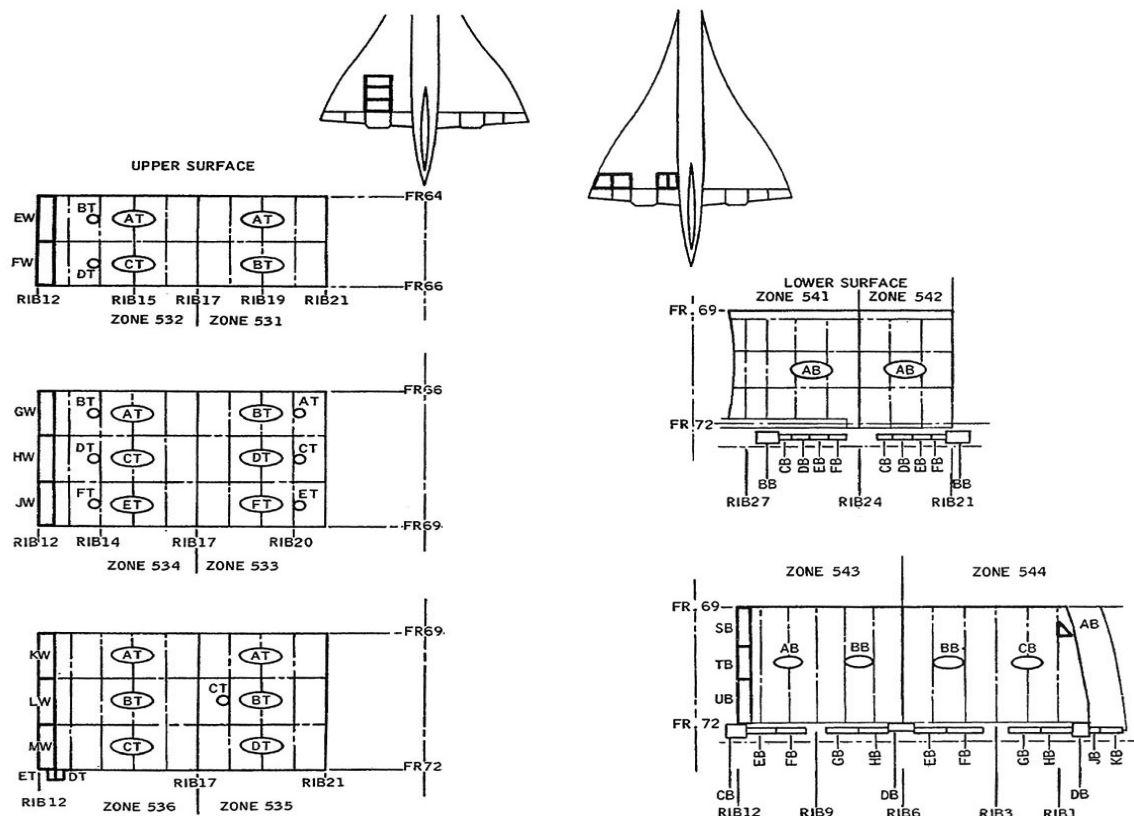
Figure 16: Dry bays

The dry bay located above engines 1 and 2 was examined by the technical investigators and their advisors. At the time of impact, it was broken off between ribs 12 and 21. All of the lateral partitions were destroyed. The heat shield was generally intact except for an indentation on impact at the level of the engine 2 nacelle.

Door 531BT was still attached to the upper surface of the bay. Door 532CT was found melted into its housing. These two doors provide access to the forward part of the dry bay. This bore no signs of overpressure, there were no traces of flames inside and the partition separating them from the aft part was generally intact. Only the tank 2 LP fuel supply valves were found there.

Eight doors located on the upper surface and providing access to the aft part of the dry bay were found under the path of the aircraft on the runway centreline extension. None of the doors bore any traces of fire. Two of the doors were equipped with an overpressure valve which opens at a pressure estimated at 200 mbar. The two valves were closed and door 535AT was bulged out as a result of overpressure directed from the inside to the outside. The valve opening rods had buckled under the effect of the distortion, which shows that the valves had no time to open. Lower surface door 541AB, which communicates with the aft part of the dry bay, was also found in the runway extension area. The section of the wing surrounding this door was found at the crash site. Both parts bore traces of soot clearly indicating the passage of the flame over the lower surface of the wing.

Examinations showed that the aft part of the dry bay as well as the communicating areas suffered a very violent overpressure after takeoff, leaving no time for the overpressure valves to open. The door latches broke off as a result of this overpressure. The manufacturer estimates that a pressure of about 450 mbar on a door could lead to the rupture of the most loaded axis. Combustion of an air/kerosene mixture in the enclosed space of the dry bay could generate an overpressure which could reach a few bars in a few tenths of a second (stoichiometric mixture). Transition from combustion to detonation (propagation of a wave of combustion at supersonic speed) can generate a shock wave equivalent to pressure rise of several dozen bars.

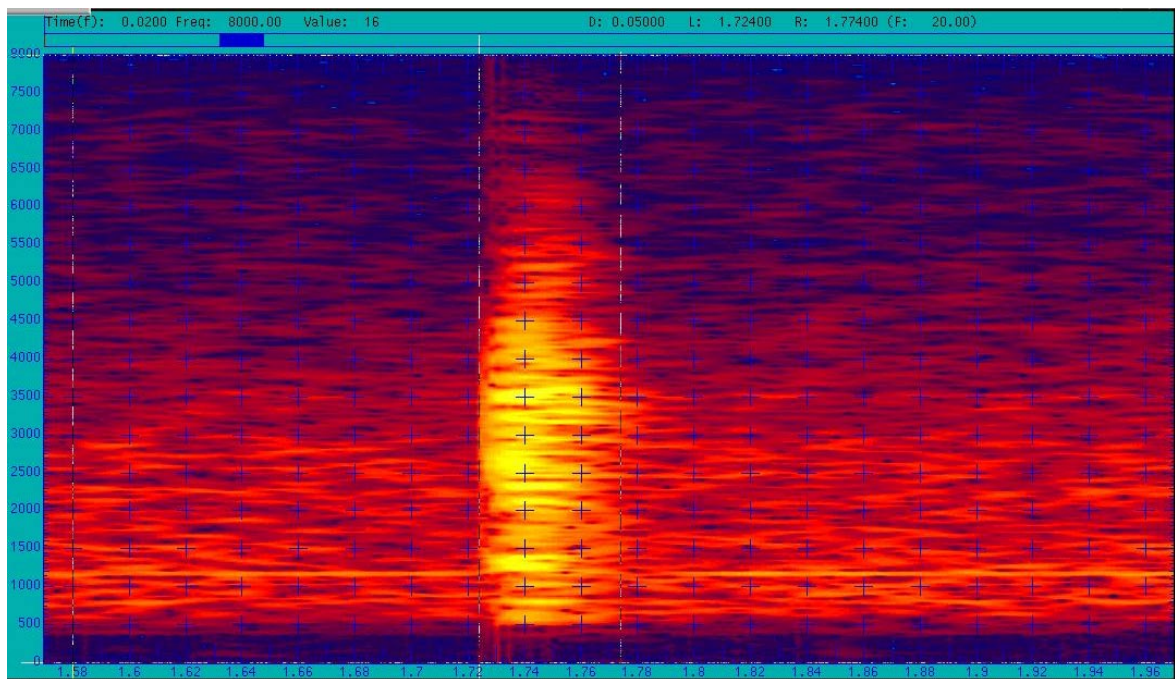
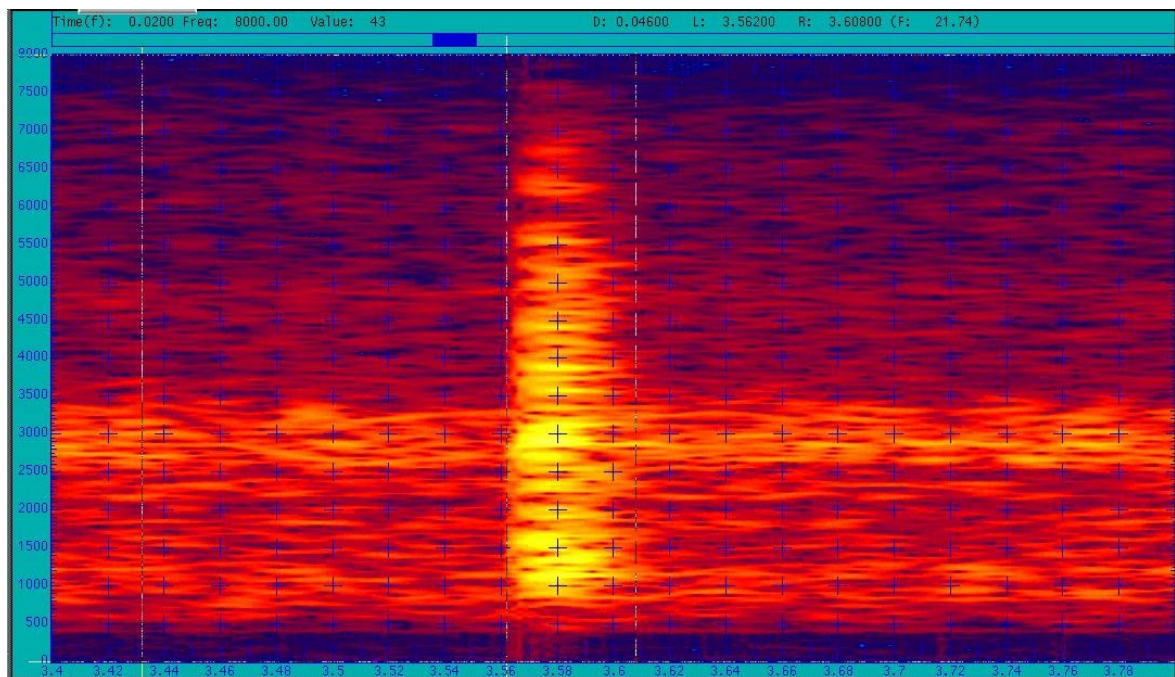
- Noise at 14 h 42 min 30.4 s

This noise is identified as the “clicking” of the thrust levers. The normal procedure, during power up, is to advance the levers to their stop. This interpretation is consistent with the results from the FDR. The comparison of the time-frequency representations recorded on F-BTSC and of that recorded on F-BTSD are shown hereafter.

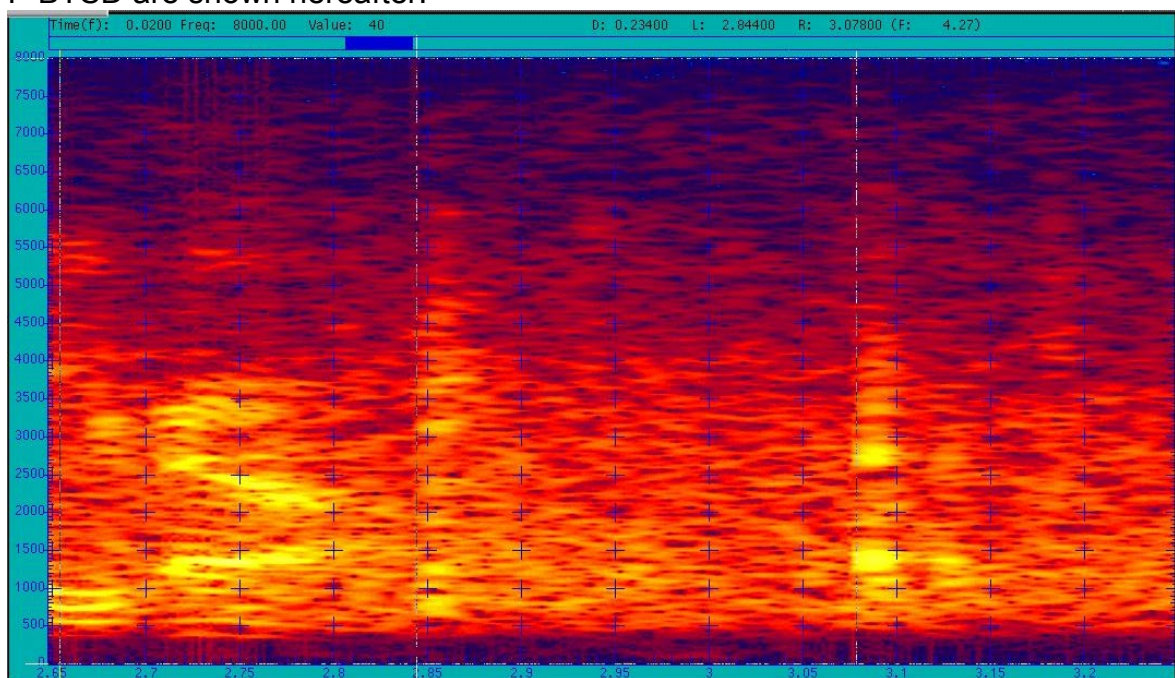
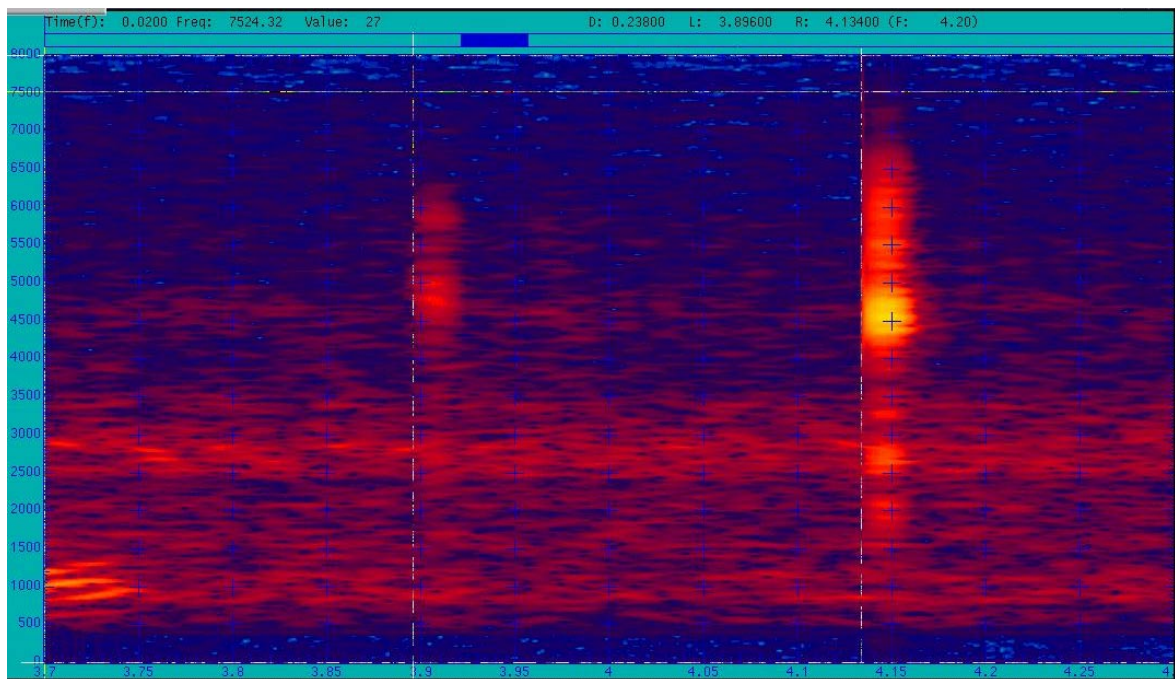
- Noise of selector at 14 h 43 min 21.3 s

The rate and auditory perception, as well as application of procedures, enabled this noise to be identified as being that of the movement of the TCU selector from “main” to “alternate”. The time-frequency analyses of the noise on F-BTSC and on F-BTSD are shown hereafter.

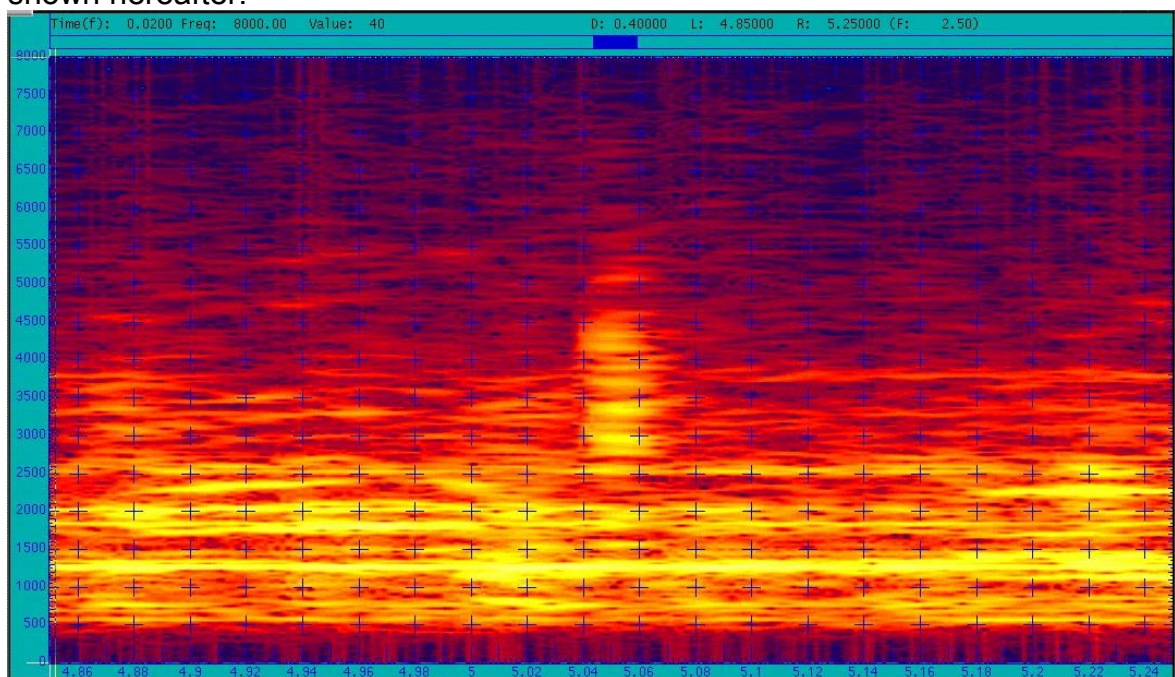
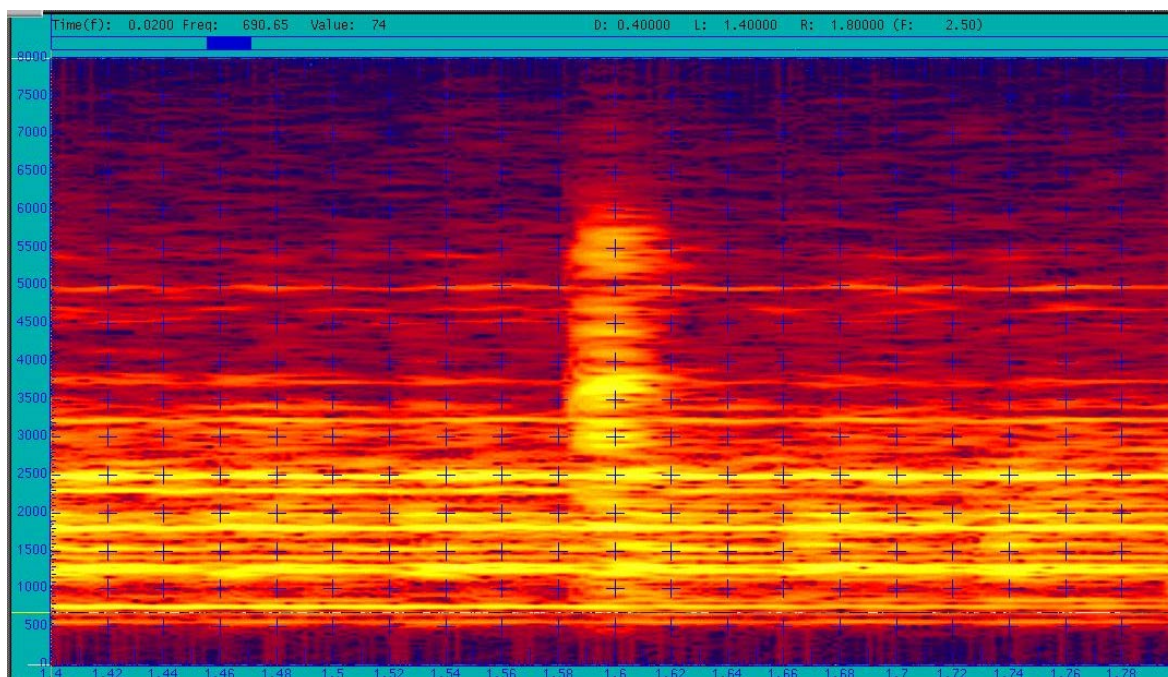
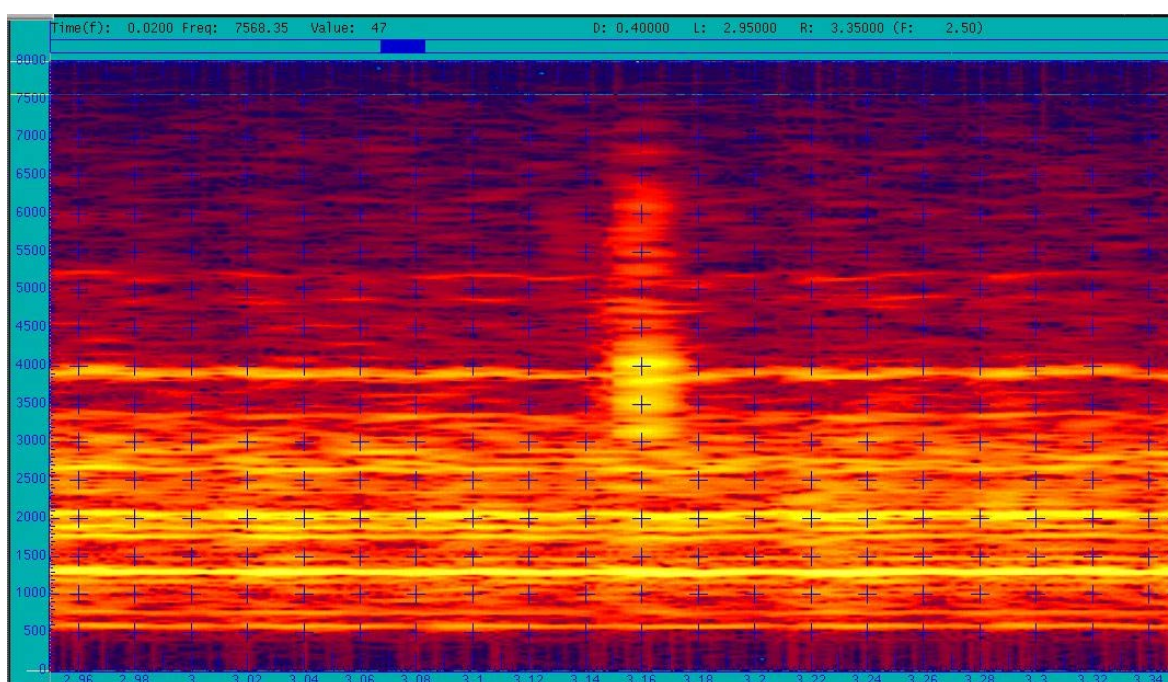
- Noise of selector at 14 h 43 min 26.2 s

On the FDR a decrease in engine speed is noted after this selector noise. There were four hypotheses to explain this decrease in speed. The first was independent of crew action in the cockpit, the three others were respectively an action on the thrust lever, a cut through movement of the HP fuel cock or a de-selection of auto-thrust. The spectral representation is very close to that of a thrust lever reduction or a HP fuel cock shutoff, though it is impossible to distinguish between them. The time-frequency analyses of the noise on F-BTSC and on F-BTSD are shown hereafter.

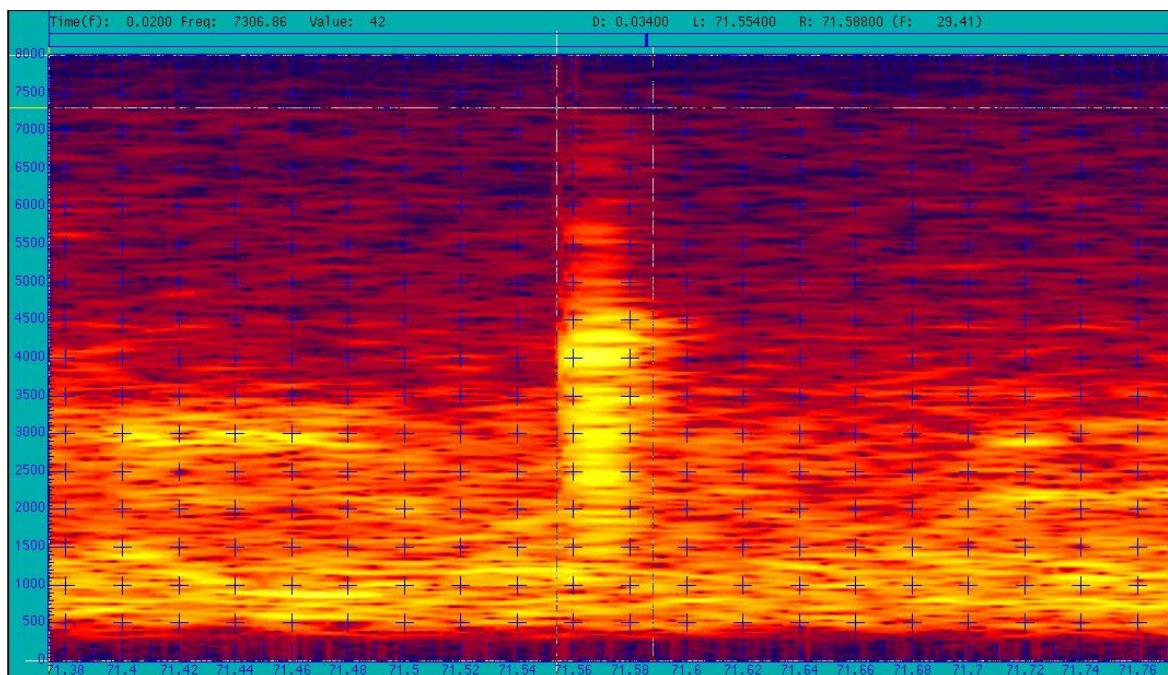
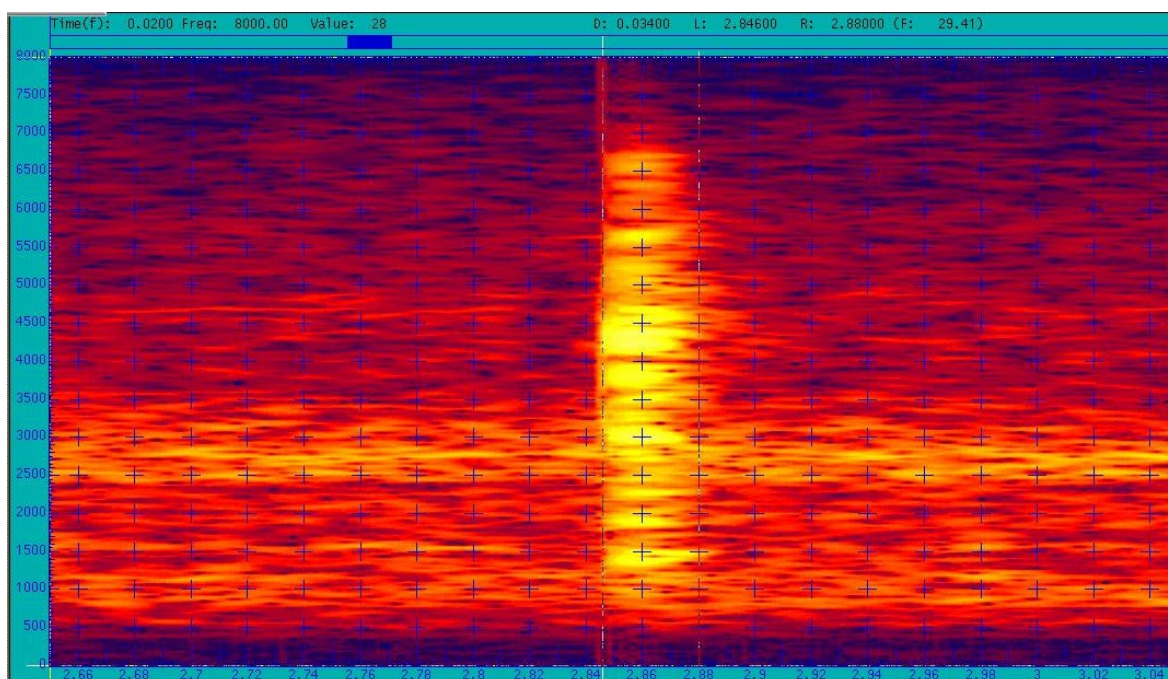
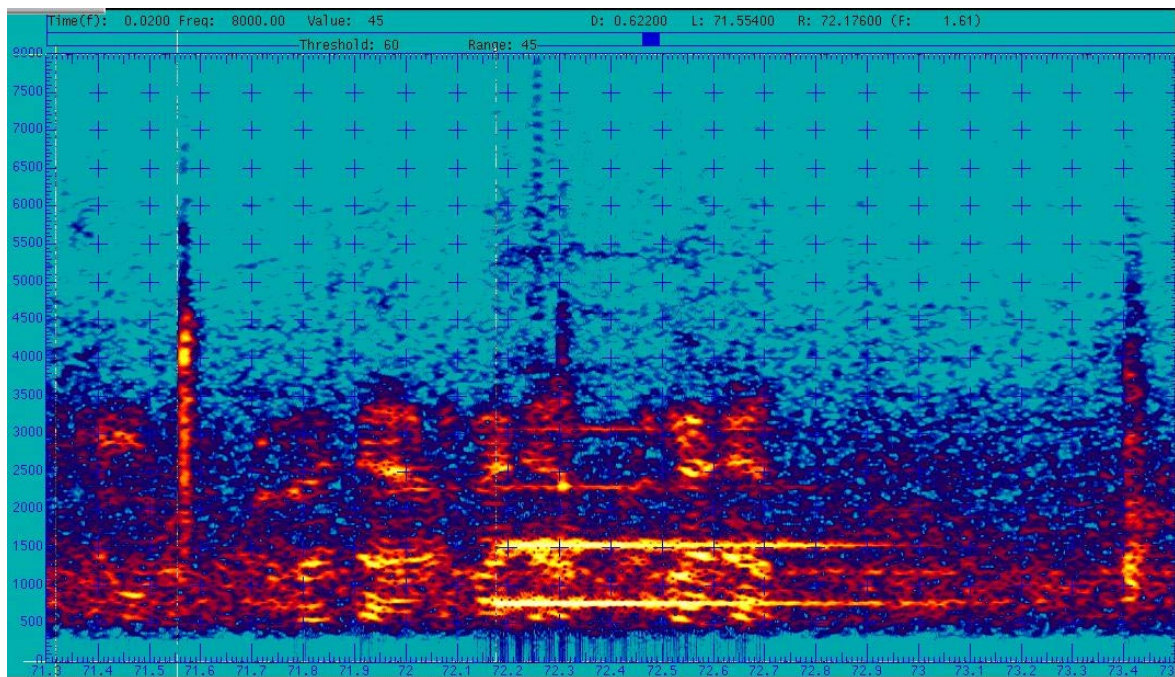
- Noise of selector at 14 h 43 min 27.5 s

Several elements enabled identification of the electric pitch trim actuators: energy peaks at approximately frequencies, the duration of the signal and the time between the selector noise and the appearance of the gong 0.7 to 0.8 s later. The time-frequency analyses of the noise on F-BTSC and on F-BTSD are shown hereafter.

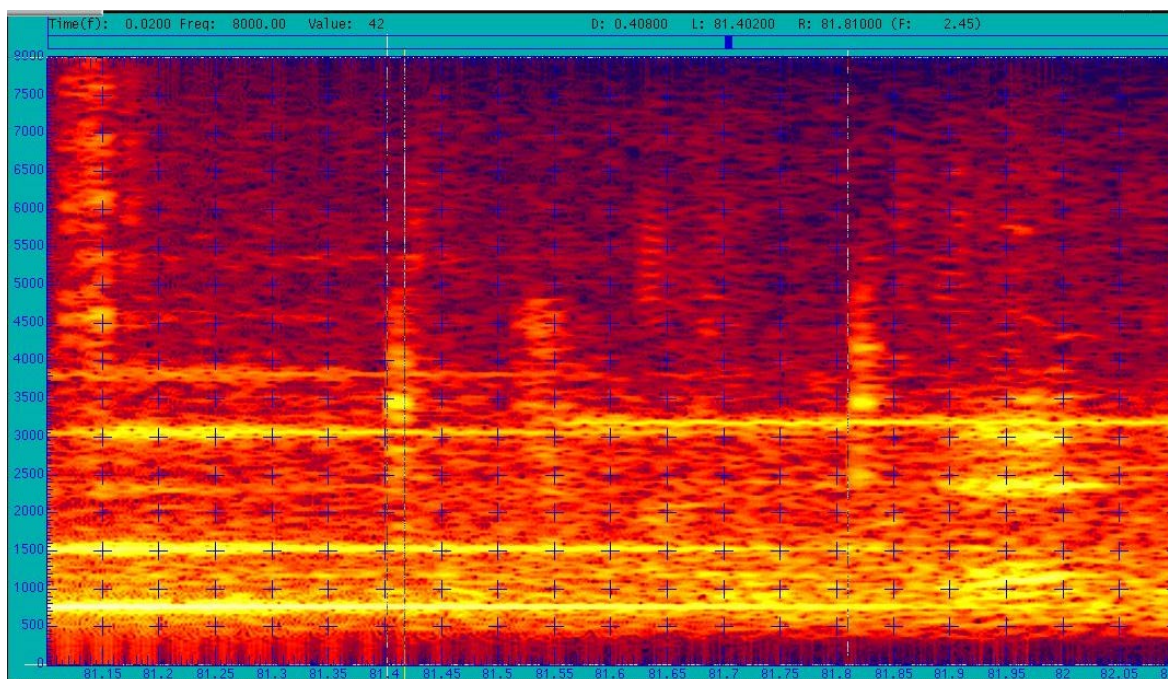
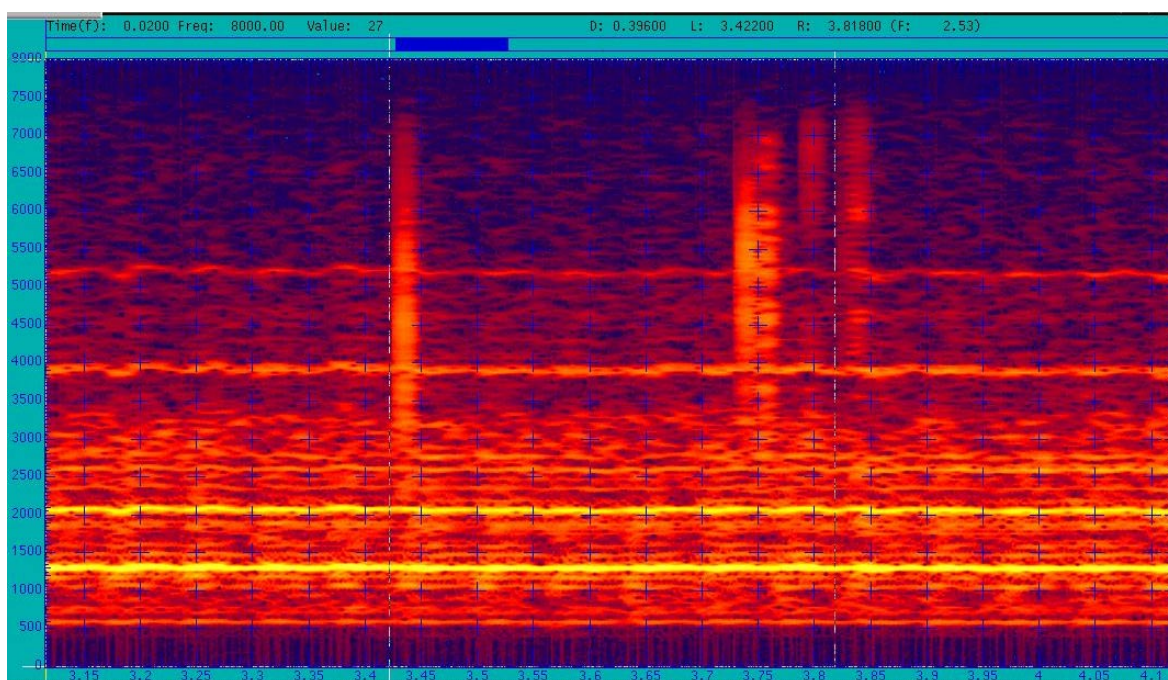
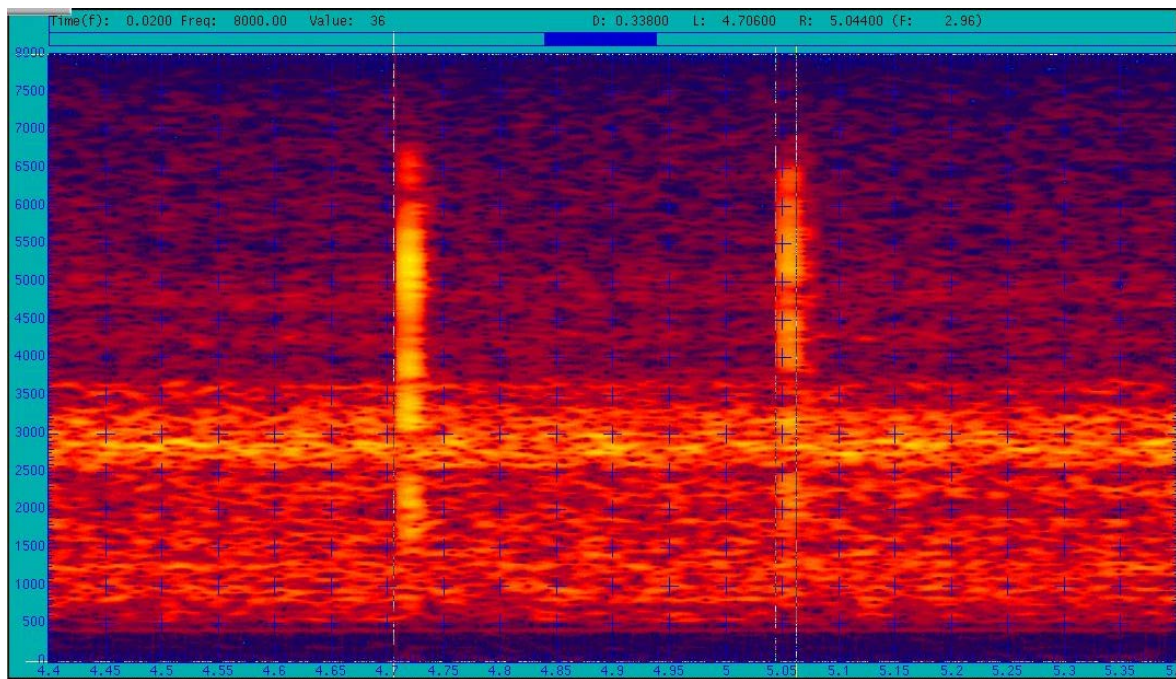
- Noise of selector at 14 h 43 min 44.7 s

This noise is similar to activation of the “first shot” pushbutton which corresponds to the firing of the extinguishers in the engines. This action can only be taken if the fire handle has been pulled. The rate between the two energy peaks which make up this noise is characteristic of action on this button or, more exactly, of the destruction of the glass which covers this button. In the three time-frequency analyses that are shown hereafter, this time is between 0.35 and 0.4 s.
