N° 9
June 2008

Incidents in Air Transport

Hydraulic Failures

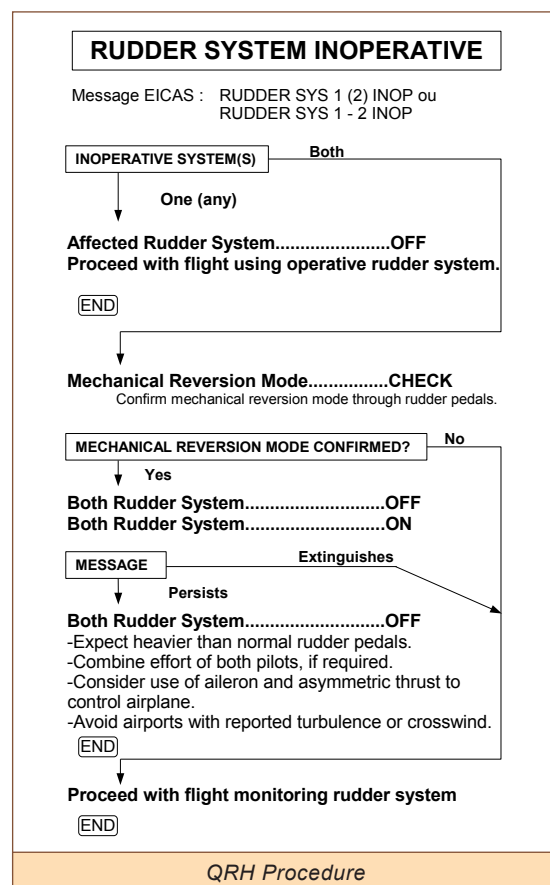
Failure of system 2 pressure switch

At a speed above 135 kt, system 1 of the actuator is normally depressurized. In case of failure of system 2 pressure switch, pressure always available in system 2, system 1 does not take over. However the SYS 1-2 INOP warning is presented to the EICAS because neither of the two pressure switches can detect pressure.

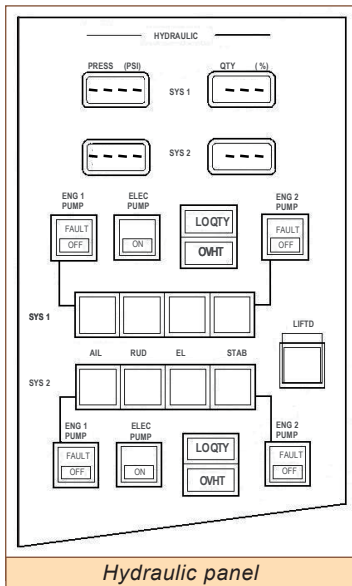
with the warnings by applying the associated procedures one after another: he stopped system 1's hydraulic pumps then system 2's⁽⁵⁾. Although he had not yet finished reading the system review, STAB TRIM 1 AND 2 message appeared. He began the associated procedure.

on the JAMMED STAB procedure. The latter required the use of neither the wheel nor the trim system's emergency electric engine (ALTN STAB).

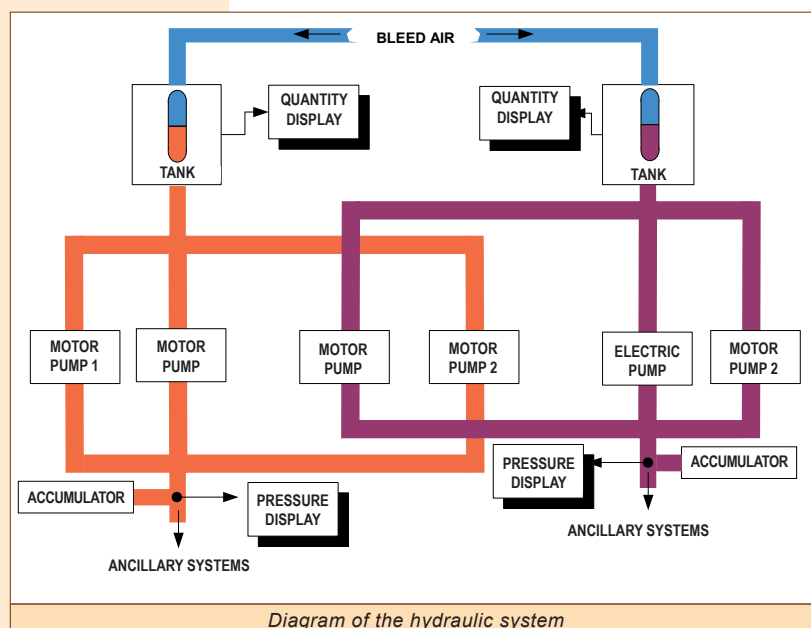
As the warning is triggered in case of the trim system being mechanically locked, the associated procedure forbids the use of the emergency electric mode so as not to damage the hydraulic servo control.

This warning is inhibited in case of a drop in pressure in both hydraulic systems.
