## Accident to the Piper PA-31 "Navajo" registered F-HGPS

on 21 August 2018

at Verneuil-sur-Vienne (Haute-Vienne)

## Fuel exhaustion, forced landing, collision with vegetation, during an aerial photography flight

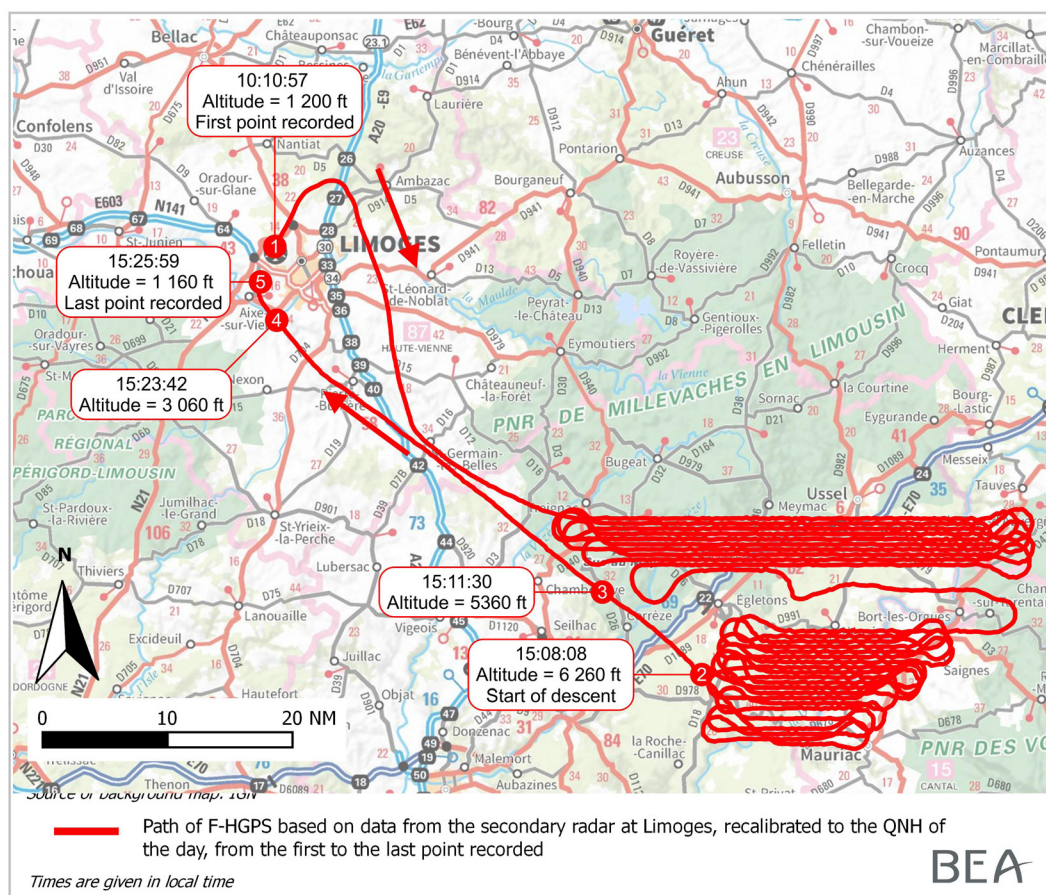
Figure 1: Flight path

At 15:06, the pilot announced on the frequency that the mission was finished and the aircraft was returning to Limoges-Bellegarde airport. The aircraft was about 52 NM south-east of the airport, at an altitude of 6,200 ft.

The pilot began the descent at 15:08.

At 15:19, the tower controller asked him to call back from the right-hand base leg for runway 03. The pilot replied that he estimated that he would arrive at the base leg four minutes later.

At 15:23, the aircraft descended below 3,000 ft. Two minutes later, the pilot announced: *"F-PS we're going to make an emergency landing, I've run out of fuel."*

Shortly after this last message, the aircraft collided with trees and then with the ground 2 NM south of the threshold of runway 03. The pilot and the operator sitting in the rear were seriously injured.
