## Accident to the Rolladen Schneider LS8-18 registered F-CIBD

on 13 April 2019

at Avize (Marne)

## Loss of control in flight, collision with the ground

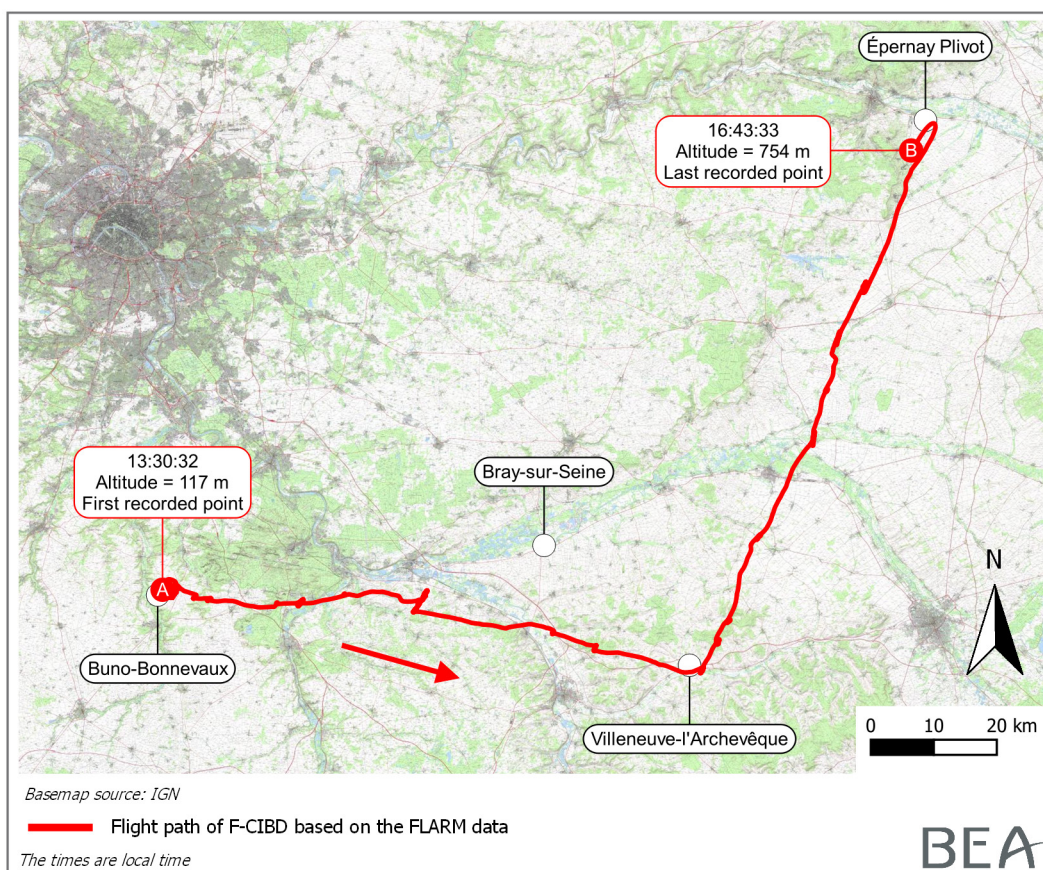
Figure 1: flight path of F-CIBD (full flight)

The pilot made a towed take-off at about 13:30 from Buno-Bonnevaux aerodrome (Essonne) for a circular eastbound flight to Épernay-Plivot aerodrome (Marne), passing over the towns of Villeneuve-l'Archevêque (Yonne) and Épernay (Marne).

At about 16:40, the glider passed over Épernay-Plivot aerodrome and the pilot began the return leg.

Approximately three minutes later, while flying at a height of 630 m above an agricultural zone, the pilot lost control of her glider and hit the ground in a vineyard.
