Accident to the HELI-SPORT SRL CH 77 RANABOT⁽¹⁾ identified 83ARG

on 13 July 2018

at Saint-Raphaël (Var)

Error message on the instrument panel, autorotation, collision with the ground, fire

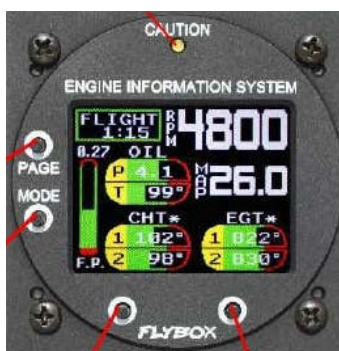
The ultralight is also equipped with a GNSS FlyBox computer equipped with a screen on the instrument panel (Mini EIS⁽⁷⁾). This computer uses the sensors and probes of the engine monitoring system. Essential engine parameters⁽⁸⁾ or, if necessary, alarms, are displayed on the main page of the screen.

Figure 3: Example of display of essential engine parameters on the Mini EIS

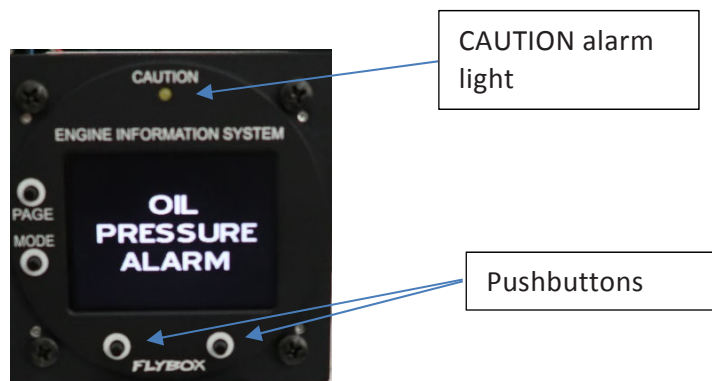
The Mini EIS user manual specifies that the computer constantly monitors all sensors and probes. When a measurement exceeds the limit value defined by the operator in the FlyBox computer, an alarm is activated. The parameters display page is then replaced with a page that identifies the alarm (displayed in white on a black background). The CAUTION alarm light flashes and a voice alarm is heard. Once the alarm has been identified, the pilot must press a pushbutton. The screen then displays the page that corresponds to this measurement and the gauge flashes until the anomaly is corrected.

Figure 4: Example of an alarm
