## Accident to the ROTORWAY - EXEC (162 HDF/A600) registered F-WSPM

on 5 November 2018

at Saint-Pierre (Saint Pierre and Miquelon)

## Loss of control during take-off, collision with ground

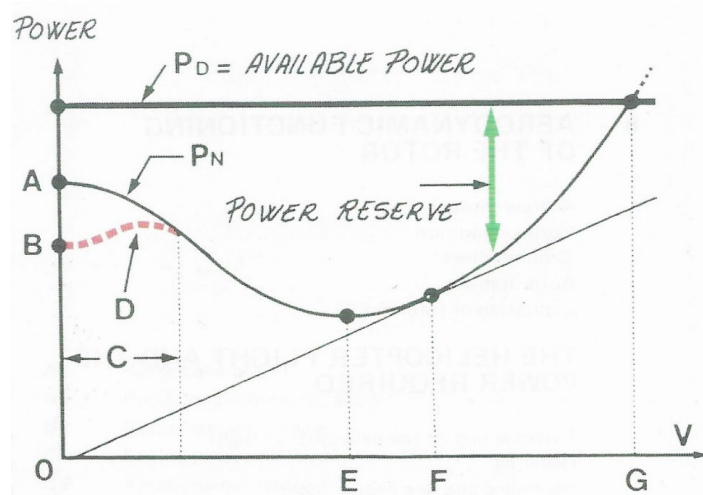
Figure 4: Simplified diagram of power vs velocity

The day of the accident, the pilot carried out a take-off which resembled a yaw take-off. He could have equally carried out a conventional take-off as he was not limited by any obstacle.
