## Accident to the Airbus AS 350 B3 registered F-GKMQ

on 7 January 2019  
at Puylaurens (Tarn)<sup>(1)</sup>

## Loss of control while setting down a slung load, collision with vegetation and then ground

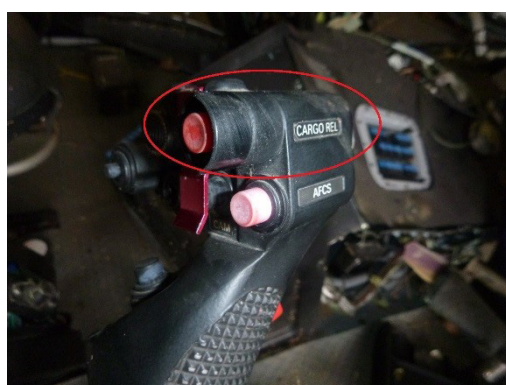
Figure 3: "CARGO REL"

The opening of the top hook can be electrically controlled using the "CARGO REL" button on the cyclic pitch stick (see Figure 3) or mechanically, by pressing the lever on the collective pitch lever (see Figure 4).
