## Accident to the AEROS SKYRANGER registered 13LZ

on 7 May 2019

at Saint-Antonin-sur-Bayon (Bouches-du-Rhône)

## Collision with the terrain

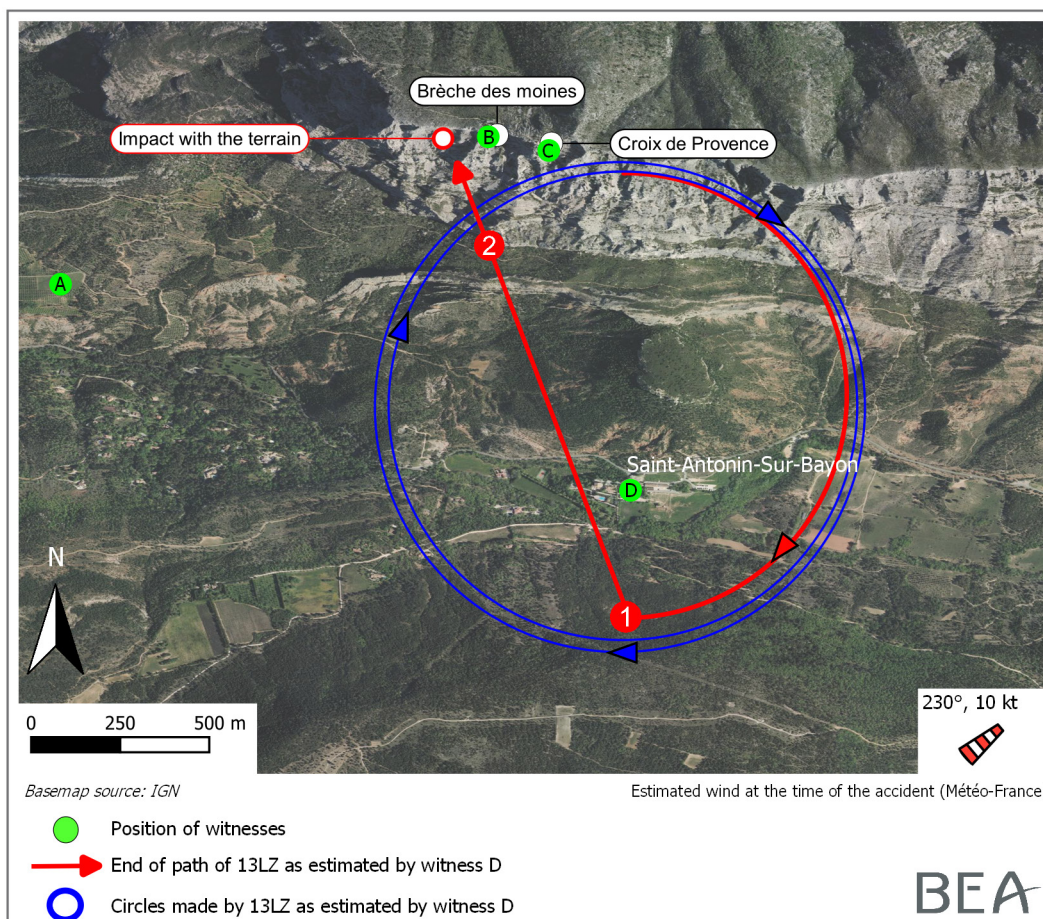
At around 16:05, several witnesses standing at the foot of Sainte-Victoire mountain (position A [Figure 1](#)) and on the peak (positions B and C [Figure 1](#)) saw the microlight make several out-and-back flights between the south face of the mountain and the village of Saint-Antonin-sur-Bayon (Bouches-du-Rhône). These witnesses stated that the microlight had each time flown along the face from west to east on a path practically parallel to the terrain, at an altitude below that of the peak, before heading southwards at Croix de Provence. During the final turnaround, a witness in the village of Saint-Antonin-sur-Bayon (position D [Figure 1](#)) saw the microlight fly at an altitude lower than that of the previous flights then turn northwards in the direction of Croix de Provence (point 1 [Figure 1](#)). All of the witnesses stated that the microlight had remained on a straight path, at a constant altitude and that they had not heard a variation in engine rating. Approximately 200 metres from the face (point 2 [Figure 1](#)), the microlight banked left then continued to fly in a straight line for around 50 metres. The wings slowly returned to the horizontal position, then the microlight collided with Sainte-Victoire mountain, around 20 metres from the top of the rocky face, to the west of "Brèche des Moines" viewpoint. The microlight caught fire and fell to the foot of the face.

Figure 1: Estimated path of the microlight according to a witness on the ground

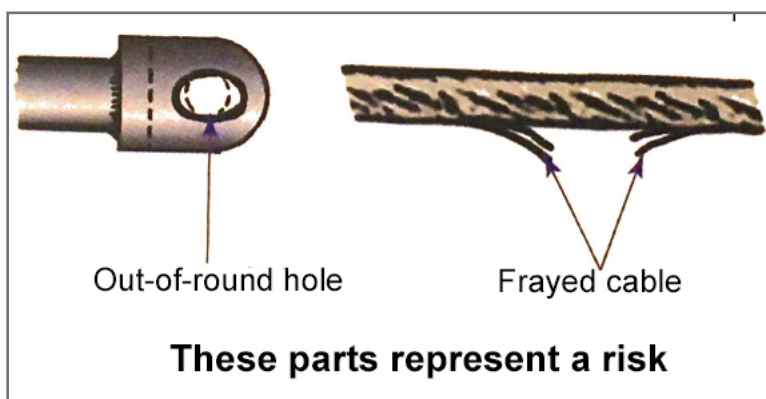
The Microlight Pilot Manual<sup>(14)</sup> states that maintenance is carried out during use of the aeroplane by observing the condition of different components and operating anomalies; and also during periodic inspections, through the inspection, adjustment or replacement of certain components. It also specifies that the manufacturer generally provides a summary of the different inspection operations and their frequency after a certain number of operating hours or every year for example. It is essential that a schedule is drawn up detailing each component to be inspected, the frequency of the inspections and the mandatory replacement of deteriorated or highly stressed parts. If an anomaly (see Figure 8) is observed during an operating phase (assembly, disassembly, flight, etc.), it is essential to remedy this anomaly without delay as safety can be compromised if a detail that appears insignificant is ignored.

Figure 8: Examples of anomalies
