## Accident to the PZL BIELSKO - SZD-51 registered F-CAJC on 3 October 2019 at Issoire Le Broc aerodrome (Puy-de-Dôme)

## Disconnection of elevator control, hard landing

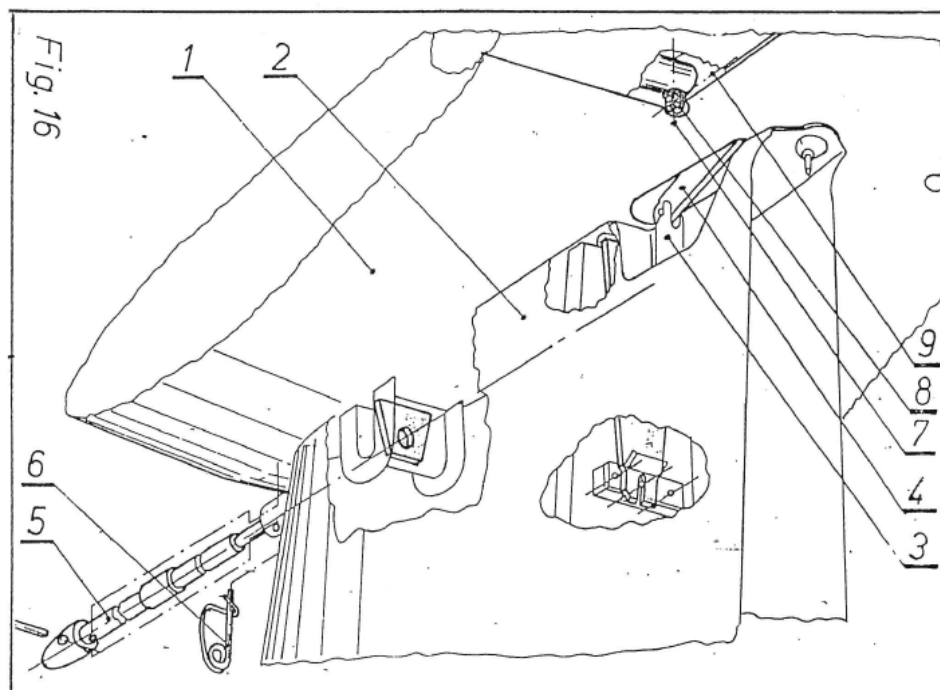
Figure 1: Rigging tailplane

After the accident, the elevator control system was found to be disconnected between the quick-release end (3) and the elevator lever (4).

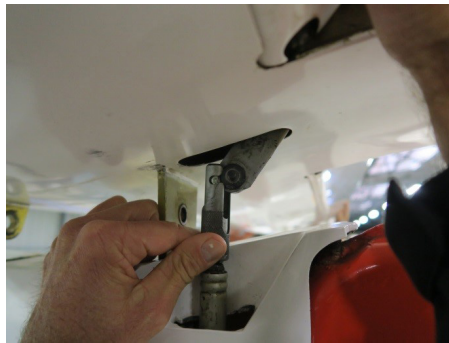
Figure 7: Positioning elevator lever bolt on quick-release end (sleeve in the down position)

Several complete rigging tests were carried out. No defects with respect to the connection and locking system were found, apart from the hindrance caused by the distortion of the washers.
