Accident to the PIPER - PA32 - 300 registered F-OKGO

on 16 February 2020

in Fort-de-France bay (Martinique)

Reduction in engine power, ditching, during parachute drop flight

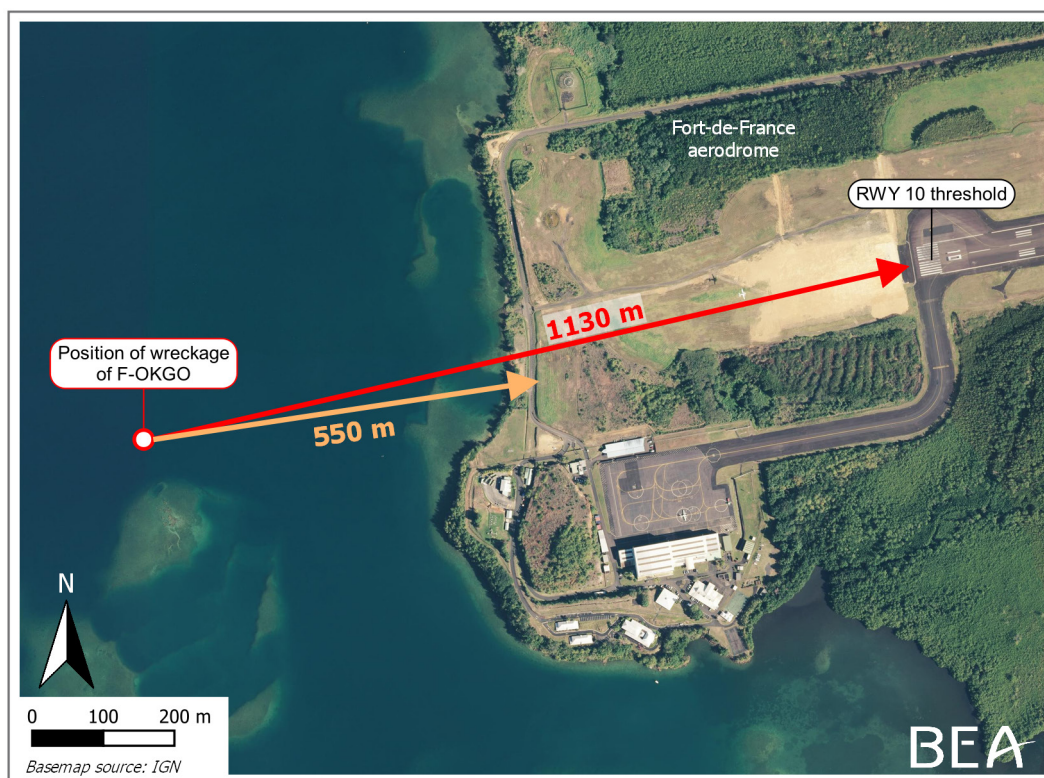
Figure 1: Position of wreckage with respect to coast and runway threshold

The pilot, having donned his life jacket, managed to evacuate the aeroplane before the latter sank at around 550 m from the coast. He was rescued by a boat 25 minutes later.
