Accident to the CENTRAIR – 101A PEGASE registered F-CHDJ

on 21 May 2020

at Barcelonnette (Alpes-de-Haute-Provence)

Partial deployment of speed brakes following a confusion between controls during approach, collision with a tree in last turn, collision with the ground

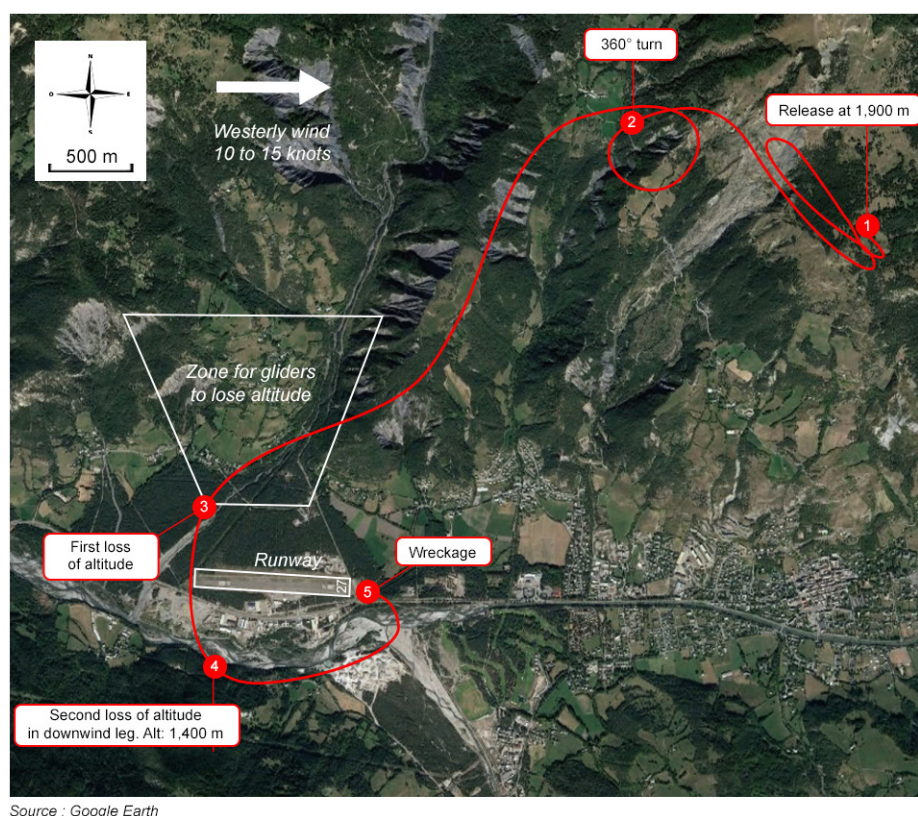
Figure 1: Approximate path of the glider based on the pilot's statement

The pilot took off in towed flight from Barcelonnette aerodrome. He released the cable at 1,900 m of altitude to the north of the aerodrome⁽²⁾ (Point ❶, [Figure 1](#)). He carried out several manoeuvres over "Soleil-Bœuf" ridge, retracted the landing gear then performed a 360° turn (Point ❷). As he could not find any uplift and with turbulence in the air mass, he decided to return to land at the aerodrome to carry out another towed take-off towards the south of the aerodrome. At 1,700 m of altitude, he joined the zone to lose altitude then configured the glider to land on runway 27. Shortly after, when crossing Ubaye River (Point ❸), as he was heading towards the start of the downwind leg, the pilot saw that the vertical speed indicator was at the instrument stop and displaying a rate of descent of at least 5 m/s for around one minute before observing a decrease in the rate of descent. The pilot joined the start of the downwind leg at approximately 1,400 m of altitude (Point ❹). He then observed a significant increase in the rate of descent. He aborted the downwind leg and made a U-shaped approach abeam the threshold of runway 27. At the end of the turn, he increased the glider's bank angle to avoid overshooting the runway centreline. The left wing hit the top of a tree, then the glider collided with the ground upside down, before the runway threshold.

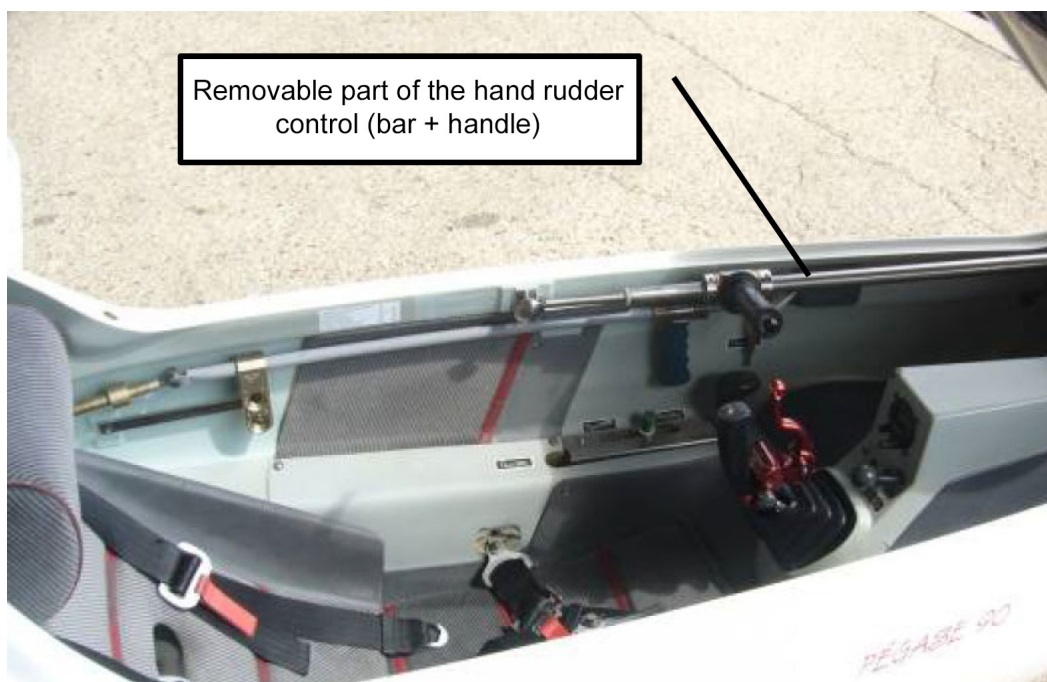
Figure 3: Removable part of the hand rudder control when this is installed

In 2014, the Pegase C101-1000 kit was developed in partnership with the French Gliding Federation (FFVP)⁽³⁾ to enable persons with lower limb disabilities to be able to fly by manoeuvring the pedals using a manual control known as a “*hand rudder control*” (Figure 3). Since the kit was certified by the European Aviation Safety Agency (EASA) through the issuance of a STC⁽⁴⁾, eight PEGASE type gliders have been modified in France. The glider registered F-CHDJ was equipped with this kit in May 2014.

To make PEGASE gliders that are not equipped with a brake lever on the stick compatible with the hand rudder control, a specific BERINGER brake lever needs to be added (Figure 3)⁽⁶⁾. The lever was installed on F-CHDJ (Figure 2). This was not present on the CCVU's unmodified PEGASE for which the brake was coupled with complete extension of the speed brakes through the speed brake control.
