Accident to the AIR COPTER - DJP 2000 identified 31LI

on 05 July 2020

at Sos (Lot-et-Garonne)

Rudder struck by main rotor, loss of control in flight, collision with the ground

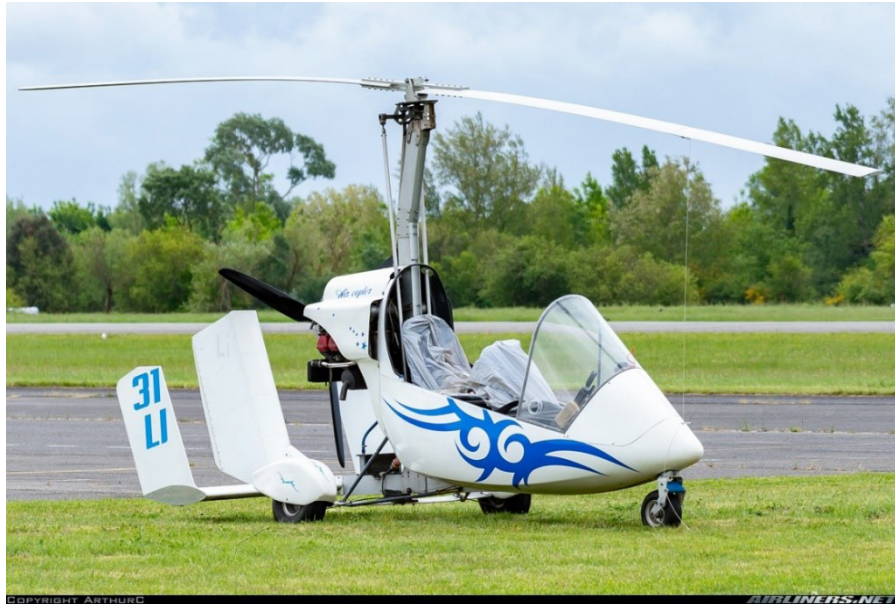
Figure 1: Gyroplane DJP2000 31LI

The DJP2000 is an amateur-built gyroplane with two seats in tandem configuration. 31LI was equipped with a Rotax 914 UL Turbo engine delivering 115 hp onto which a composite three-blade propeller was assembled. The aluminium rotor measured 8.60 m in diameter. 31LI entered into service in 2009. The pilot bought the gyroplane in May 2016.
