## Accident to the MAGNI - M16 identified 48BU

on 18 January 2021  
at Valmeinier (Savoie)

### Interference of rotor with tailplane, loss of control, collision with ground

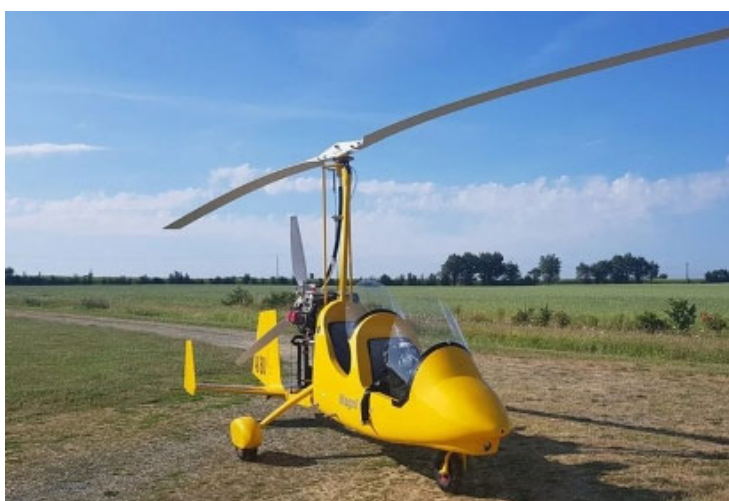
Figure 4: Gyroplane 48BU

This MAGNI M16 Tandem Trainer R914 gyroplane entered into service in November 2016. It was powered by a ROTAX type 914 UL engine and a composite three-blade propeller. The main rotor comprises two composite blades. Its empty weight was 260 kg and the maximum permissible take-off weight was 450 kg.
