Federal Democratic Republic of Ethiopia
Ministry of Transport
Aircraft Accident Investigation Bureau

Aircraft Accident Investigation Final Report

Delta 2 Turbo Thrush (F-HLDD)

Report No. AI-01/21

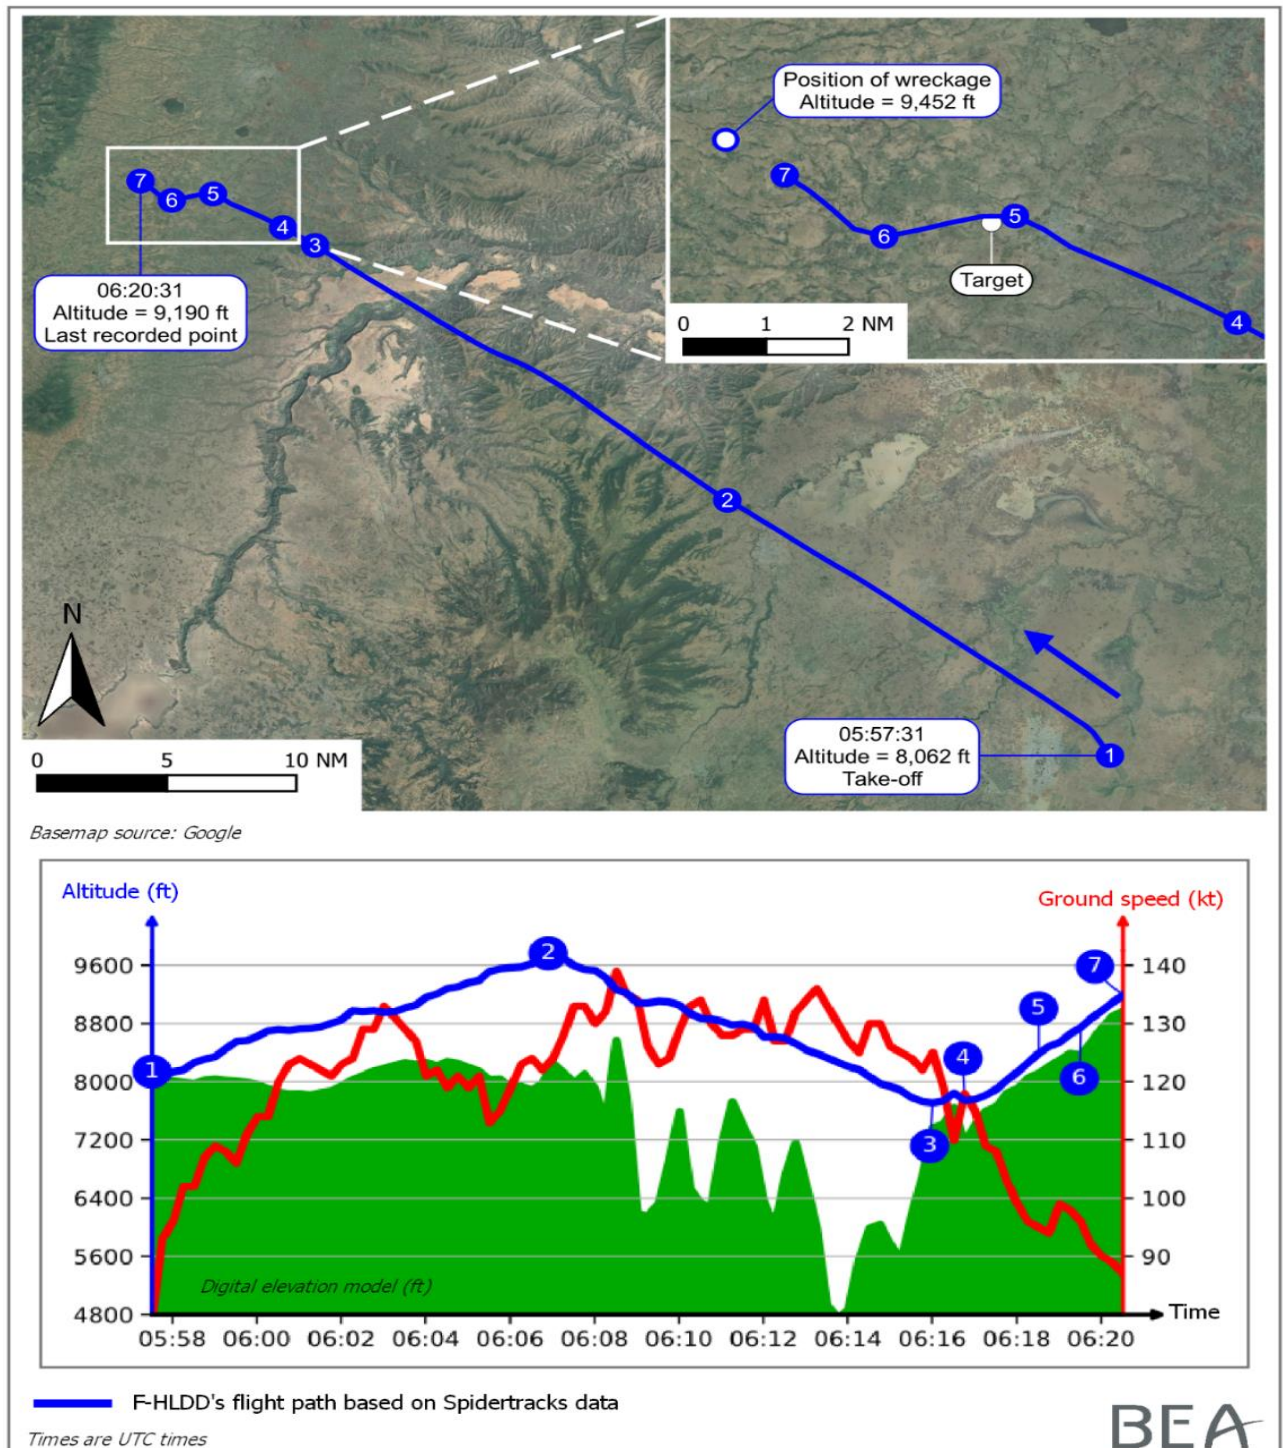
There was no other solution for him at that time than performing a forced landing. Any turn could cause a stall. The pilot maintained his current heading and very likely looked for a suitable land. The area ahead of him was composed of fields, little woods and scattered housing. He chose a set of fields which, from his position, probably seemed to be flat with no obstacle. However the fields are surrounded by

ditches and mounds which could not be easily spotted from the sky. Farmers working in the fields witnessed that the aircraft was dumping the chemical before it crash landed. The landing gear hit a first mound of earth, continued its run on about 10 meters and hit a second mound head-on. At impact the plane turned approximately 150 ° on itself to the right and caught fire causing the total damage of the aircraft.
