Accident to the PIPER - PA30
registered **N7977Y**
on 2 March 2021
at Courcelles-sur-Viosnes

Right engine shut-down in airport circuit, difficulty in holding level flight, forced landing in a field, in instruction

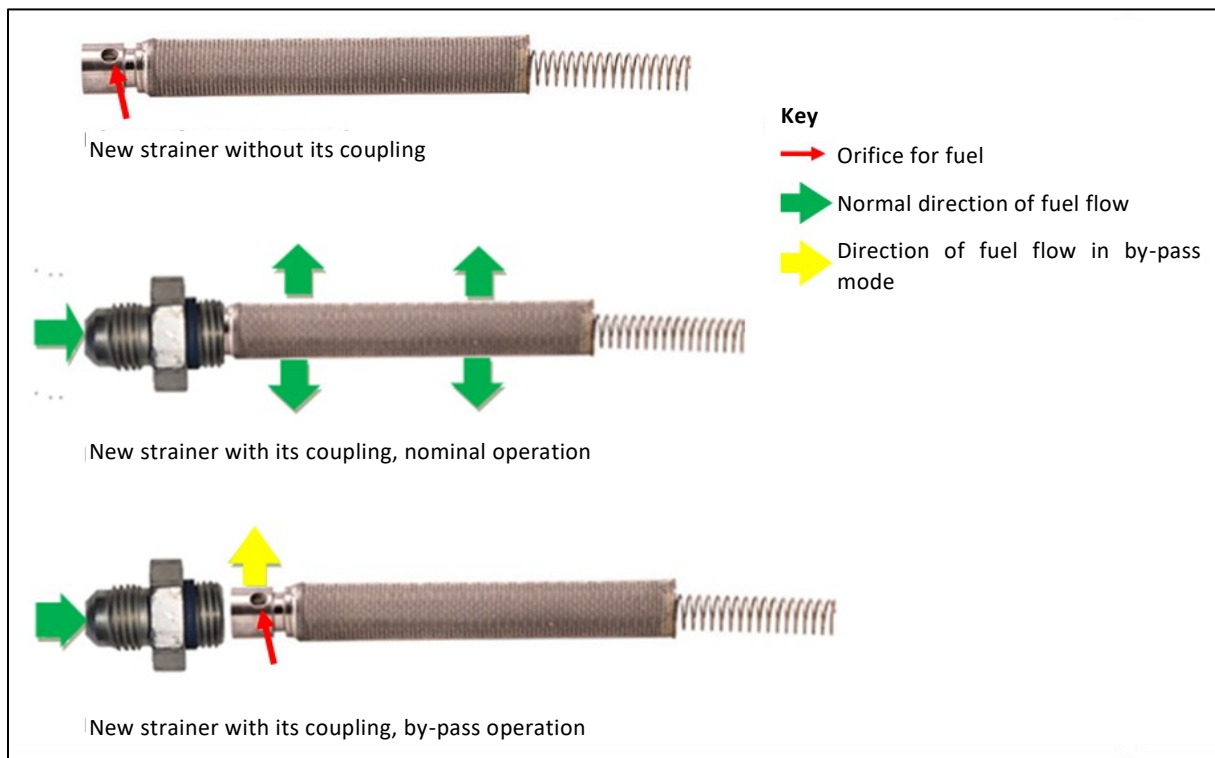
Figure 5: FSI strainer operating principle (source: BEA)

The fuel strainer of the right FSI was found bent. This distortion implies that the strainer will take a "bypass" position when installed in the FSI. The fuel is then no longer filtered. It should be noted that the strainer could be installed in the FSI without any particular difficulty despite this distortion and that it was difficult to detect that it took a bypass position.

Figure 5 below details the operation of a strainer in good condition, i.e. not bent.
