INVESTIGATION REPORT

Incident to the ATR 72-212A operated by Caribbean Airlines registered 9Y-TTC on 4 May 2014 at top of descent to Piarco airport (Republic of Trinidad and Tobago)

Safety investigations

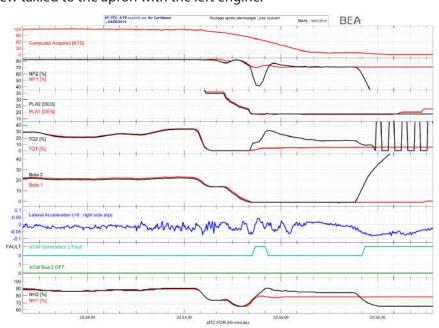
Figure 2: QAR parameters recorded during landing run on 5 May 2014

The next day, the aeroplane took off from Piarco international airport bound for Arthur Napoléon Raymond Robinson international airport . The flight proceeded normally. The recorded parameters were normal with no difference in values between the left engine and the right engine. During the landing run, the crew reported a loud vibration noise when they moved the power levers from the flight idle to ground idle position. The recordings showed a reduction in torque of both engines, to around zero whereas the angle of the propeller blades was at 1° and the propeller rotation speed was at 71% Np. The rotation speed of the right propeller decreased with respect to that of the left propeller and the torque provided by the right engine increased again, up to 27 % more than the left (31 % compared to 4 %). Thereafter, the right engine provided around 10 % more torque than the left engine up to its shutdown (Figure 2). The crew reported that the vibrations and noise disappeared when the right propeller was feathered. No warning appeared in the cockpit. The crew taxied to the apron with the left engine.

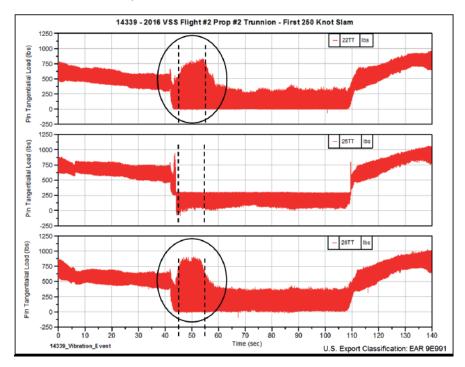
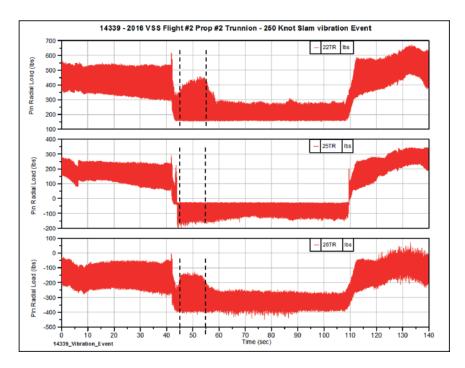
During 2016 VSS flight, trunnion cyclic load increase event was noted on two 250 knot descent maneuvers. This trunnion load "vibration event" occurred immediately after the first 250 knot slam on flight 2.

The two following figures show the complete prop 2 tangential and radial 2000 Hz strain gage recordings. The 'vibration event' is the load amplitude increase on gages 22TT, 26TT, 22TR and 26TR that occurs immediately after the PLA reduction.

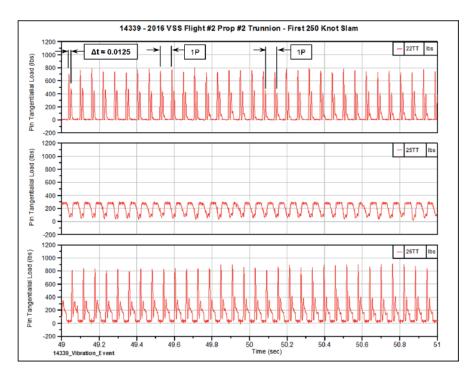
At this resolution, two distinct load peaks occurring at 1P intervals are visible in the 22TT and 26TT signals. The first peak is the higher load on the aft plate. The second peak occurs 0.0125 seconds after the first peak, also on the aft plate. This implies a double impact load on the aft plate. No double impact was observed for the forward plate for any case. Since the air data is only sampled at 0.125 second intervals, it cannot be directly correlated to the load data to identify drivers of such a double impact load. Additionally, blade angle is derived from actuator position, which disallows identification of different blade angles for different blades.

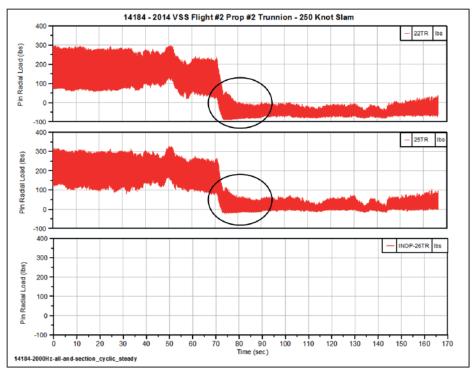
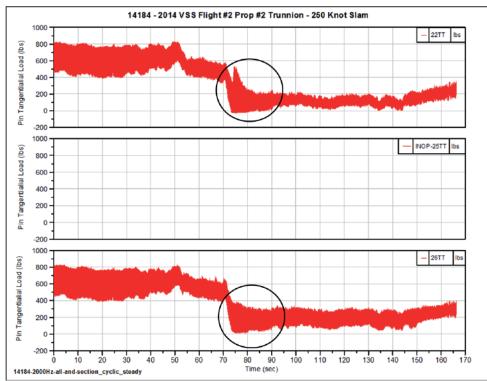
For comparison, 2014 VSS 250 knot slam data was analyzed. Prop 2 trunnion gages show a small dip in the cyclic load after PLA reduction occurring during 6 seconds. Trunnion data shows that it is unloading the aft plate to a near zero load between impacts.

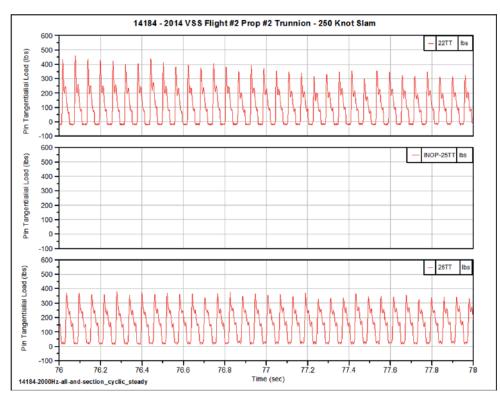
The 26TT sensor does not dip below zero because of a positive offset in the gage. Similarly, although both 22TR and 25TR 2000 Hz signals show a dip after slam, both are below zero due to gage offset.

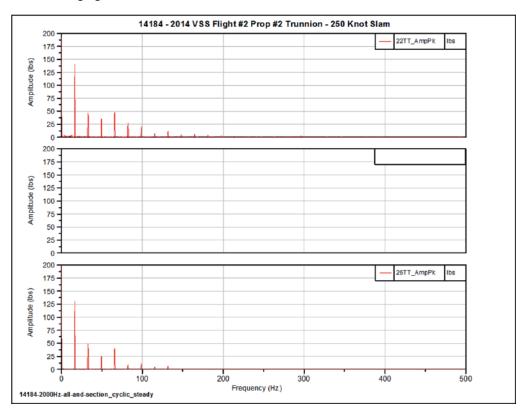
It reveals a broadband frequency response similar to that of 2016 VSS (250 knot slam.).
