Accident to the Tecnam P2002-JF
registered **F-HFCM**
on 26 July 2015
at Compiègne aerodrome (Oise)

Fatigue failure of left main landing gear while taxiing during a training flight

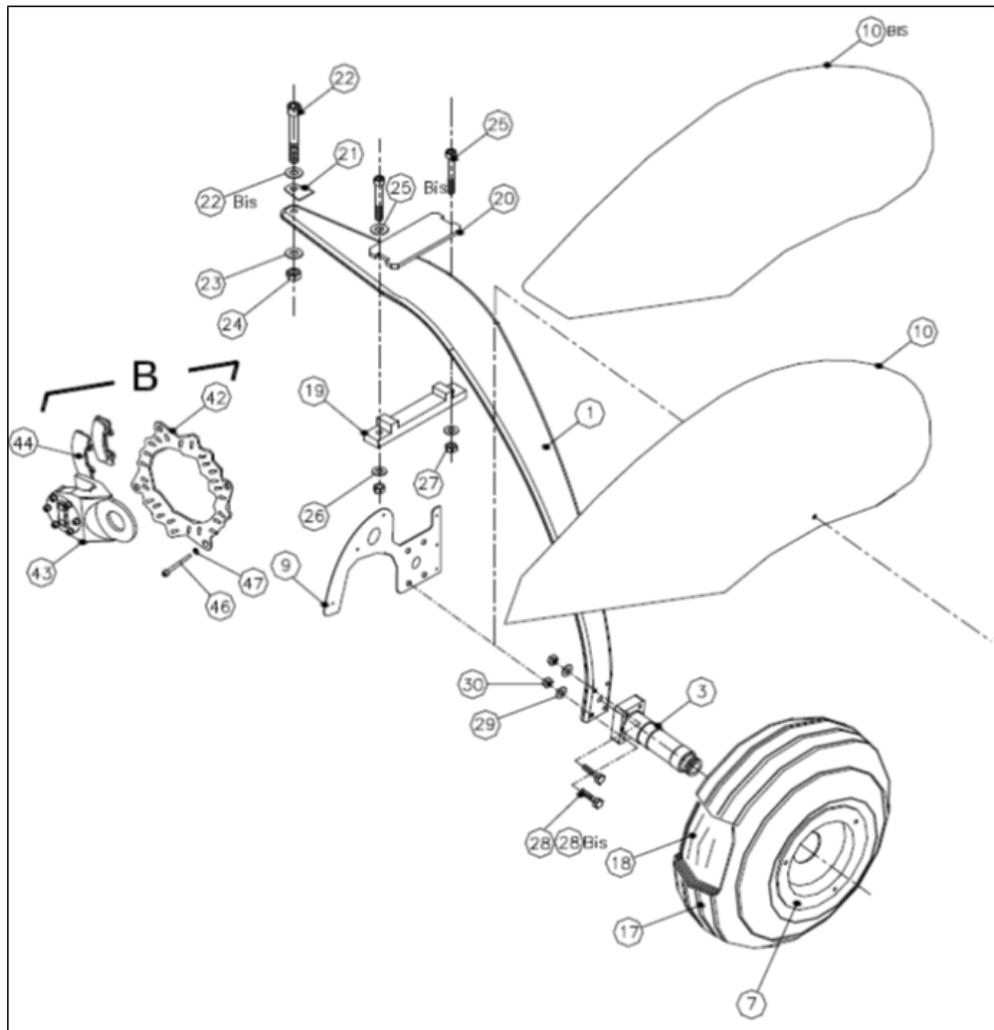
Figure 1: diagram of right main landing gear (taken from Tecnam P2002 Illustrated Parts Catalog)

The left main landing gear's central attachment bolt (22) was found broken into two parts.

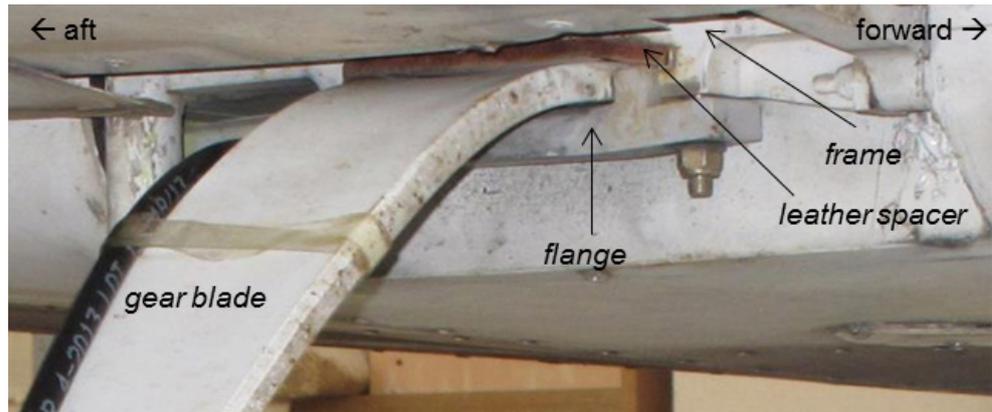
Figure 5: right main landing gear attachment before disassembly

The right main landing gear central attachment bolt was taken for examination. It had circumferential markings on its shank, approximately 33 mm below the head, in the same location where the left bolt had fractured. Between this marking and the head, numerous circumferential wear marks could be observed, as for the left landing gear bolt. A SEM examination showed a circumferential crack in the same location as the left bolt fracture.

The crack in the leaf spring central attachment bolt of the right main landing gear was opened up in the BEA laboratory. Examination of the fracture surfaces showed two diametrically opposed fatigue cracking areas, characteristic of alternate bending loading.

Furthermore, when carrying out the 50-hour check of the bolt torque value, the replacement of the leather spacers is now required if damage is observed.
