Accident to the SCHEMPP HIRTH - JANUS C registered F-CFAL

on 25 June 2019

at Laval Entrammes aerodrome (Mayenne)

Spurious air brake extension during winch launch, hard landing

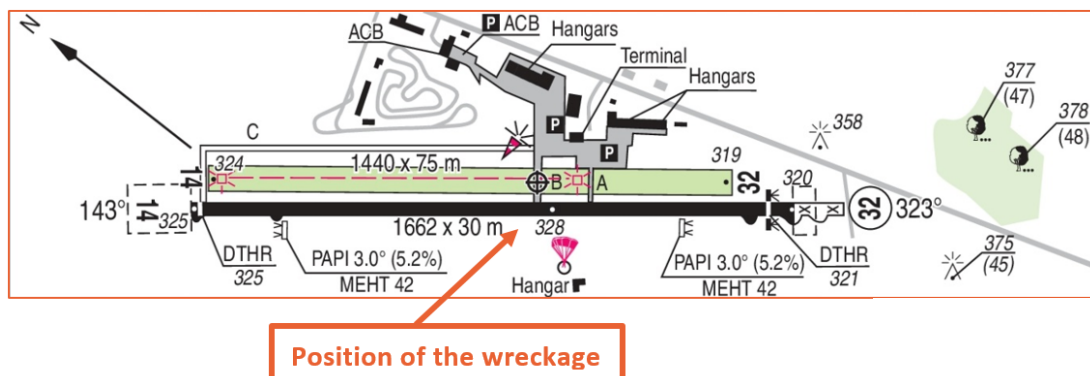
Figure 2: excerpt from the VAC

Laval Entrammes AFIS aerodrome has two parallel runways oriented 14/32. One is paved, the other is grass. QFU 32 is the preferred QFU with a right-hand pattern into the grass runway, which is 1440 m long and 75 m wide. Two taxiways, A and B, leading to the paved runway cross the grass runway. Two taxiways, A and B, leading to the paved runway cross the grass runway.
