Low oil pressure on one engine in cruise, diversion, dual hydraulic failure during landing roll

Aircraft	Airbus A320 registered CS-TKP
Date and time	25 April 2014 at 07 h 45 ⁽¹⁾
Operator	Thomas Cook
Place	Toulouse Blagnac Airport (31, France)
Type of flight	Public transport
Persons on board	Captain (PF), co-pilot (PM), 5 cabin crew members, 179 passengers
Consequences and damage	None

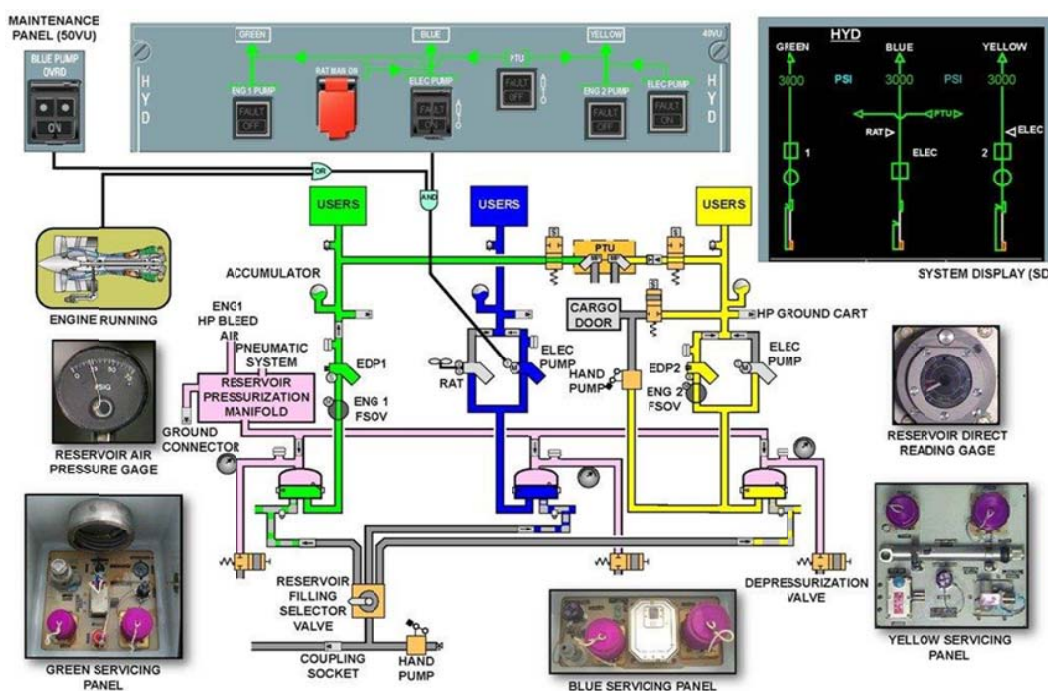
- ☐ a "green" system, pressurized by a pump⁽⁴⁾ (EDP 1,) driven by engine no.1;
- ☐ a "blue" system pressurized by an electric pump that can be supplied by a Ram Air Turbine in case of failure;
- ☐ a "yellow" system pressurized by a pump (EDP 2) driven by engine no.2. An electric pump and a manual pump can operate the yellow system.

A Power Transfer Unit (PTU) also allows one of the systems (yellow or green) to increase the pressure of the other (green or yellow) when a pressure differential of 500 Psi is detected between the two systems. This system works without exchanging any fluid.
