Accident to the replica Fokker DR1 identified 59DPK

on 28 December 2019

at Valenciennes-Denain (Nord)

Pilot incapacitation, asymmetrical stall in initial climb, collision with the ground

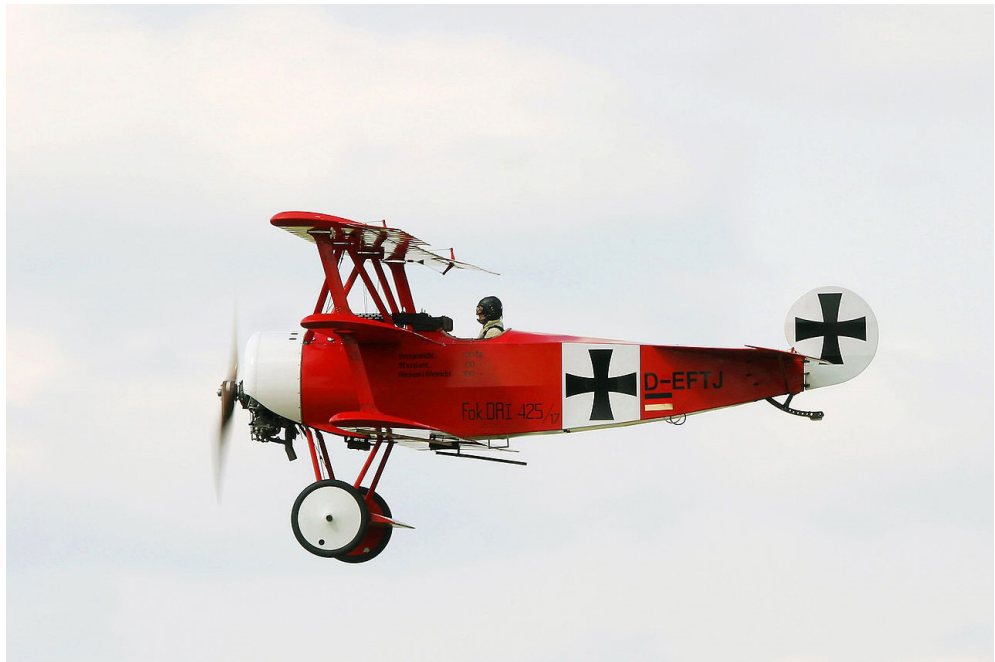
The microlight was a 7/8-scale replica of the historic Fokker DR1 triplane. According to the statements taken during the investigation, the pilot built this replica himself based solely on photographs. No document relating to the build was found. Moreover, the pilot had already built several other different types of aircraft.

Replica of Fokker DR1
