Accident on 29 June 2021 at Paris-Charles de Gaulle airport (Val-d'Oise) during disembarkation from the **AIRBUS A350** registered F-HTYH

Fall of a passenger on steps during disembarkation

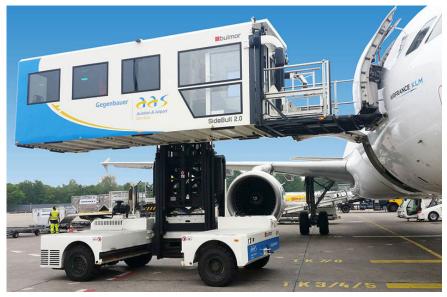
Figure 1: example of HELP vehicle

(2) Vehicle with lift adapted to the specific requirements of the PRM assistance services. The model in question has a maximum capacity of eight passengers.

The cabin crew members stated that the list of passengers selected to take the HELP vehicle had not been given to them before the arrival. It was only during the disembarkation phase, after the able-bodied passengers had boarded the buses, that the arrival agent handed this list to the chief purser, who had to explicitly ask for it. The cabin crew added that it is usual for the situation to become confusing when disembarking a lot of PRMs away from the terminal, as passengers not initially identified as PRMs may request assistance due to fatigue caused by a long flight, and their travel companions often want to board the HELP vehicle.
