Mid-Air Collisions

1989-1999

SAFETY STUDY

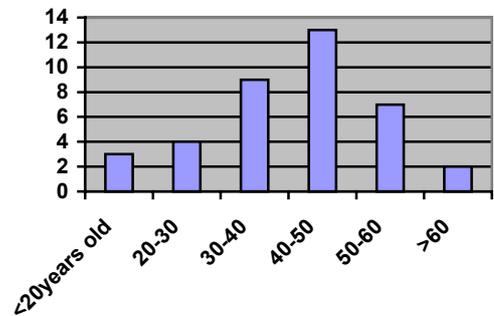
The accompanying bar graph shows the various age ranges of the pilots. All those in the cockpit were taken into account.

Note that all the age ranges are affected by mid-air collisions, with an increase up to the 40-50-age range.

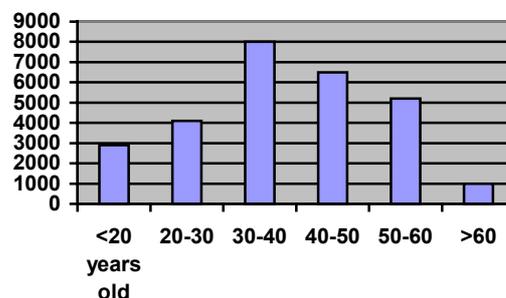
As a rough guide, the second graph shows the age distribution of the private pilot population in 1997. The two graphs show almost the same trend, with the 40-50 age group - where there are a smaller number of licensed pilots - having a higher number of mid-air collisions.

Notice: the above analysis is based on a small group sample and, in the absence of information regarding the exact activity of the pilots in each age group, it seems difficult - not to say impossible - to try to interpret the above findings.

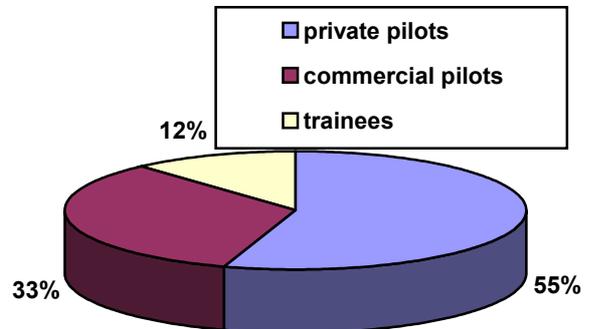
The accompanying pie chart represents the different flying licenses held by the pilots who were in the cockpit during the mid-air collisions studied.

The collisions involved all pilots, regardless of the license they held. The great majority were private pilots. Of the pilots holding a commercial pilot's license, three involved transport aircraft and the others were instructors.

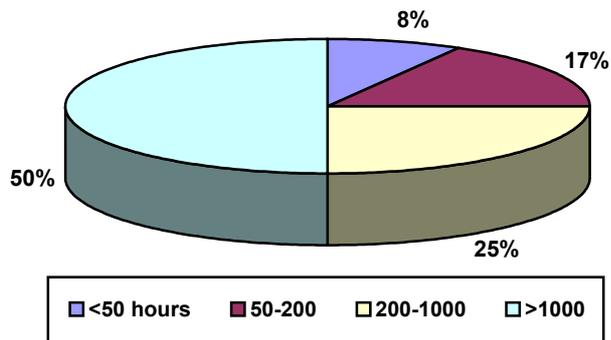
The accompanying pie chart shows the overall flying experience of the pilots involved in the collisions, the number of hours logged for each aircraft corresponding to the number of hours flown by the most experienced pilot in the cockpit.

Note that all types of pilots, experience notwithstanding, are involved in mid-air collisions, with a large number having more than 1,000 flying hours (50%)

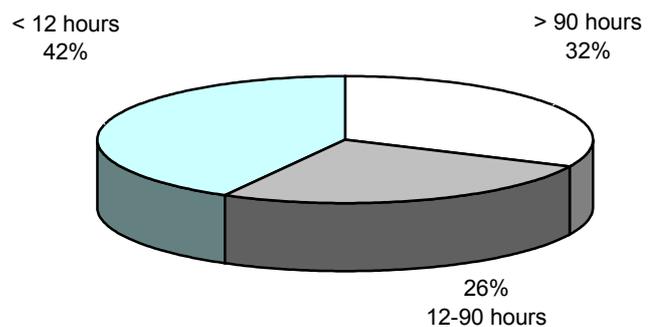
Recent flying experience, covering the last three months of the pilot at the controls, was studied. The 90-hour sector corresponds to professional pilots or instructors. The 12-hour sector corresponds roughly to private pilots flying about one hour per week. In seven cases, the recent experience of the pilot at the controls was very low (about one hour per month).

The lack of recent experience, which lowers the outside monitoring of the pilot in the aircraft, is certainly a serious factor. Nevertheless, it is important to note that pilots who fly regularly are not immune to mid-air collisions.

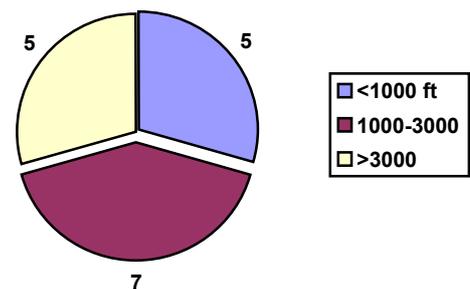
The accompanying graph shows that these accidents occurred mainly below 3,000 feet. It is in this altitude range that most VFR flights are found. In fact, this corresponds to departures, arrivals and aerodrome circuits, as well as a large number of flights in VFR cruise.

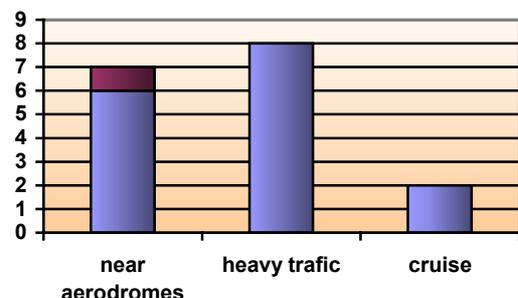
Seven collisions occurred around an aerodrome. In six cases, one of the two planes was in the integration phase. The seventh accident occurred on the extended centerline. One collision occurred at a controlled aerodrome. Air-to air communication was in force at the other aerodromes.

Eight collisions took place in zones where the concentration of traffic is high (vicinity of aerodrome, overhead a radio navigation device, large number of gliders). Only two mid-air collisions took place during cruise.

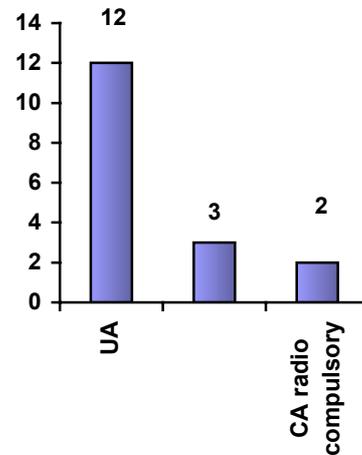
Twelve collisions occurred in uncontrolled airspace (UA). Three took place in controlled airspace (CA) in which radio contact was not compulsory. Finally, there were two accidents in controlled airspace where radio contact was compulsory.

In three cases, one of the two aircraft was passing from controlled airspace to uncontrolled airspace.

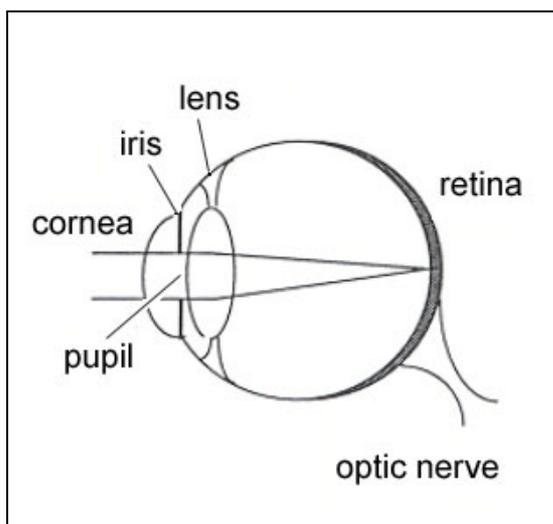
The front part of the eye is called the cornea, a transparent tissue protecting the eyeball. The iris is the colored part of the eye. In the center of the iris is the pupil that allows light to enter the eye. Behind the iris and the pupil is the lens that changes shape through muscle action. This action enables the lens to focus objects at varying distances on the retina.

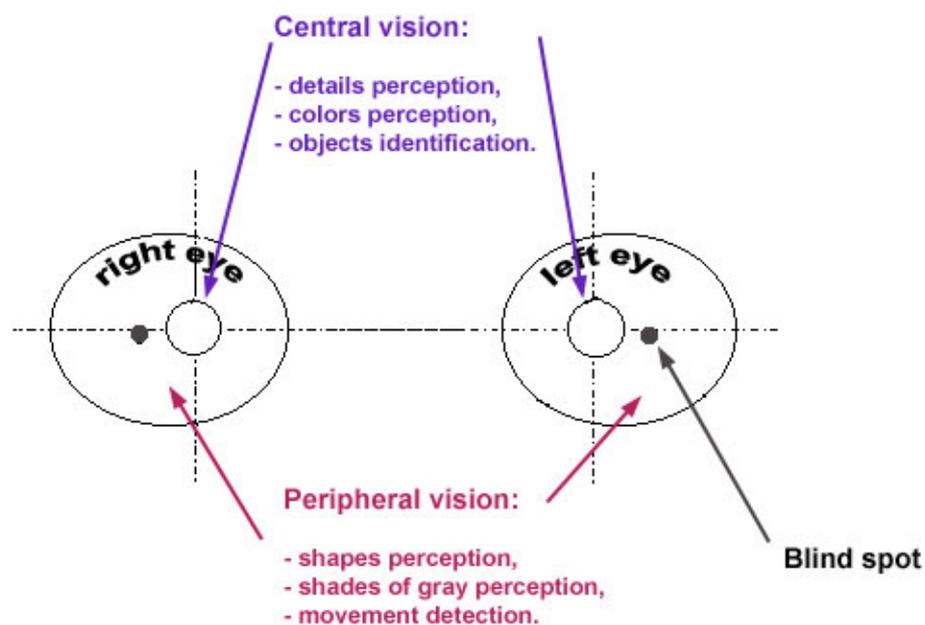
The eye contains about 125 million light-sensitive cells (120 million rods, 5 million cones). The information from these cells is sent to the brain via the optic nerve. This optic nerve consists of around one million nerve fibers. Its function is the coding of the information before sending it to the brain. The optic nerve is connected to the retina at a point where there are no light-sensitive cells. This area is called the blind spot. It is centered, according to certain individuals, between 10 and 16° to the left of the optical axis for the left eye and 10 and 16° to the right of the optical axis for the right eye with each covering a square section of about 3°. No detection is possible in these monocular visual areas. To compensate for the lack of detection in the blind spot of one eye, the brain uses information collected from the other eye.

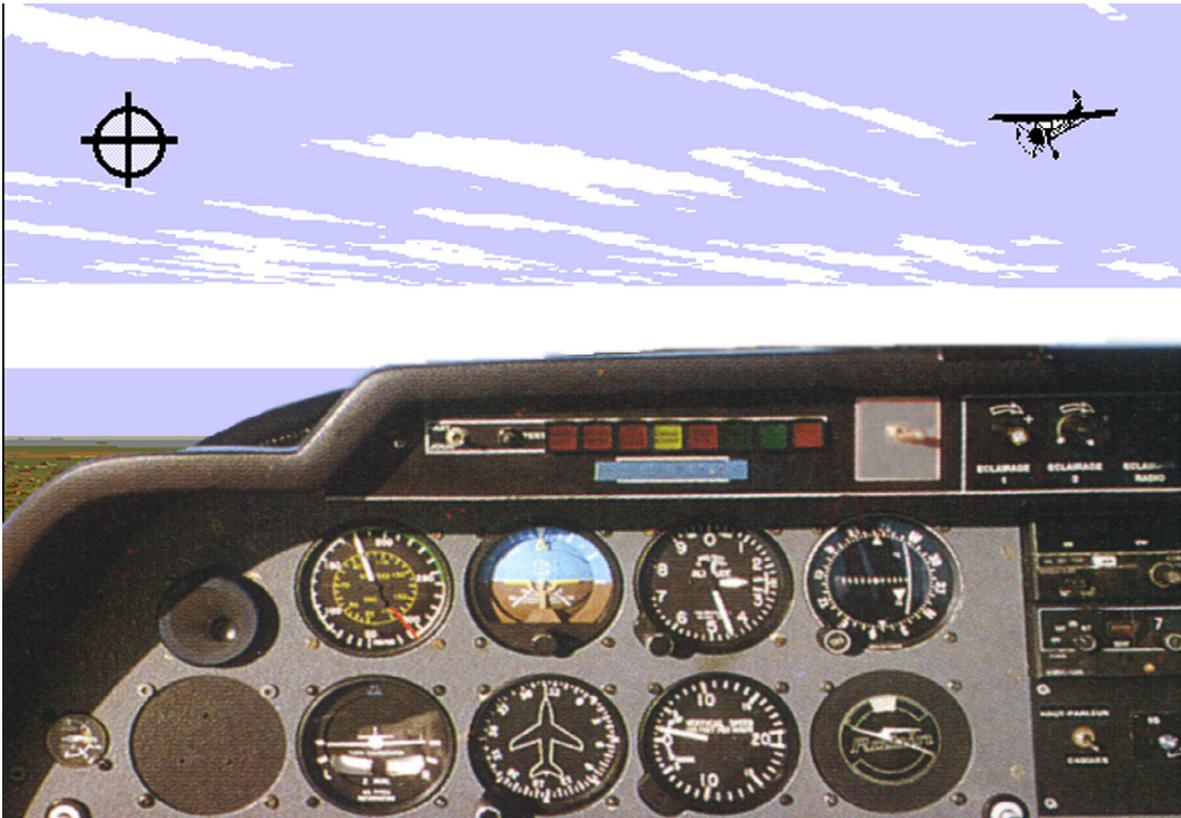
To demonstrate the eye's blind spot the reader should refer to the following illustration. Cover the left eye and focus on the cross with the right eye. Holding the diagram at arm's length, move it forwards until the plane disappears.

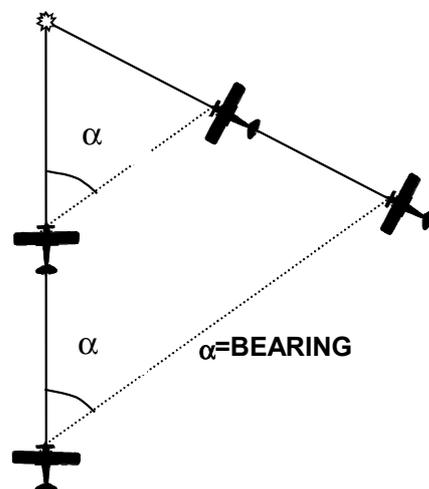
The pilots of two aircraft flying at a constant speed and altitude and having convergent trajectories will each see the other aircraft at a constant bearing. In other words, the converging traffic will be motionless for the pilot. This visual immobility is dangerous because detection is very often made through peripheral vision and, as seen previously, peripheral vision is mainly stimulated by movement.

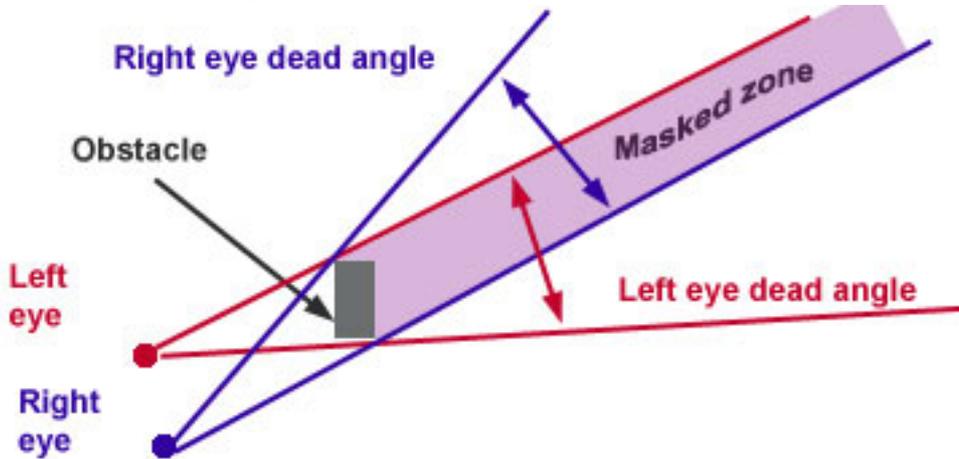
Binocular vision passes on two images from the eyes to the brain. For an object placed at infinity both images are similar. For an object moved closer (around one meter) it is observed by both eyes at different angles. This phenomenon allows terrain to be differentiated.

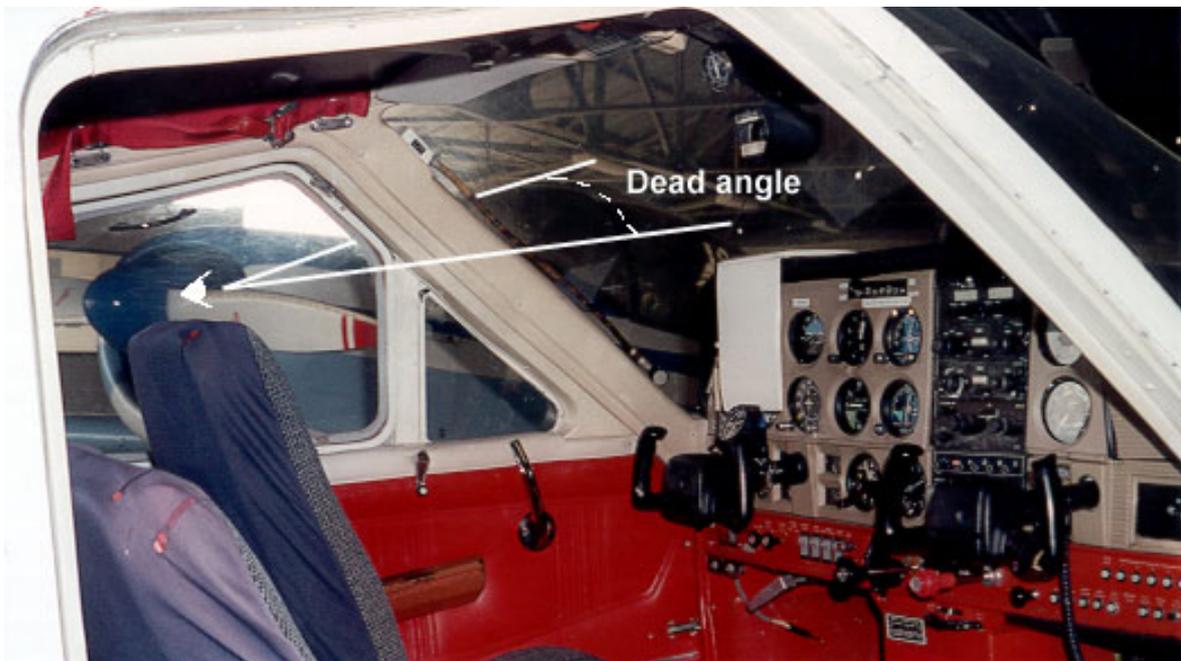
The outside visibility limitations are shown below for the C177, due to the dead angle caused by the door and windshield posts.

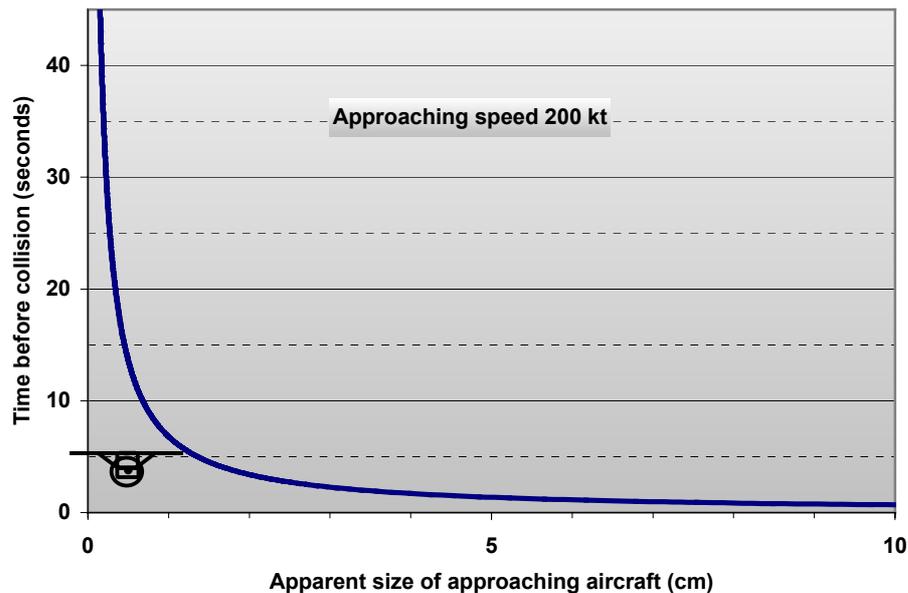
When two planes are approaching, their pilots will obviously see the other plane get bigger. However this increase in size does not follow a law of linear variation. The following drawing illustrates this phenomenon. It represents the view that a pilot flying a plane at 100 kt has of another approaching plane also flying at 100 kt and with about a ten-meter wingspan. In order to better illustrate the drawing, place it at arm's length.

The previous illustration shows the size of an aircraft approaching at low speed five seconds before impact. Detection of this small target, integrated into the workload of the pilot, is not easy.
